HOW EFFECTIVE IS HEC-RAS 2D AT PREDICTING STREAM INSTABILITY?

- A STUDY BASED ON NATURAL CHANNEL DESIGN STREAM RESTORATION SITES

- By Blair Borries

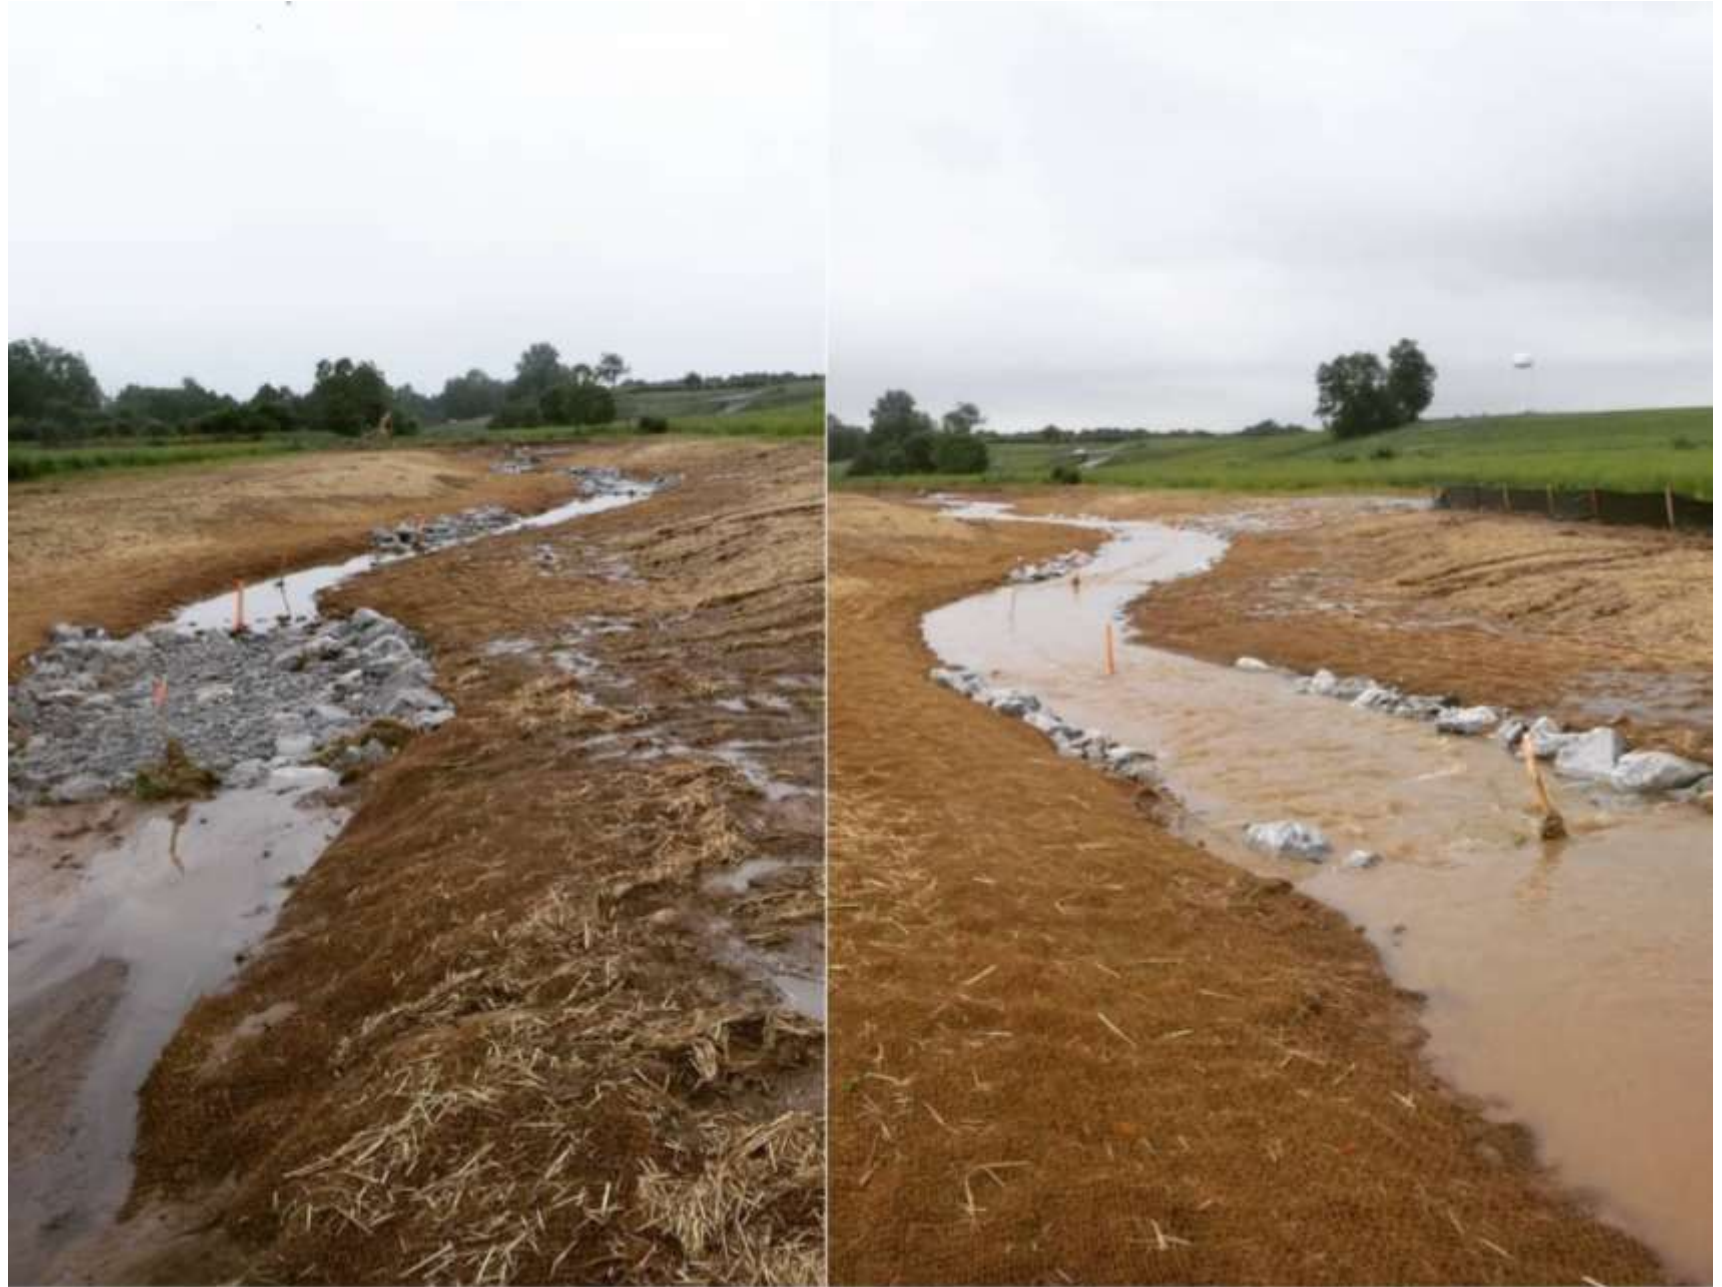
(Pictured: Medline Stream Mitigation before the storm and 30 minutes later)

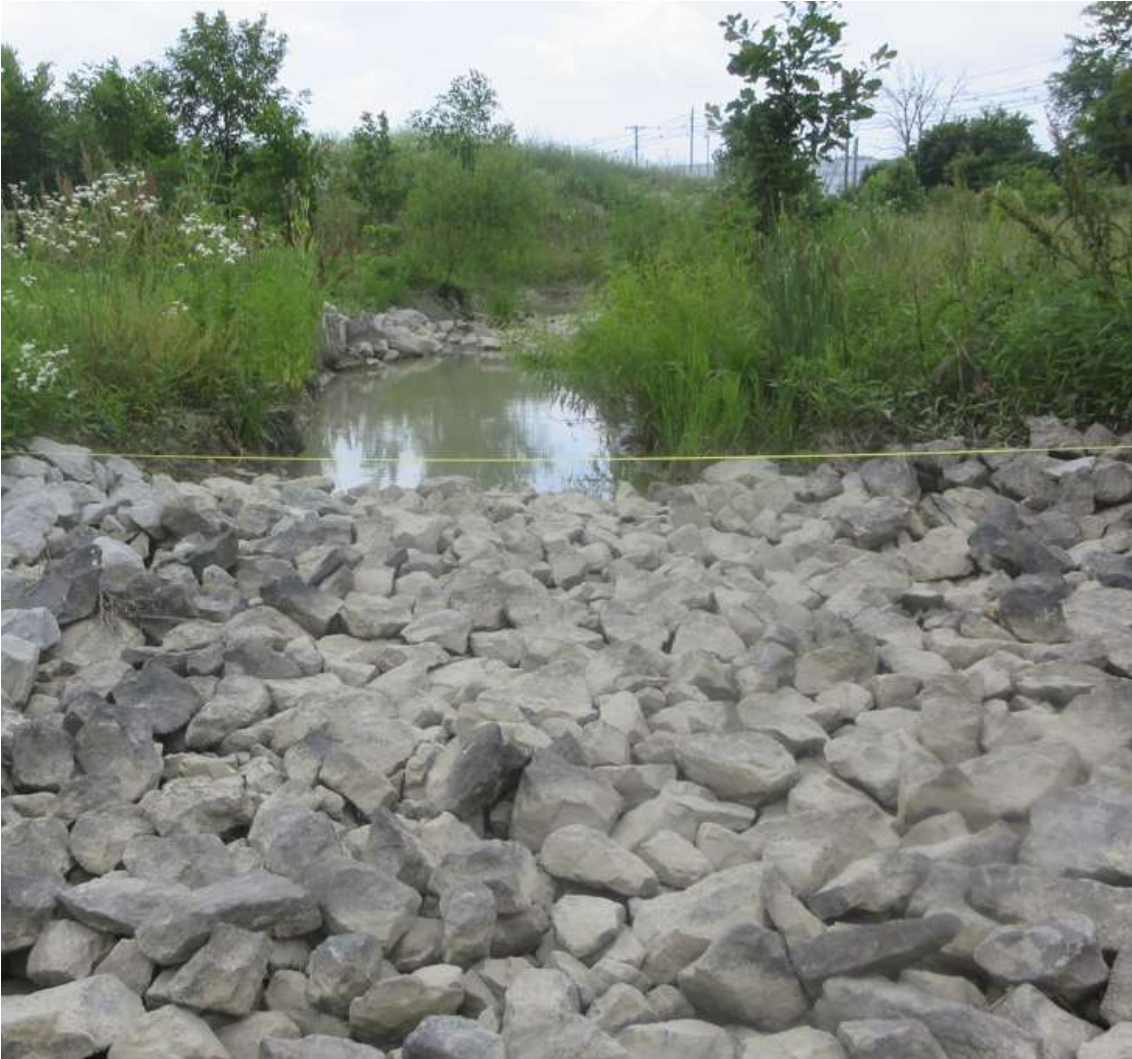
Cross section 6 looking upstream (2022)

- Background:
 - 4,000 feet intermittent re-establishment, built in 2016
 - 8 cross sections monitored, 6 riffles and 2 pools
 - A culvert divides the stream in the middle
- Riffle Cross section 6 had the highest velocity (2.98 ft/s) and shear stress (0.64 lb/ft²) and continues to meet success criteria (<25% Deviation) after 6 years
- Riffle Cross section 1 and Pool Cross Section 5 failed to meet success criteria, both have shear stress below 0.25 lb/ft² and velocity below 2 ft/s
- Based on field observation, does not reflect where cross sectional changes fail to meet criteria

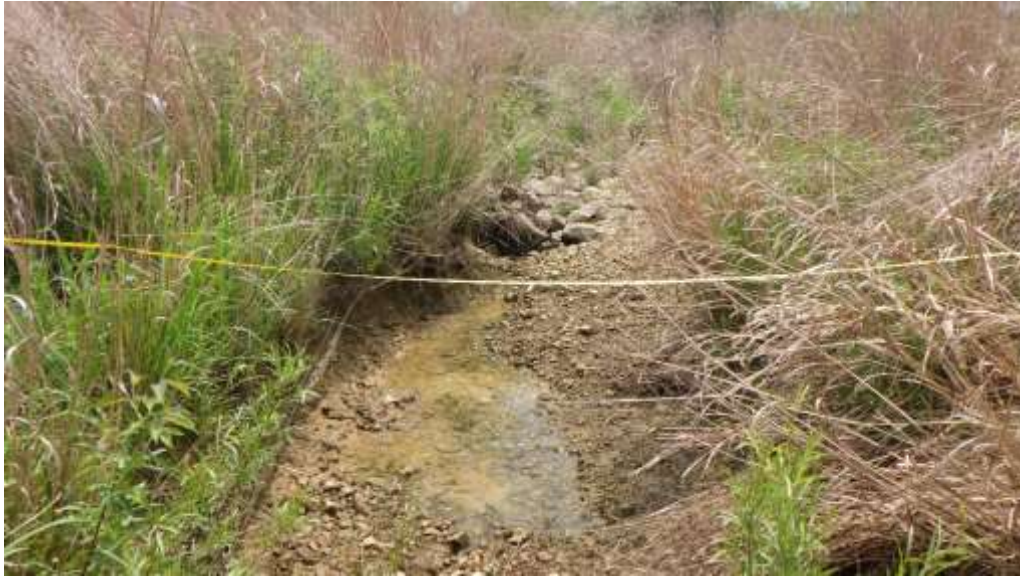
Cross section 2 looking downstream (2023)

- Background:
 - 1,100 feet intermittent rehabilitation, built in 2018
 - 4 cross sections monitored: 2 riffles and 2 pools
 - Karst watershed >2 sq miles, stream sized for much small watershed downstream of sinkholes
- Riffle Cross section 4 had the highest velocity (3.61 ft/s) and shear stress (0.92 lb/ft²) and continues to meet success criteria (<25% Deviation) after 6 years
- Pool Cross section 2 and 3 failed to meet success criteria for bankfull depth and area, both have shear stress below 0.4 lb/ft² and velocity below 2.6 ft/s
- Based on field observation, does not reflect where cross sectional changes fail to meet criteria; especially in terms of vertical scour depth

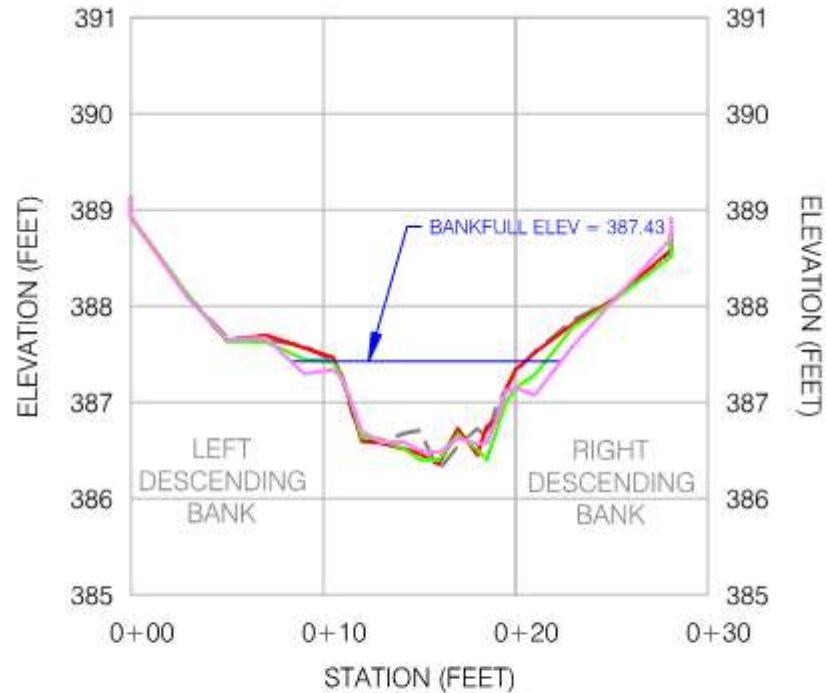
INTERMITTENT STREAM 1 - RIFFLE CROSS SECTION 10 AT STATION 33+04

- Background:
 - 4,600 feet of intermittent re-establishment and rehabilitation, built in 2020
 - 13 cross sections monitored: 7 riffles and 6 pools
 - This site contains a monofill to the north with steep slopes and a catch basin before flow can reach the stream from overland flow.
- Riffle cross section 10 had the highest velocity (3.3 feet/sec) and highest shear stress (1.15 lbs/sq ft) and exceeded success criteria for bankfull width (40.5%). This cross section also had the highest deviation in the maximum depth criteria (15.9%) compared to other cross sections
