# Long-term Study of the Effectiveness of In-stream Structures near Bridges for Streambank Stability

**Jason R. Vogel, Ph.D., P.E.**

Civil Engineering and Environmental Science  
University of Oklahoma

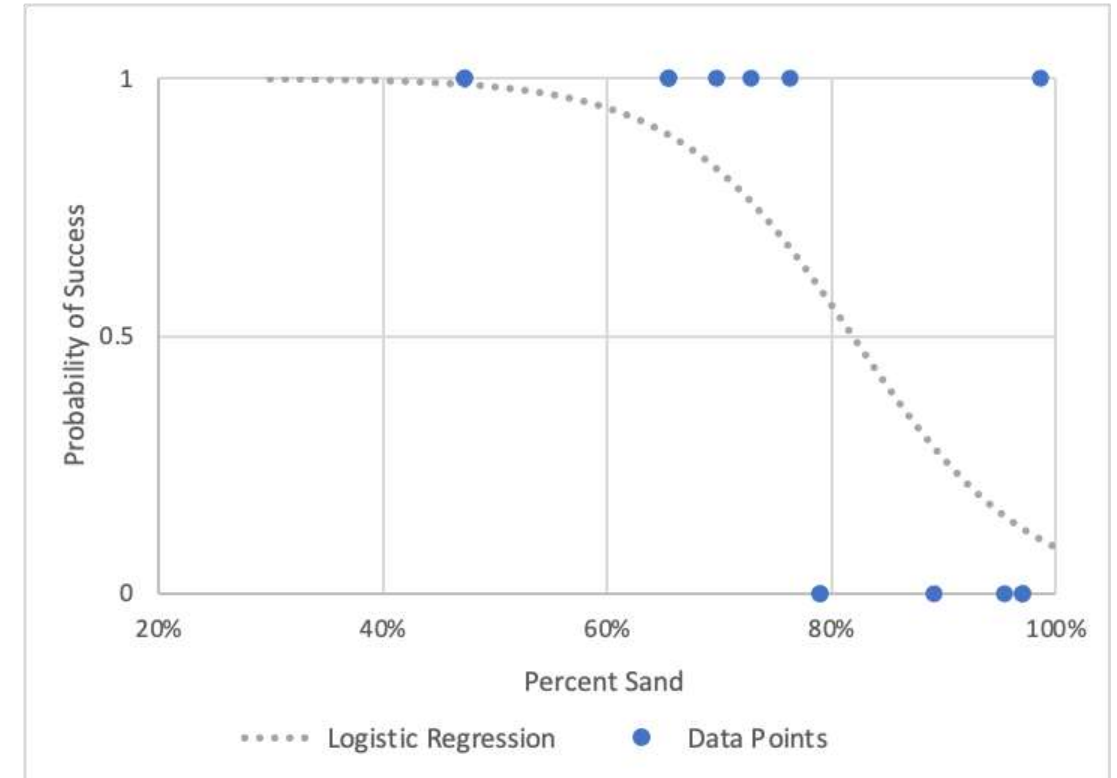
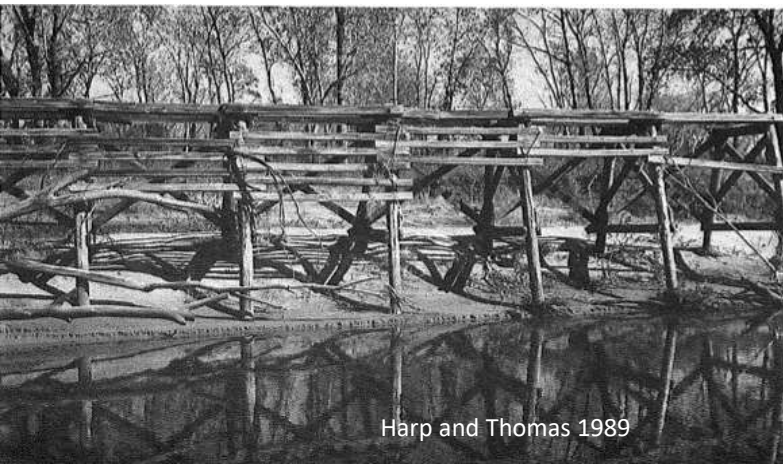
- 10 sites, 14 installations
- 52-71 years old, 63 years old on average
- Most were badly damaged
- Deemed failure if stream eroded behind pile diversions
- 57% successful (8/14 successful)
- Percent sand and precipitation within first three years correlated to their success

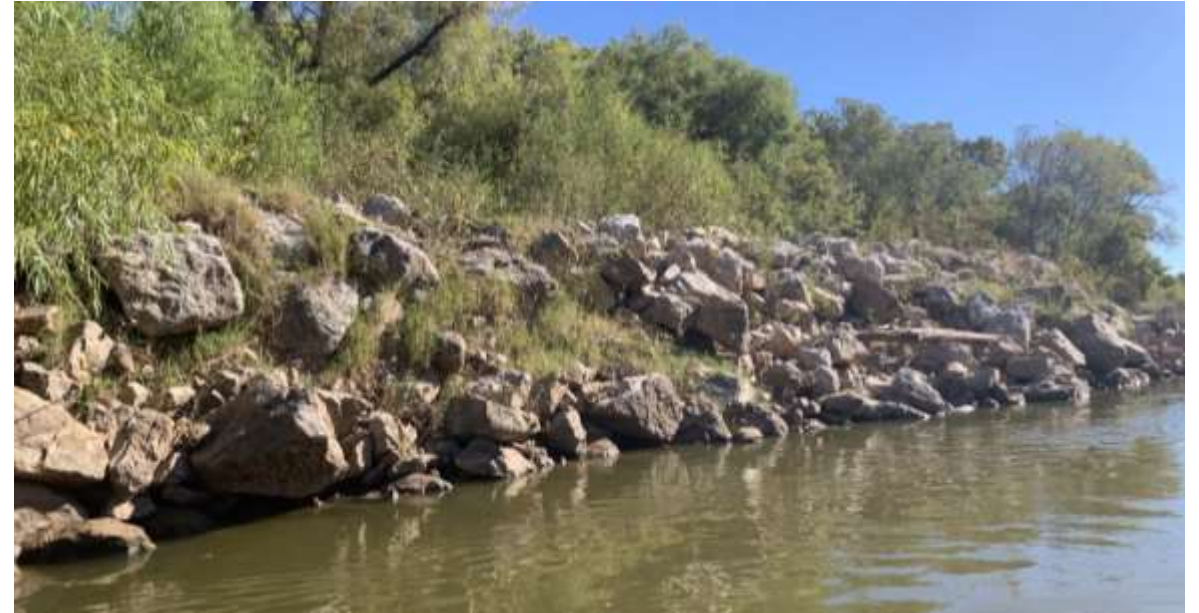
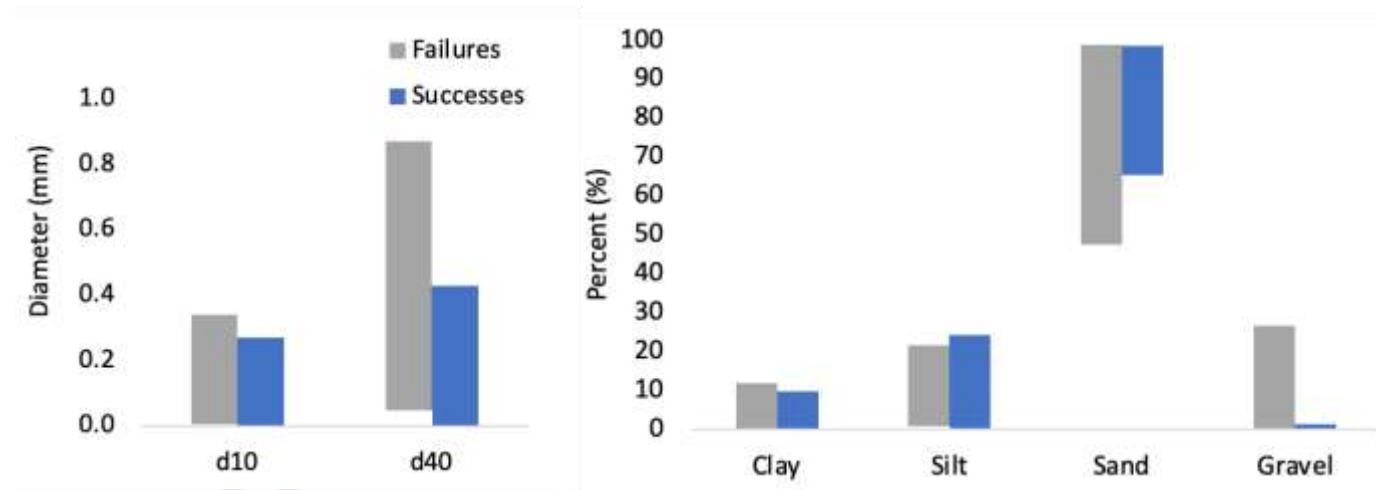
- 12 sites, 13 installations
- 32-70 years old, 54 years old on average
- Deemed failure if washed away
- 46% successful (6/13 successful)
- No significant regressions

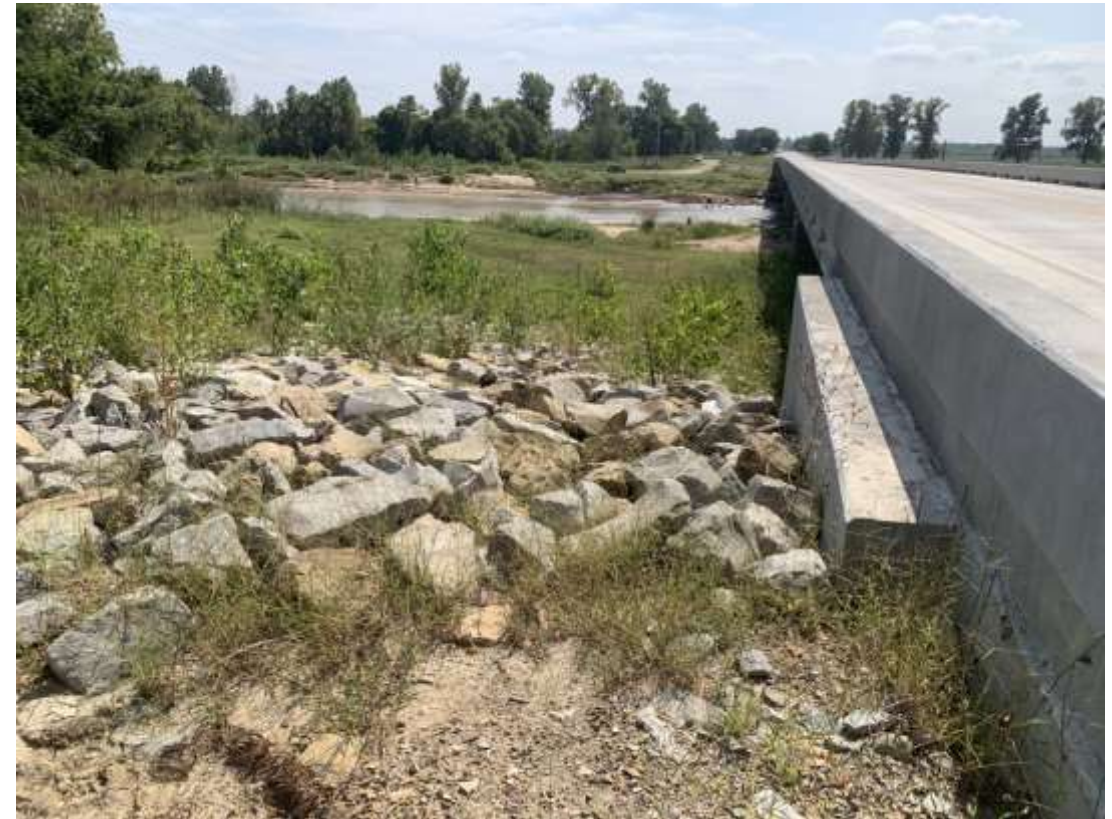
- 7 sites, 8 installations
- 49-64 years old, 62 years old on average
- Deemed failure if stream cut behind it
- One failure
  - Old bridge abutment rip rapped to be used as a spur dike
- Largest return period in watershed = 68 years

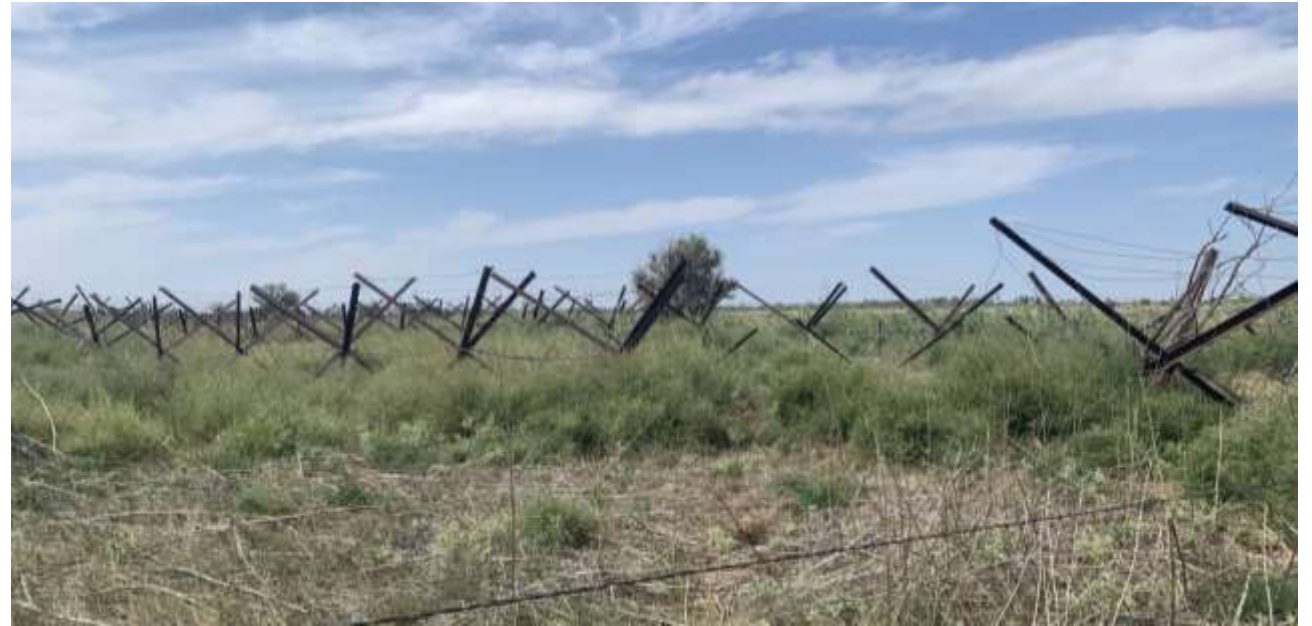
- 22 sites, 28 installations
- 17-94 years old, 61 years old on average
- Deemed failure if stream eroded through jetty field
- 79% successful (22/28 successful)
- Site 21 had largest thalweg movement
  - Kellner jetties washed away
  - Bridge washout

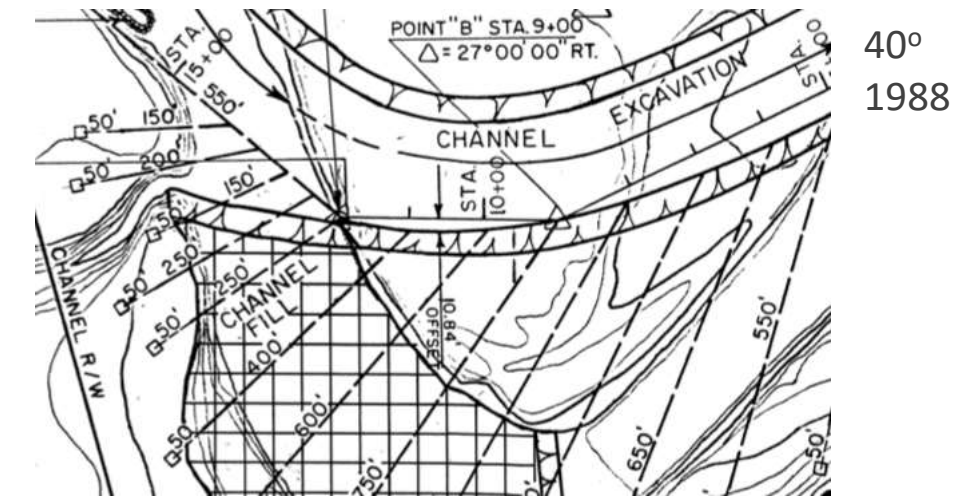
40°  
1988

- Higher angle between Kellner jetties and thalweg, more likely to succeed

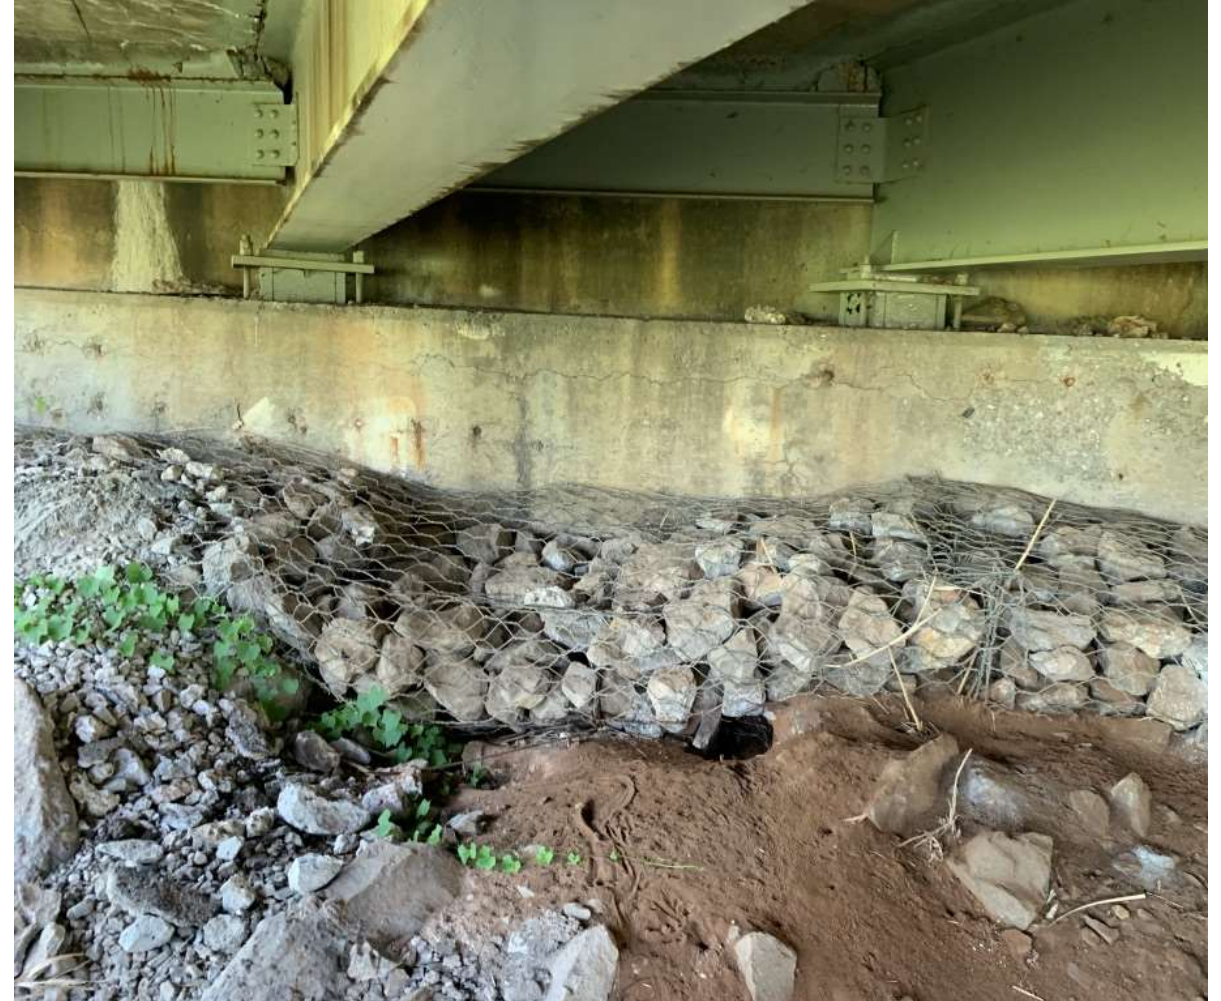
- Gabion baskets successful at less sandy site
  - Sunk into sand
  - Common problem with gabion baskets (Freeman and Fischenich 2000)
- Rock drop structures were both successful

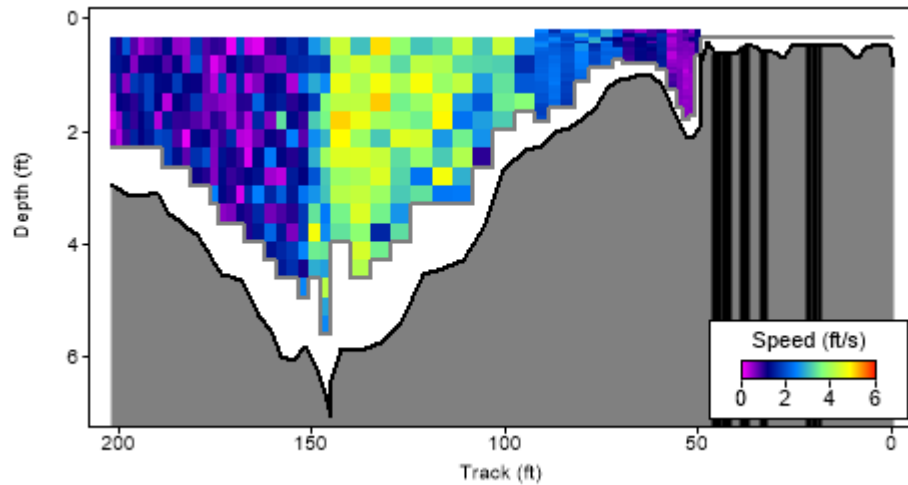
Site 1 – Washita River and U.S. 77 NW of Wynnewood, Garvin county

Very Low (Left)

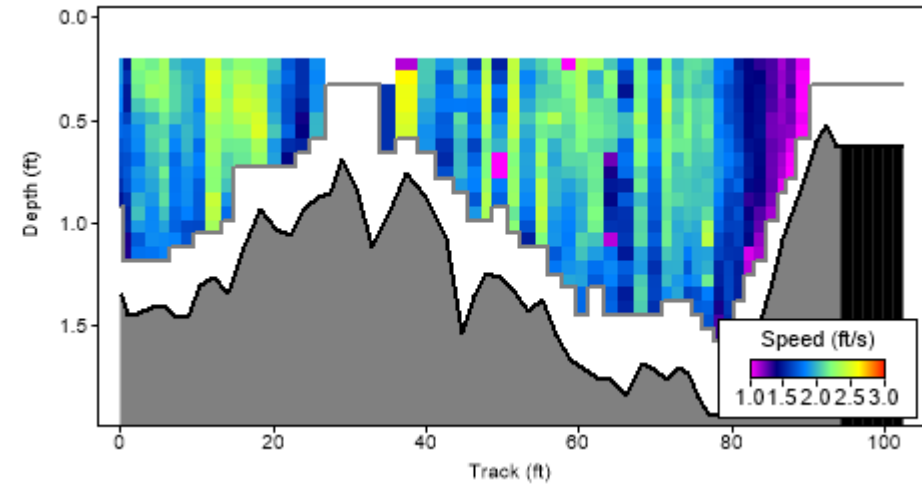
Site 27 – North Canadian River and S.H. 99, Seminole county

Low (Left)

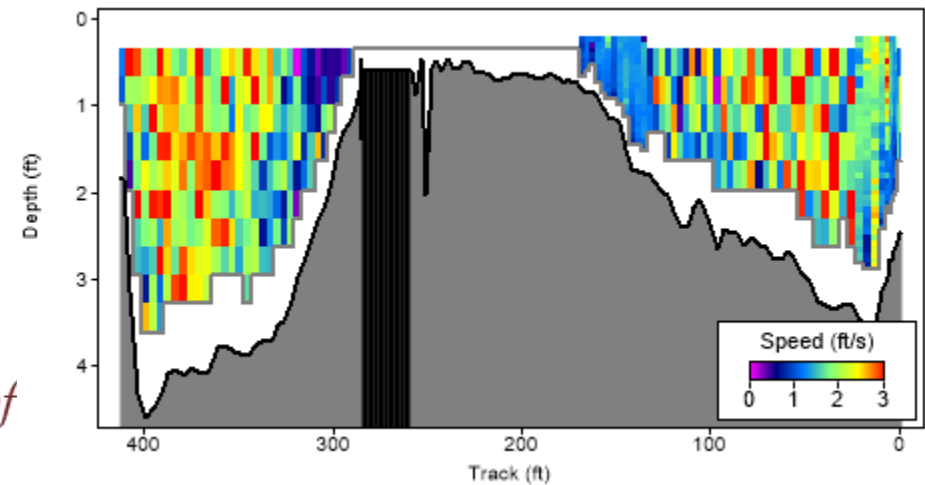
Site 2 – Cimarron River and U.S. 177 south of Perkins, Payne county

High (Left)
