Catheys Creek Restoration and Water Intake Rehabilitation

Achieving Multiple Objectives in a Water Supply Watershed

# Catheys Creek Project: 2018-2022

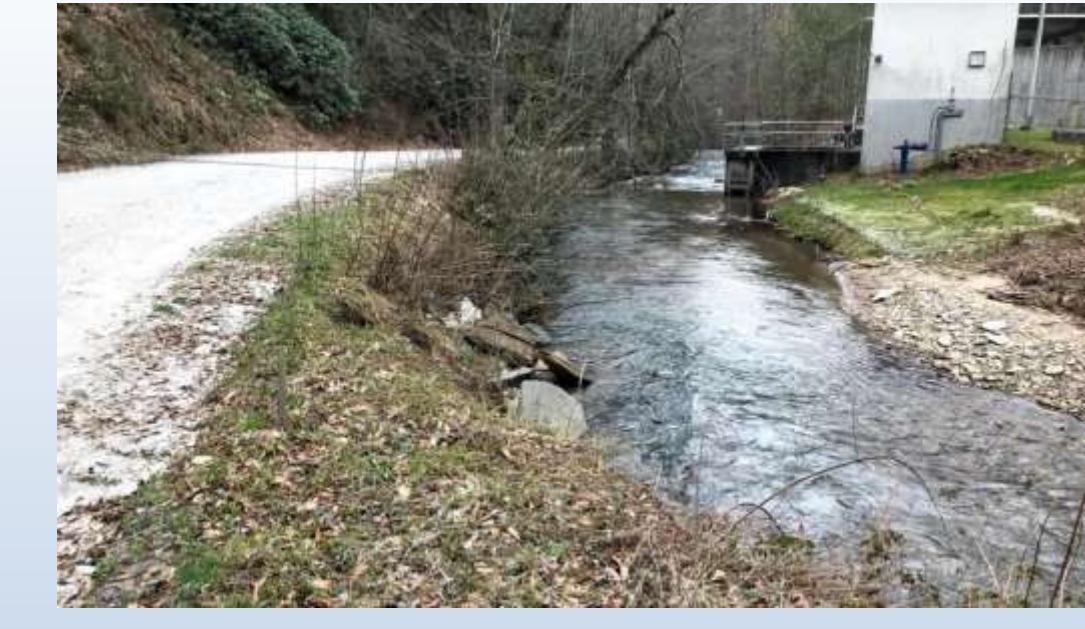
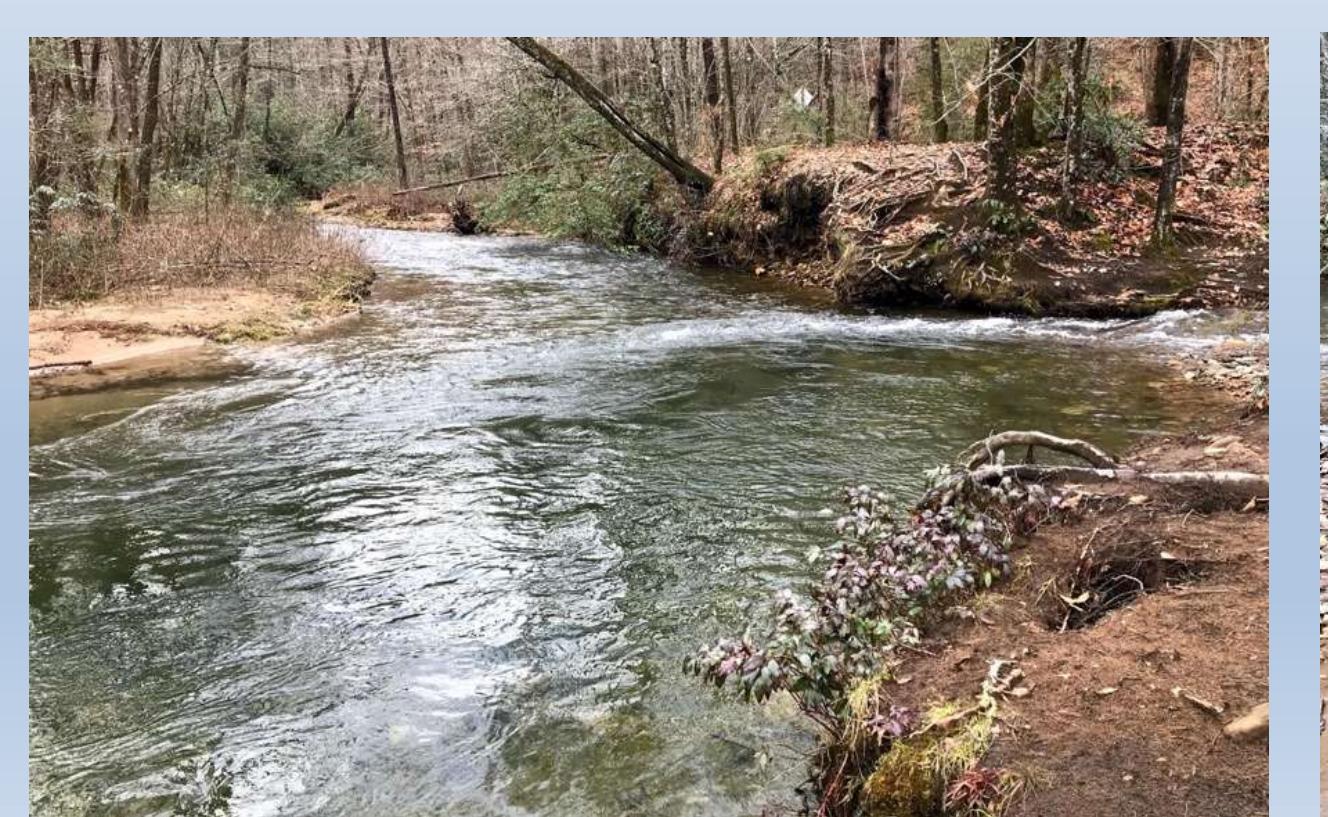
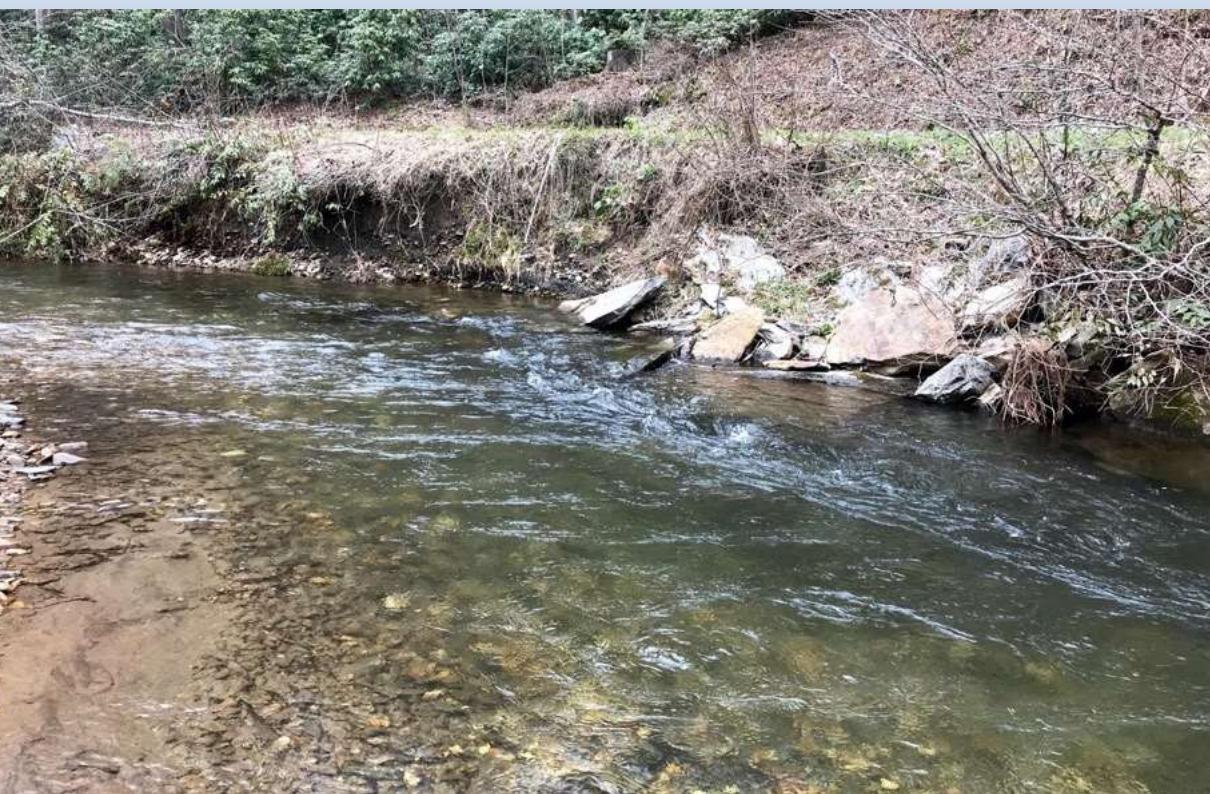
## Catheys Creek: Brevard Water Treatment Plant

- Unstable streambanks and road bank
- Sediment clogging water intake
- Poor habitat trout stream in National Forest

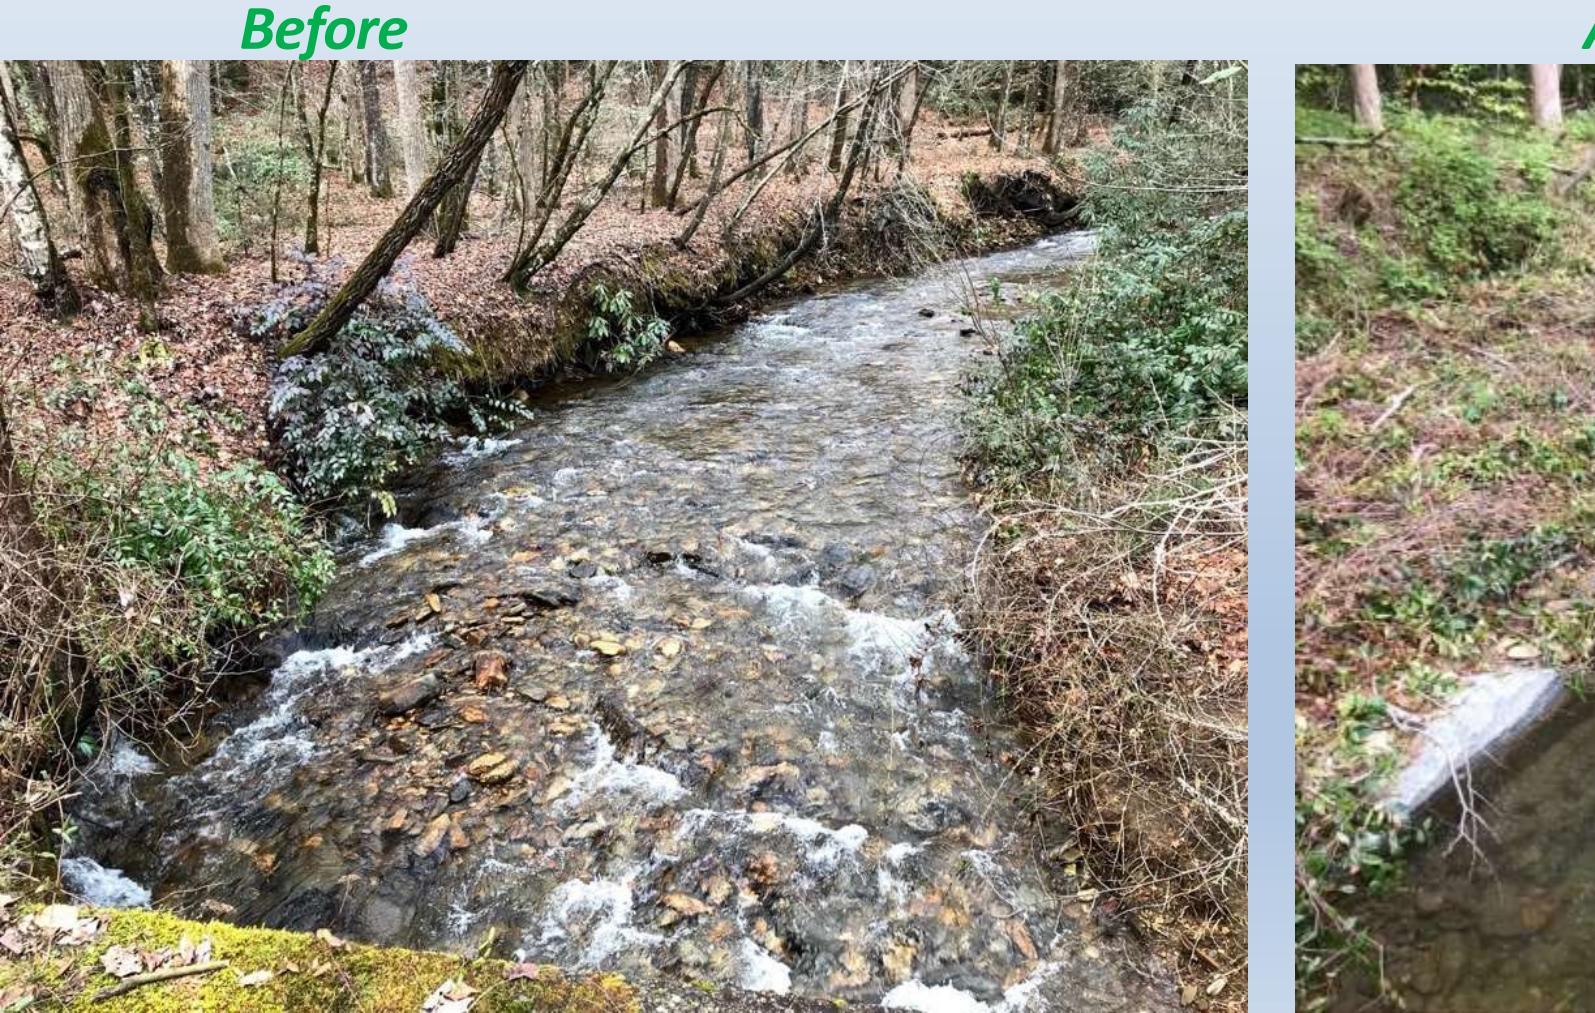
# Kuykendall Creek: Tributary with DA = 3.0 sq mi

- Eroding bank on outside bend threatening archaeological site
- Floodplain Connection, Log J-Hook Vane, Boulder Cascade, Riparian Vegetation

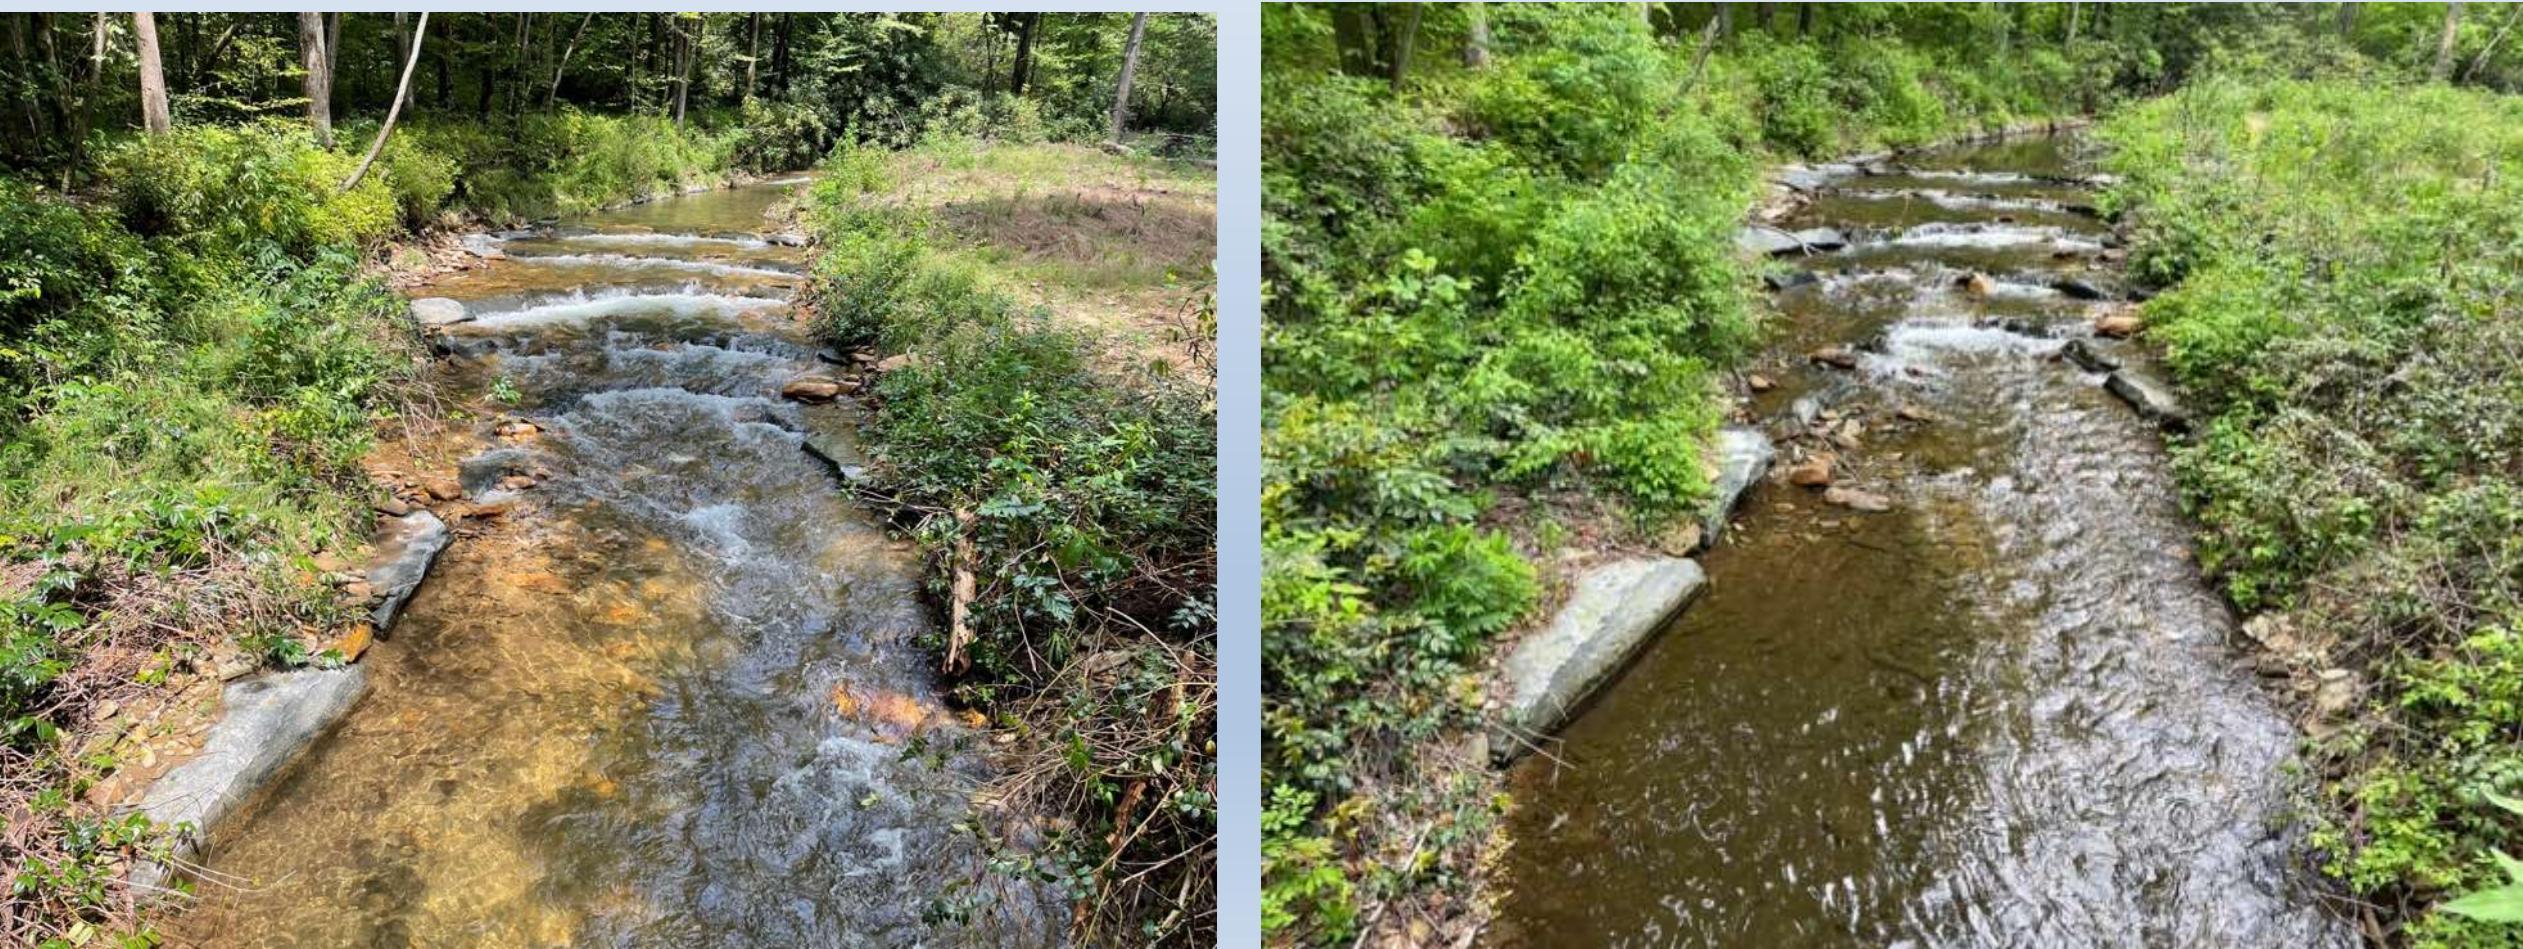
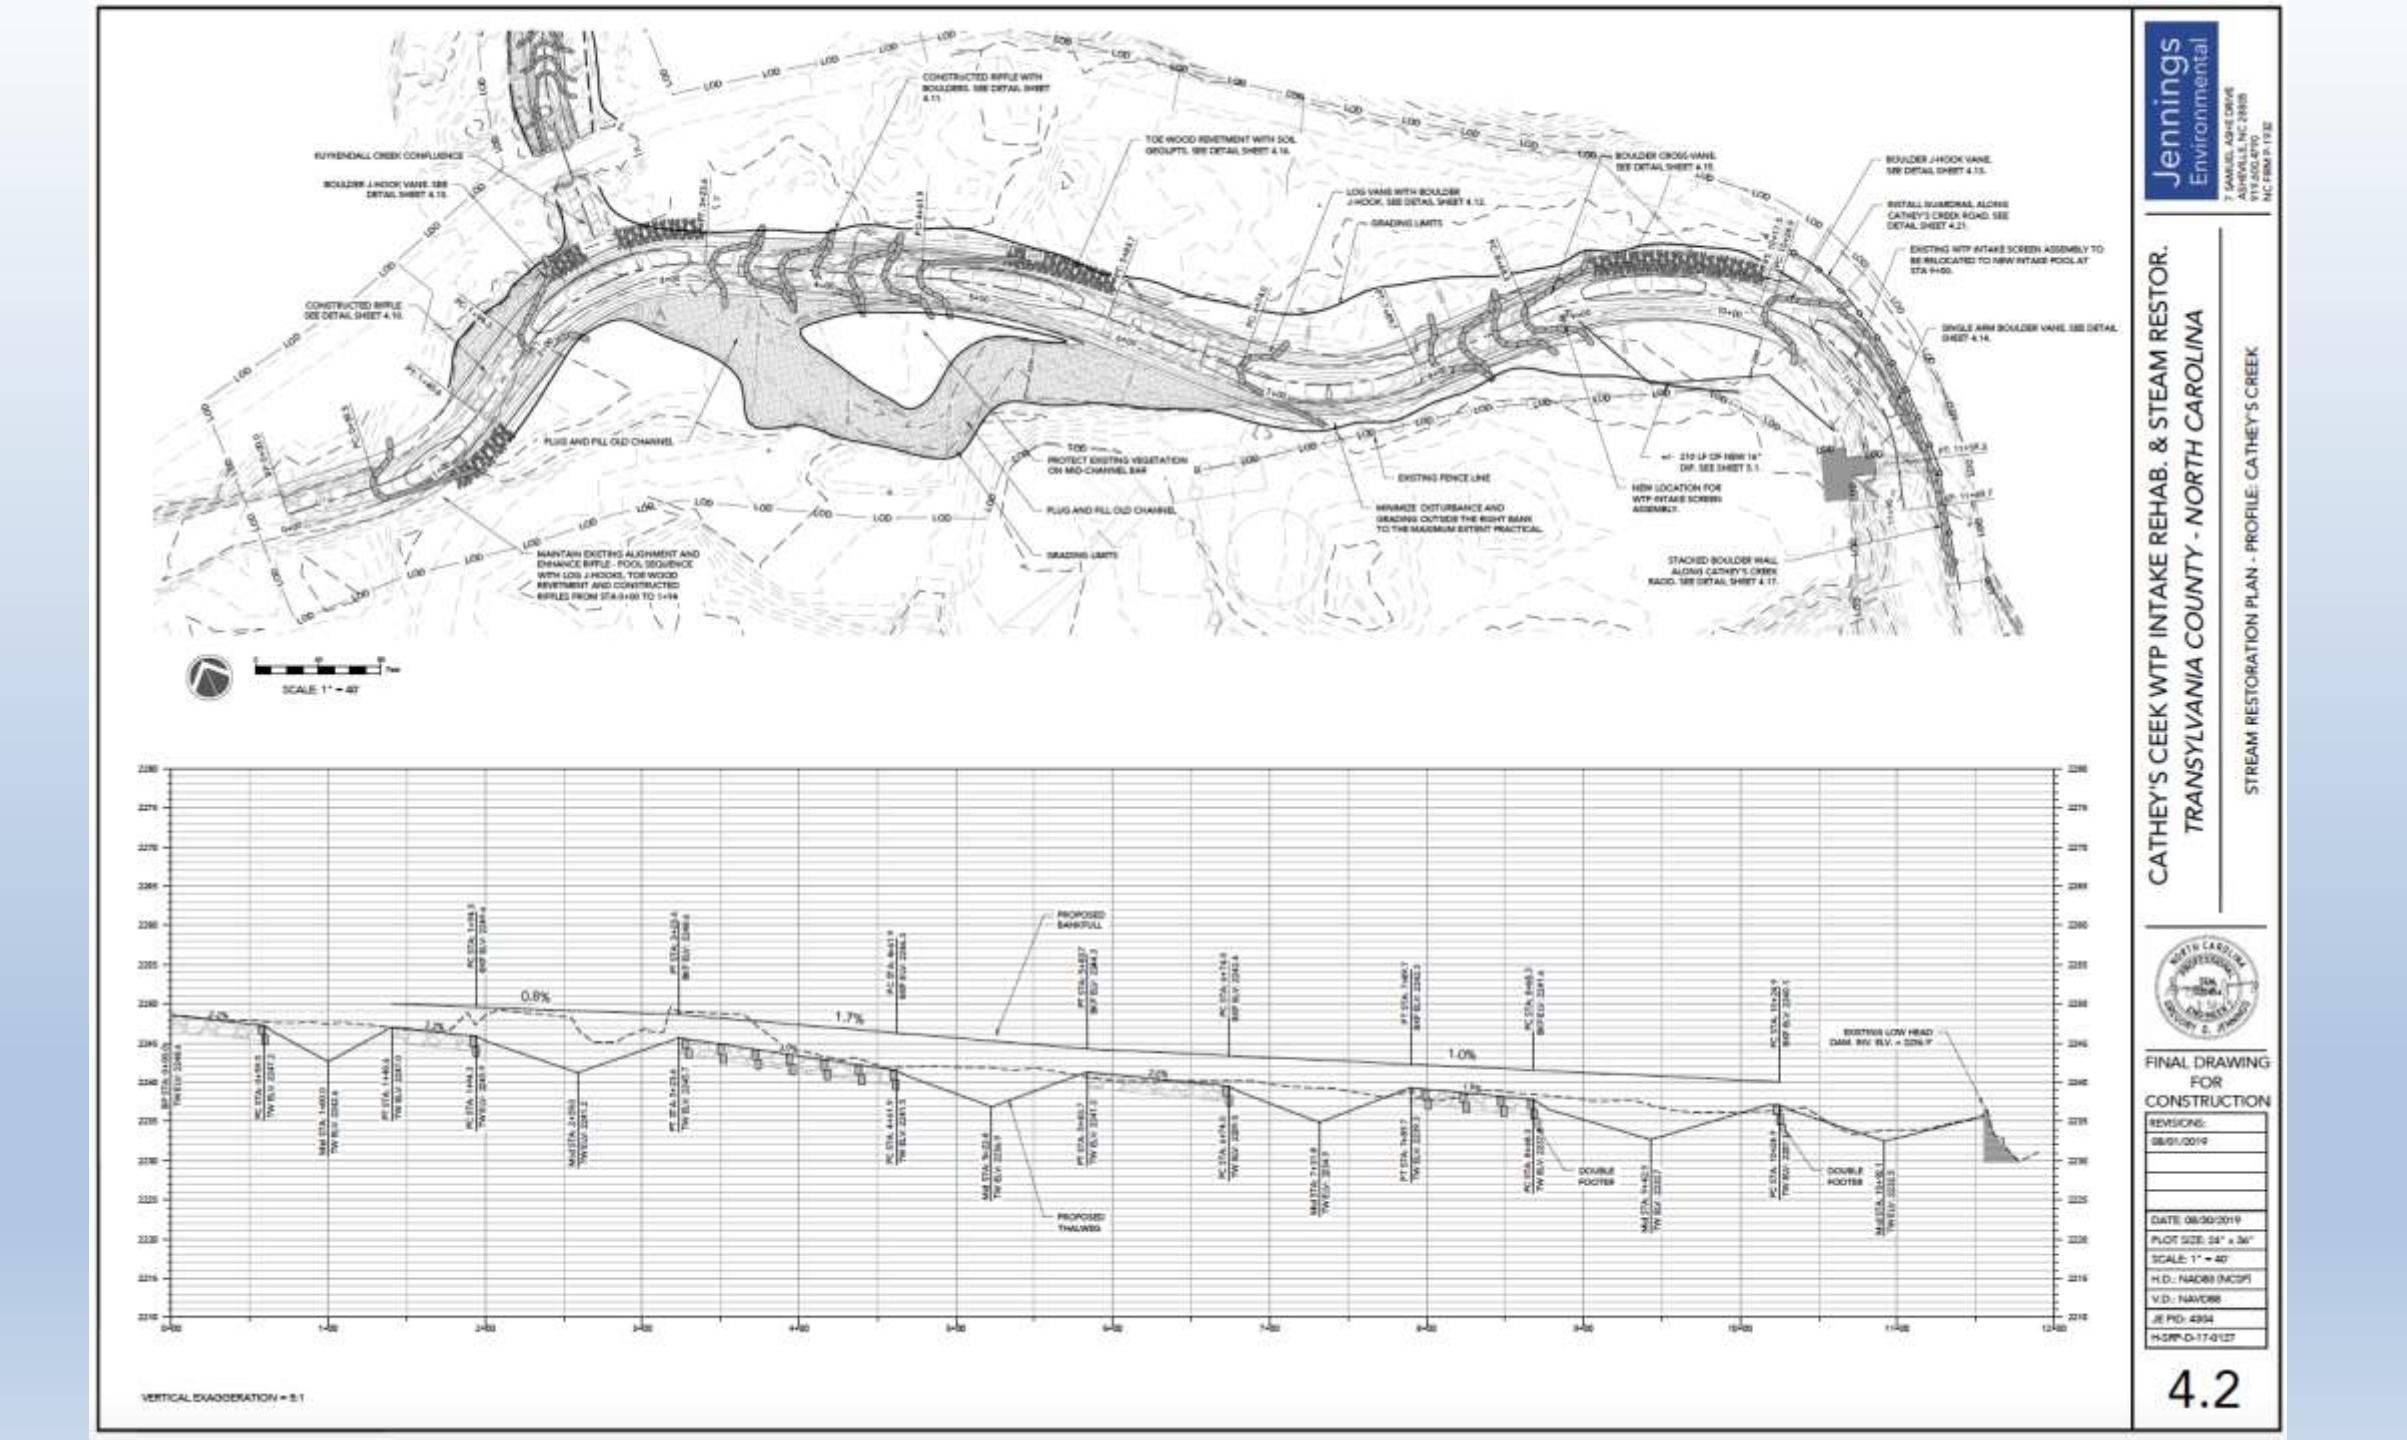
## Kuykendall Creek: After T.S. Fred in August 2021

- Floodplain scour and loss of vegetation
- Minor erosion

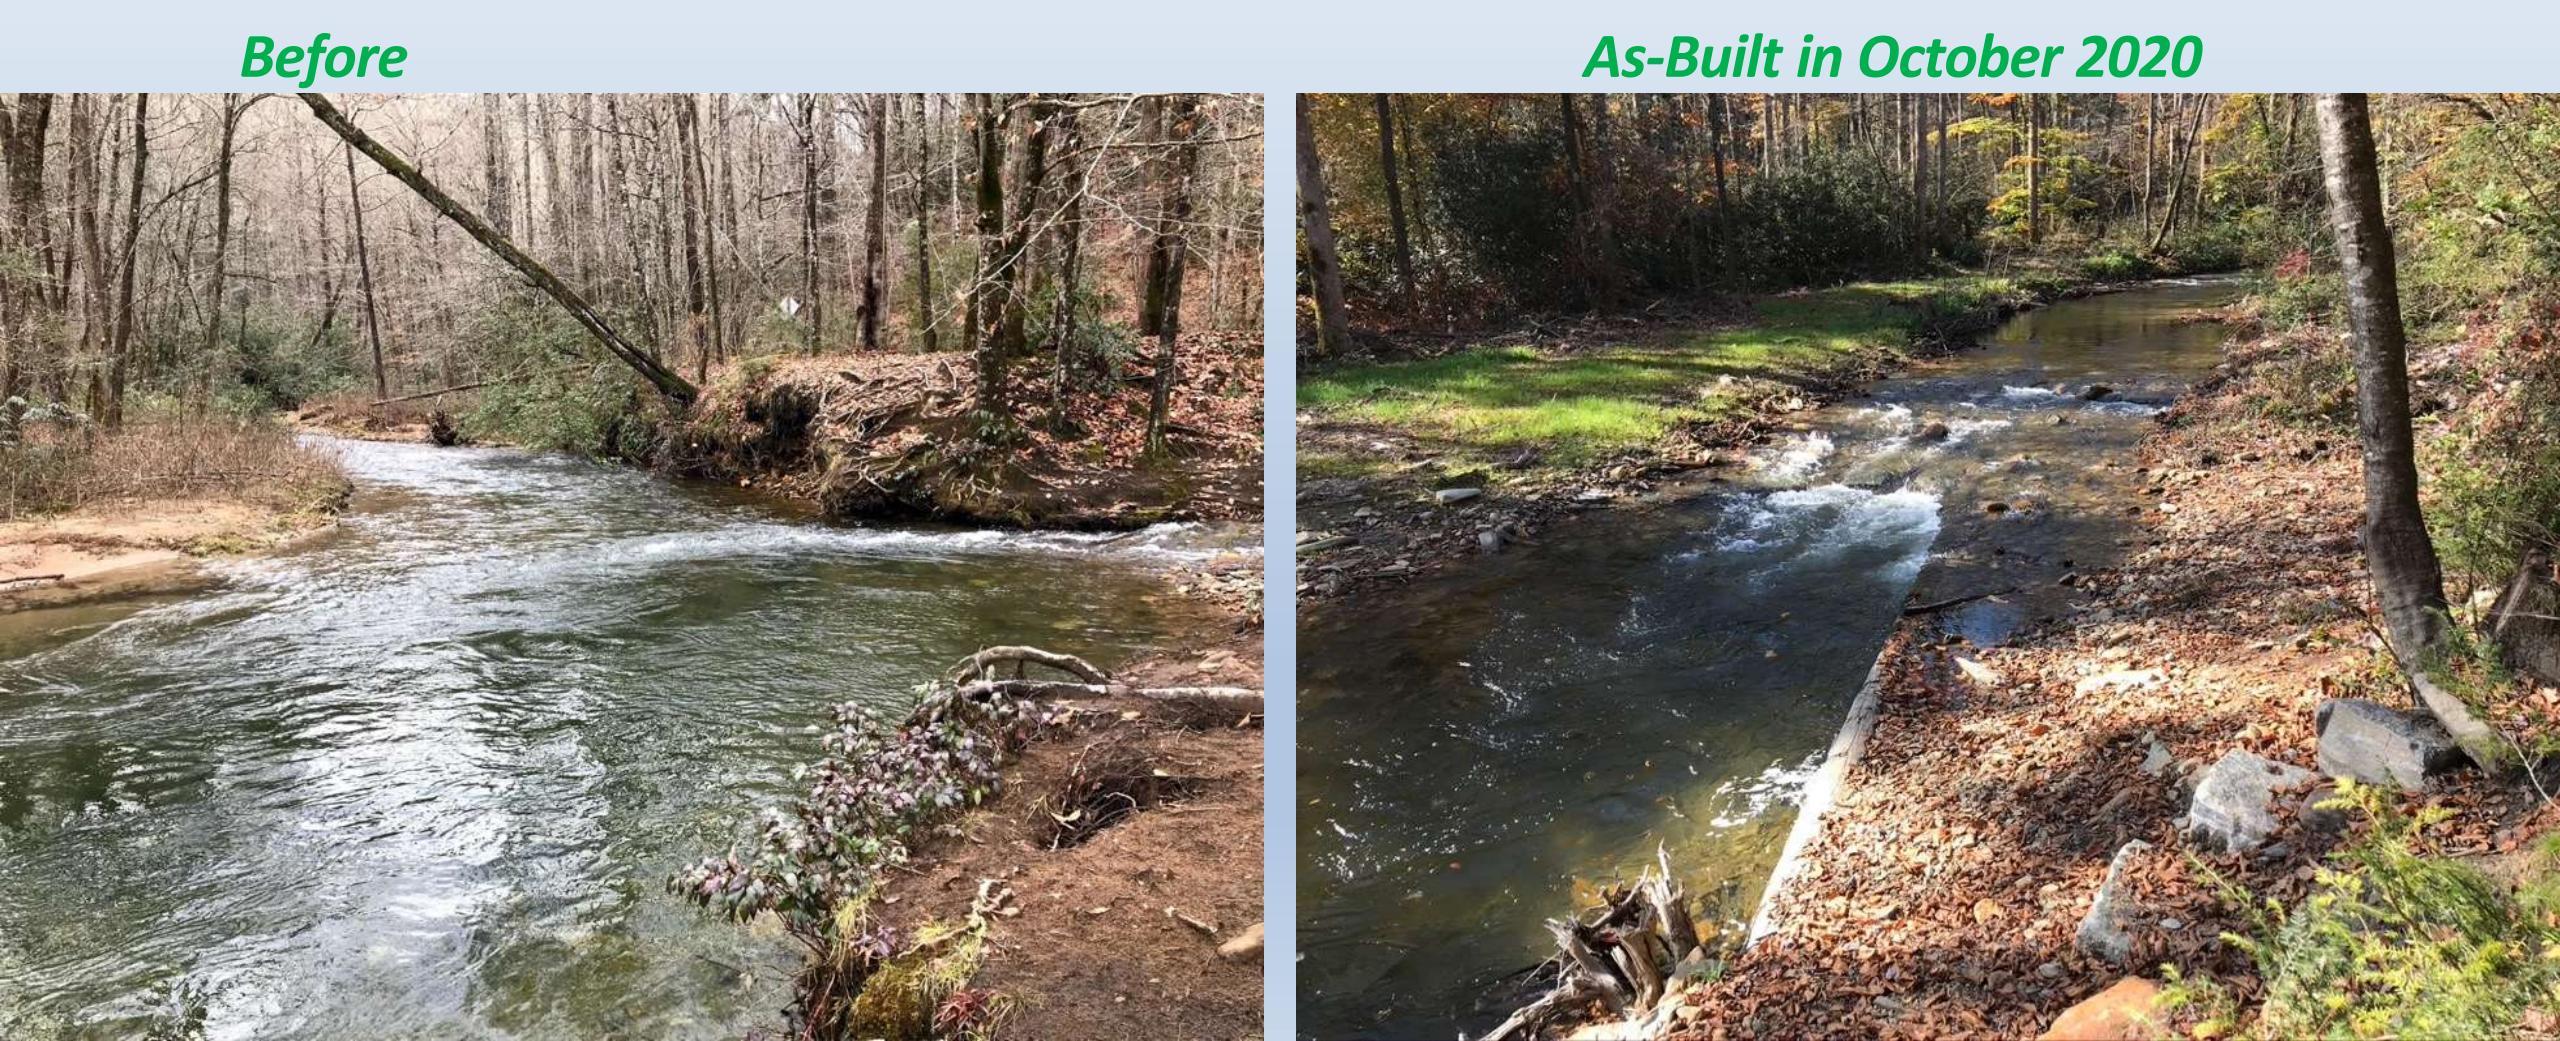
# Catheys Creek Reach 1: Upstream of Confluence with Kuykendall Creek

- Eroding banks on outside bends
- Floodplain Connection, Log J-Hook Vanes, Wood Toe Revetments, Riparian Vegetation

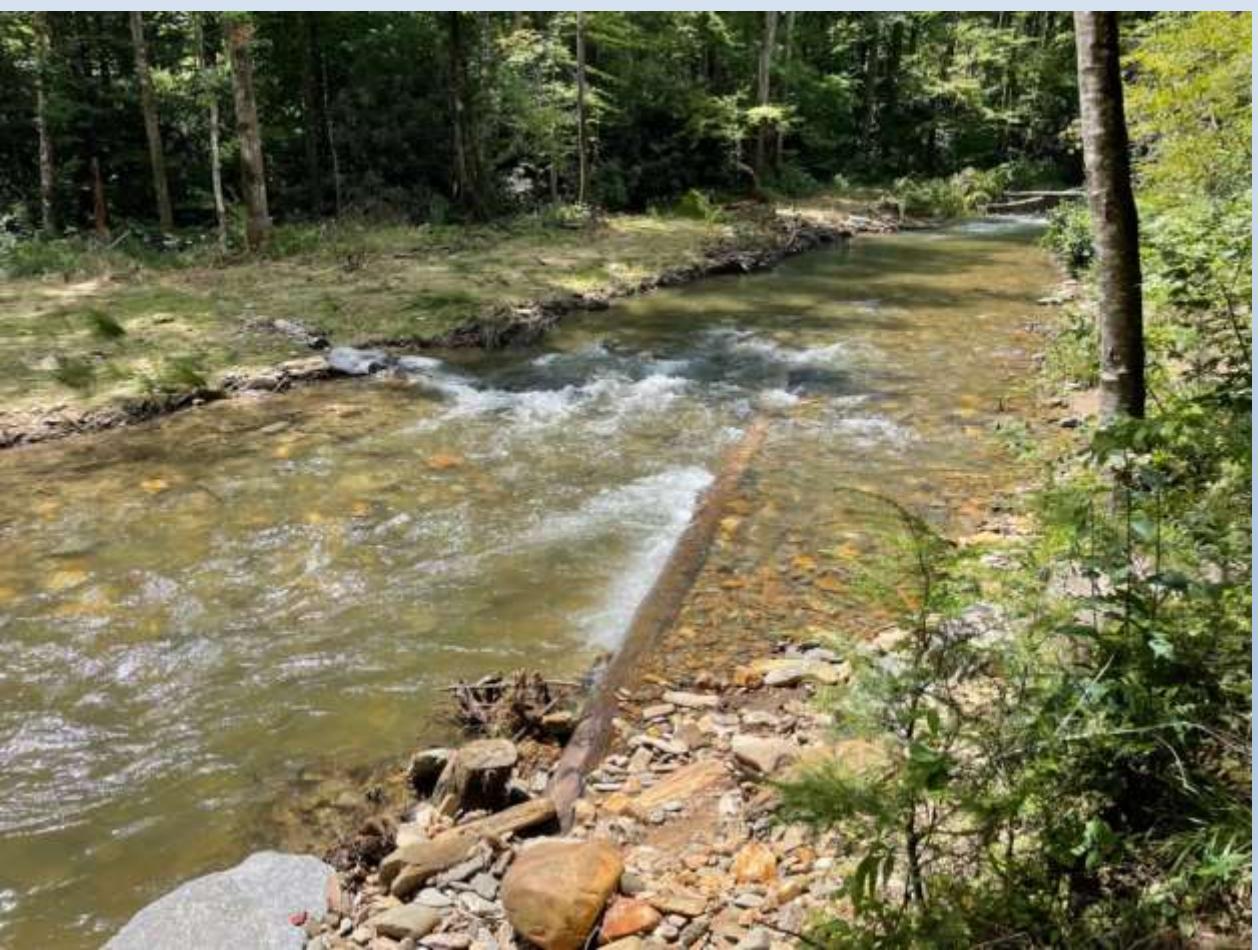
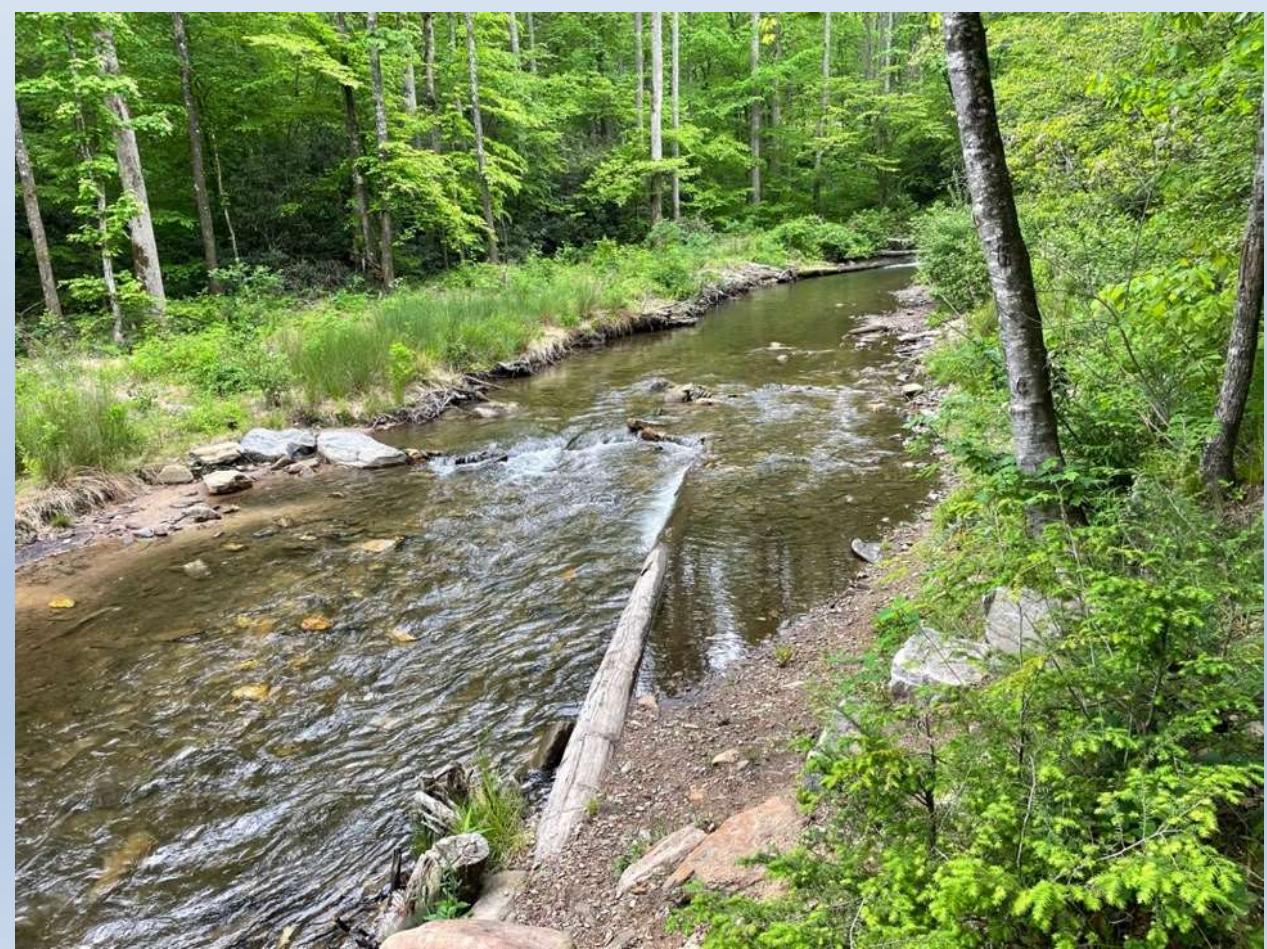
## Catheys Creek Reach 1: After T.S. Fred in August 2021

- Floodplain scour and loss of vegetation
- Minor erosion

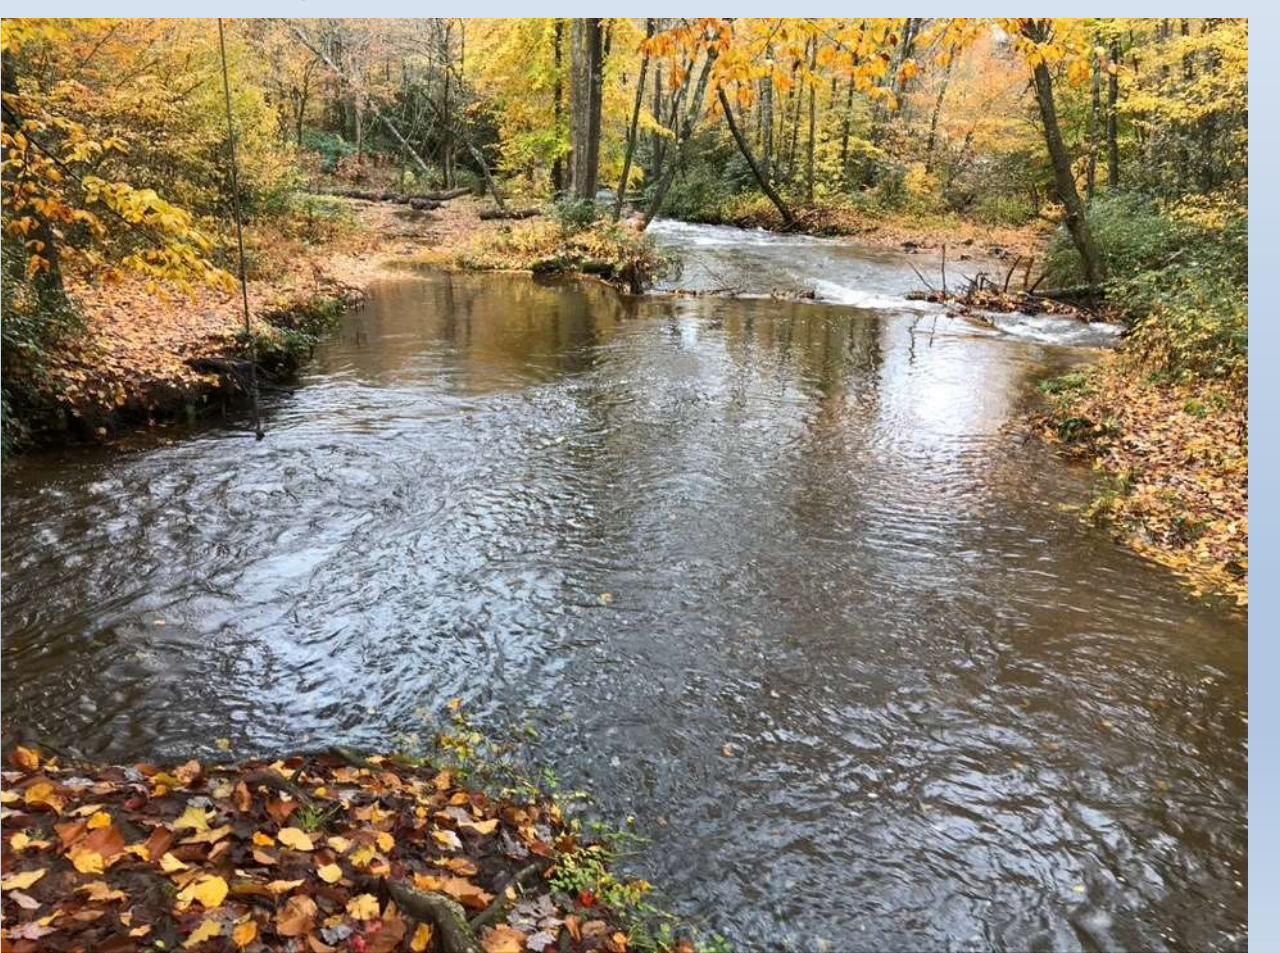
#### **Before**

- Eroding banks on outside bends
- Floodplain Connection, Log J-Hook Vanes, Wood Toe Revetments, Riparian Vegetation

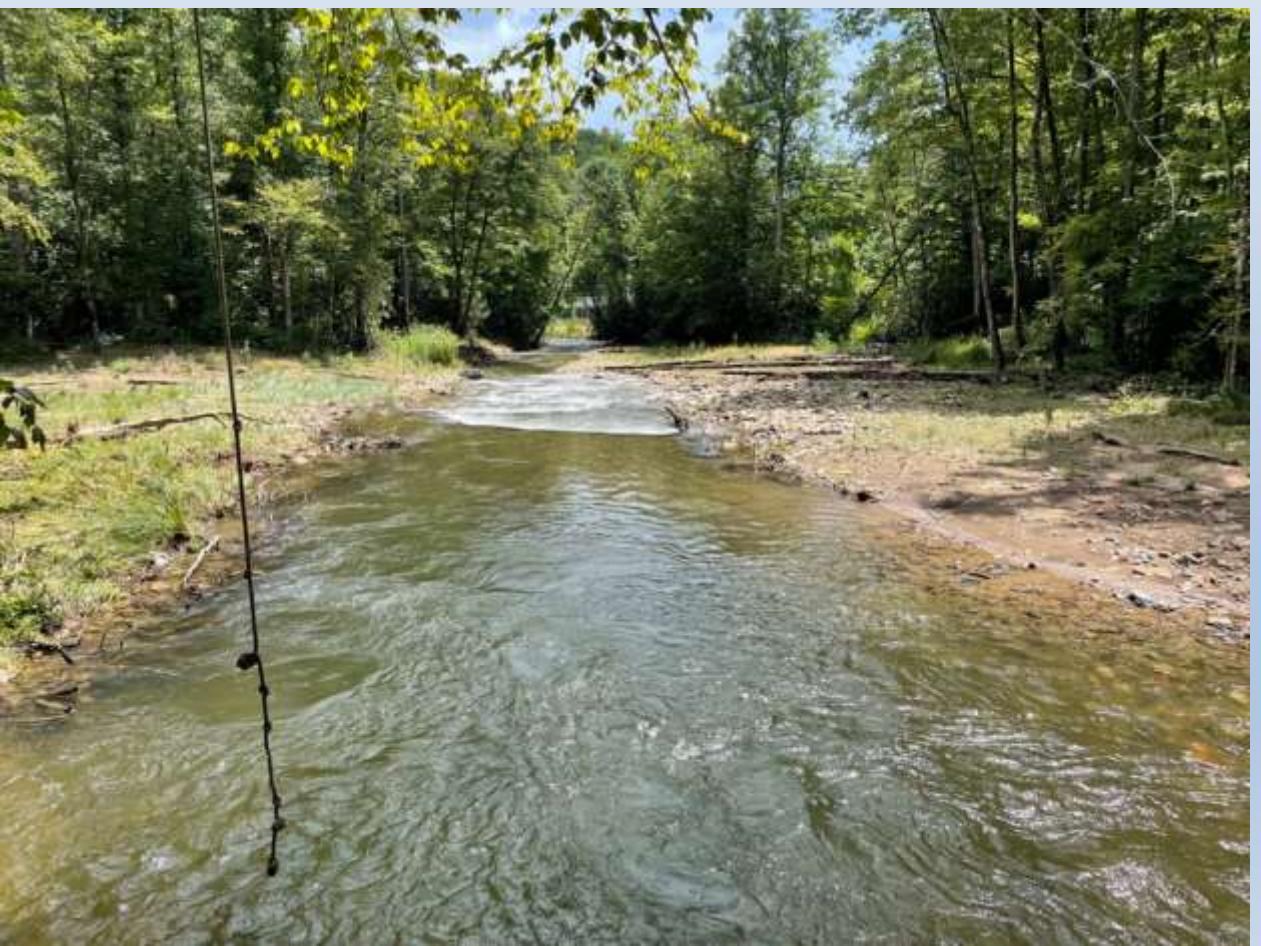
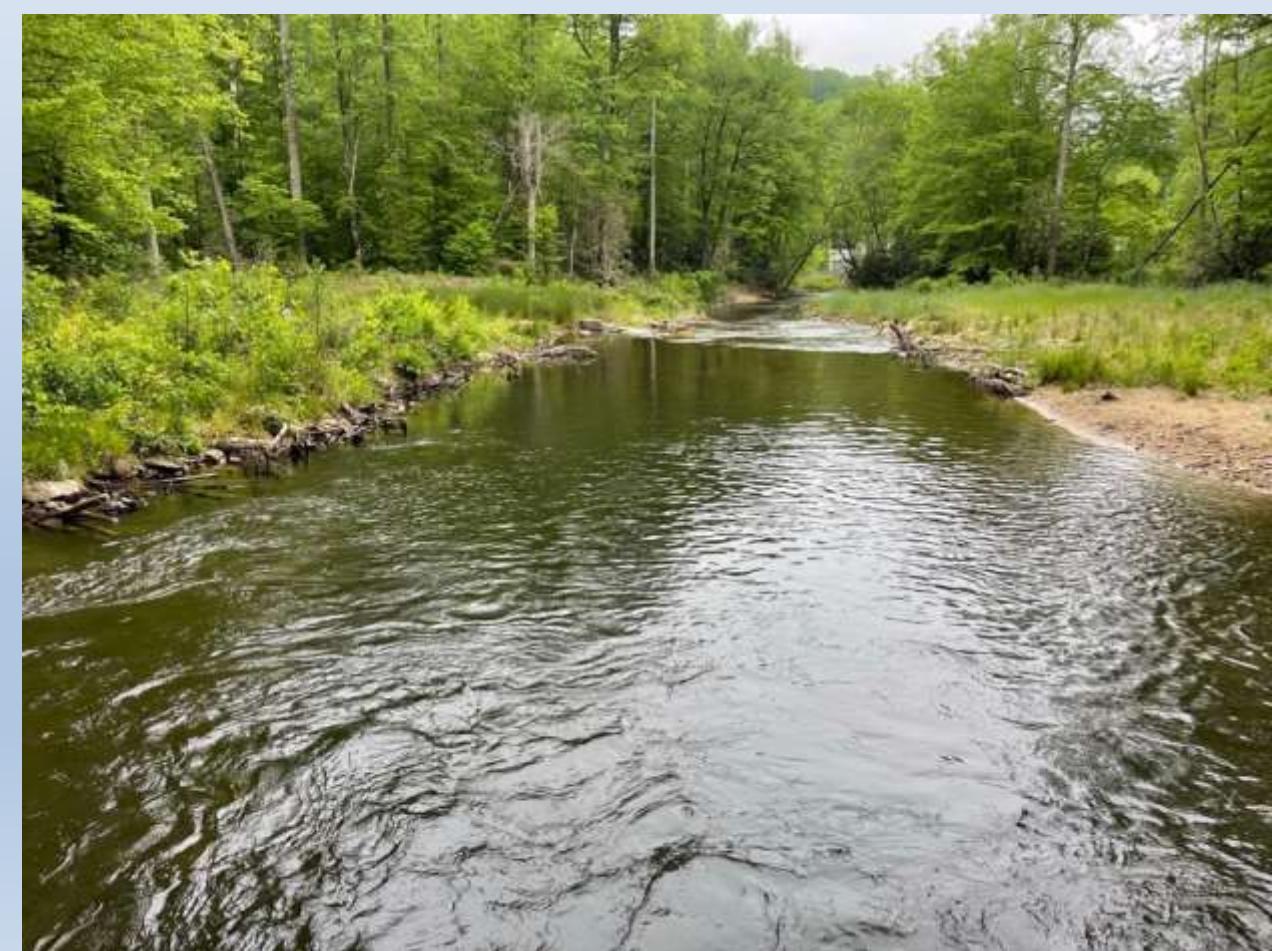
## Catheys Creek Reach 2: After T.S. Fred in August 2021

- Floodplain scour and loss of vegetation
- Moderate erosion

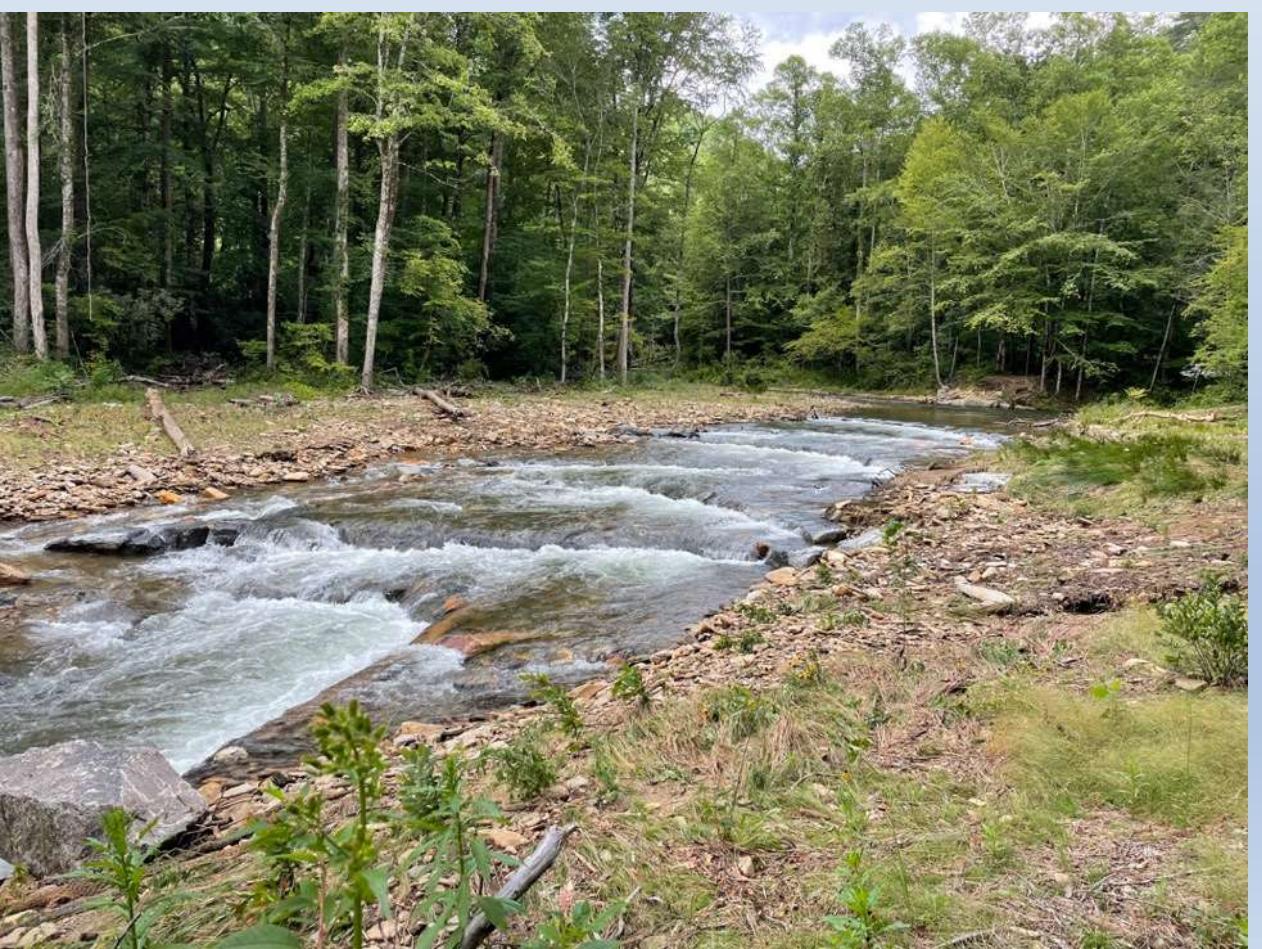
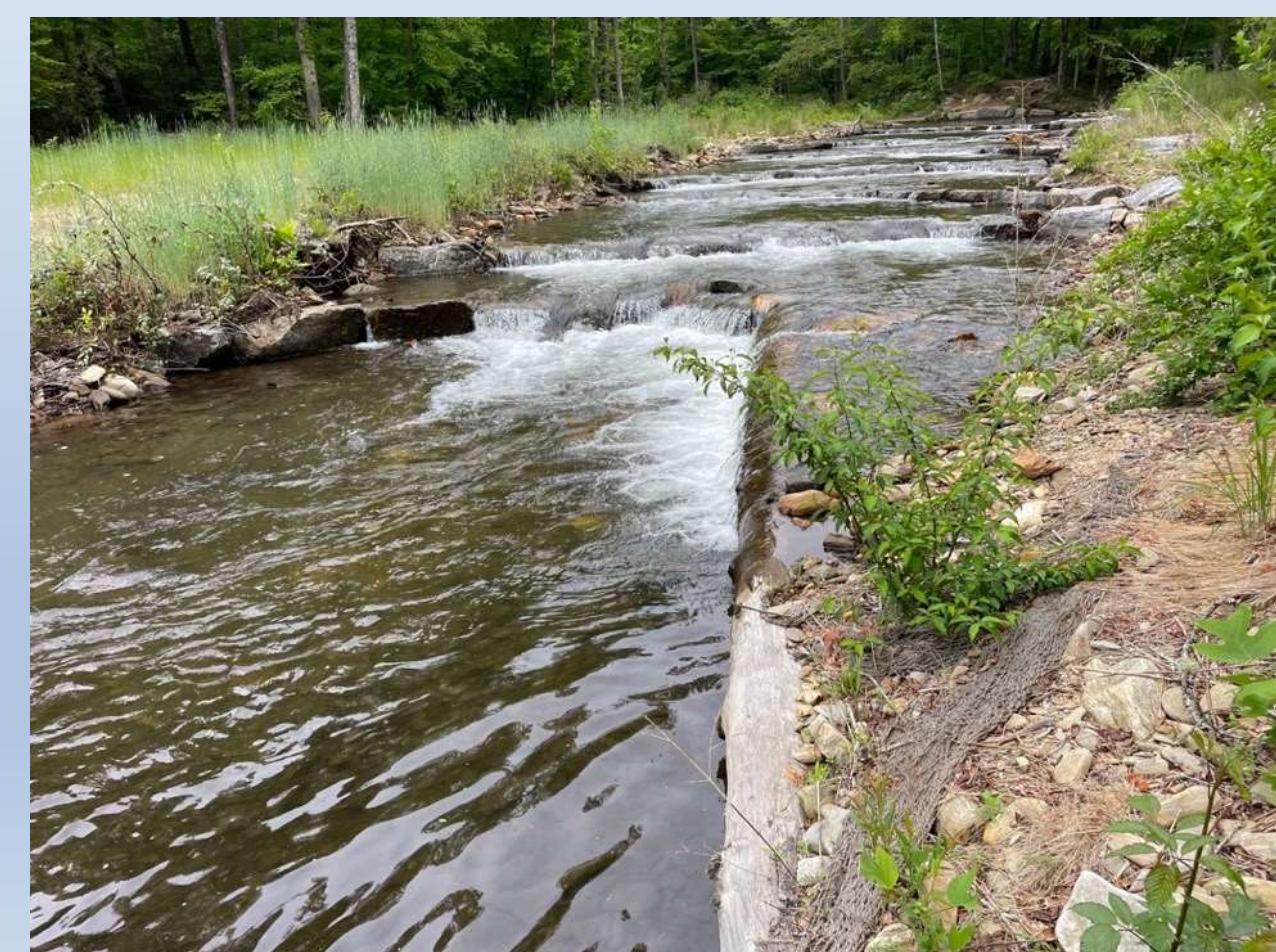
## Catheys Creek Reach 2: Facing Upstream

- Floodplain scour and loss of vegetation
- Moderate erosion

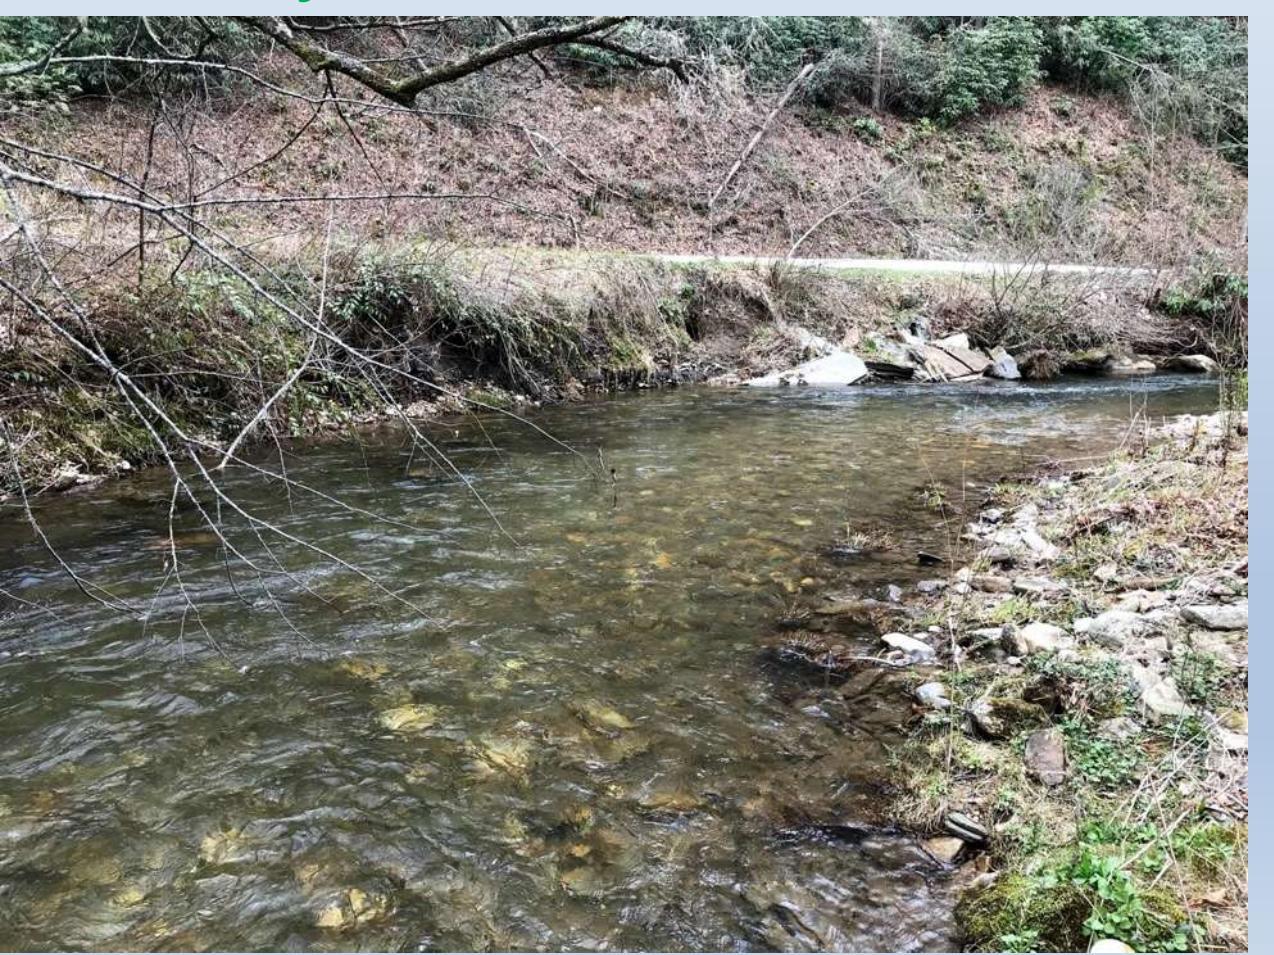
#### **Before**

- Eroding bank threatening road stability
- Floodplain Connection, Log J-Hook Vanes, Wood Toe Revetments, Riparian Vegetation
