Catheys Creek Restoration and Water Intake Rehabilitation

Achieving Multiple Objectives in a Water Supply Watershed

# Catheys Creek Project: 2018-2022

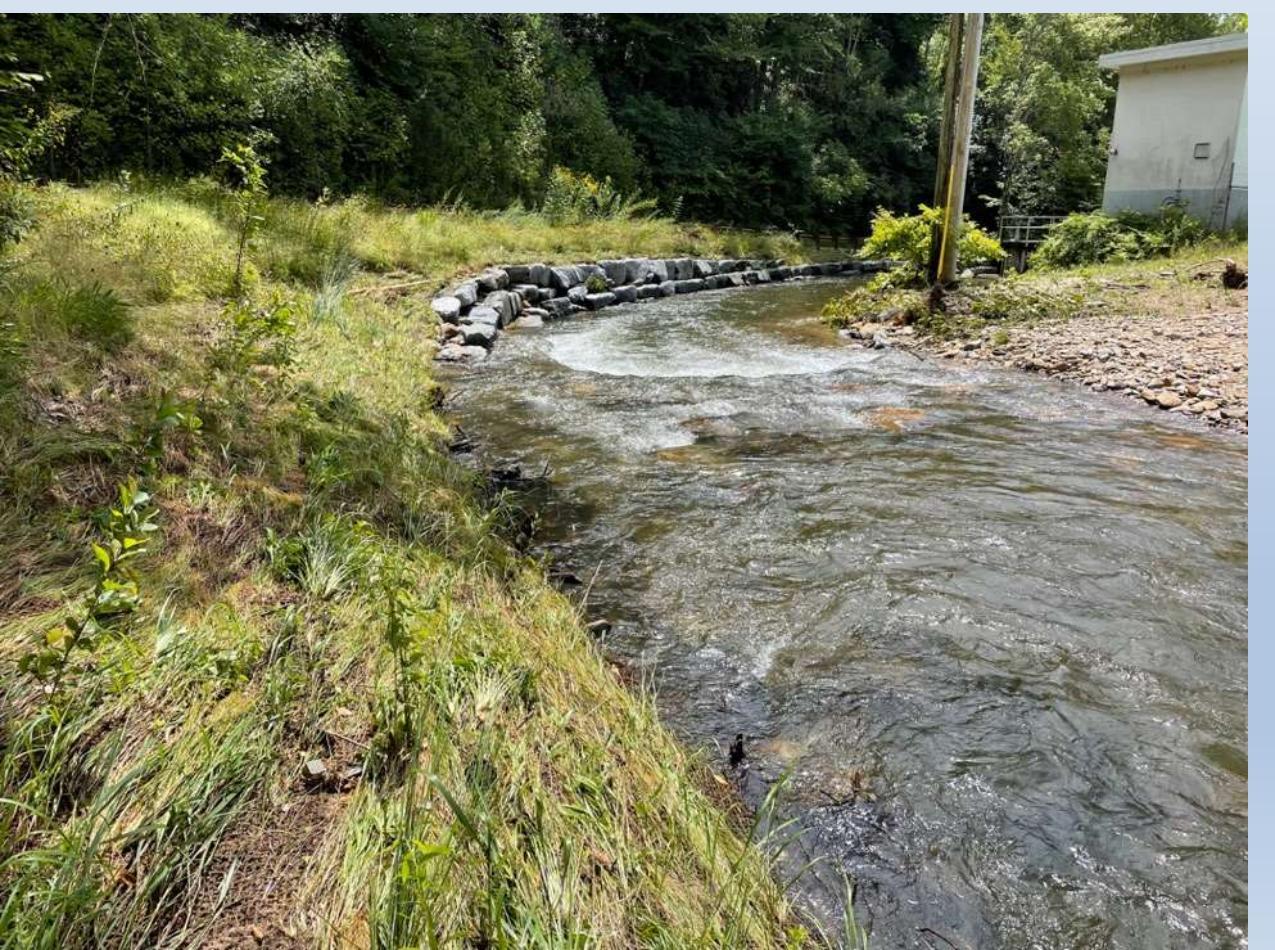
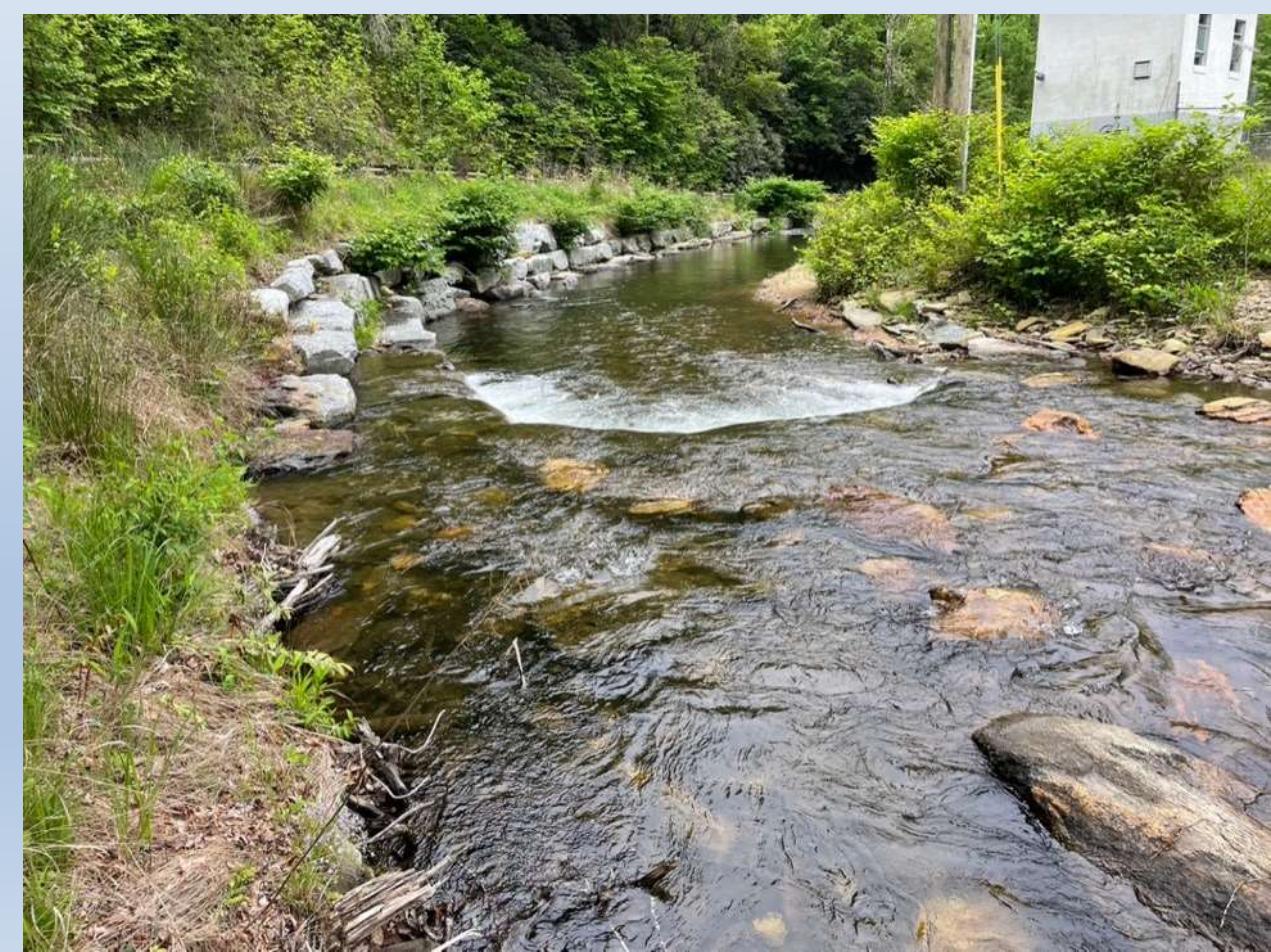
### Catheys Creek Reach 2: After T.S. Fred in August 2021

- Floodplain scour and loss of vegetation
- Sediment deposition on inside bend

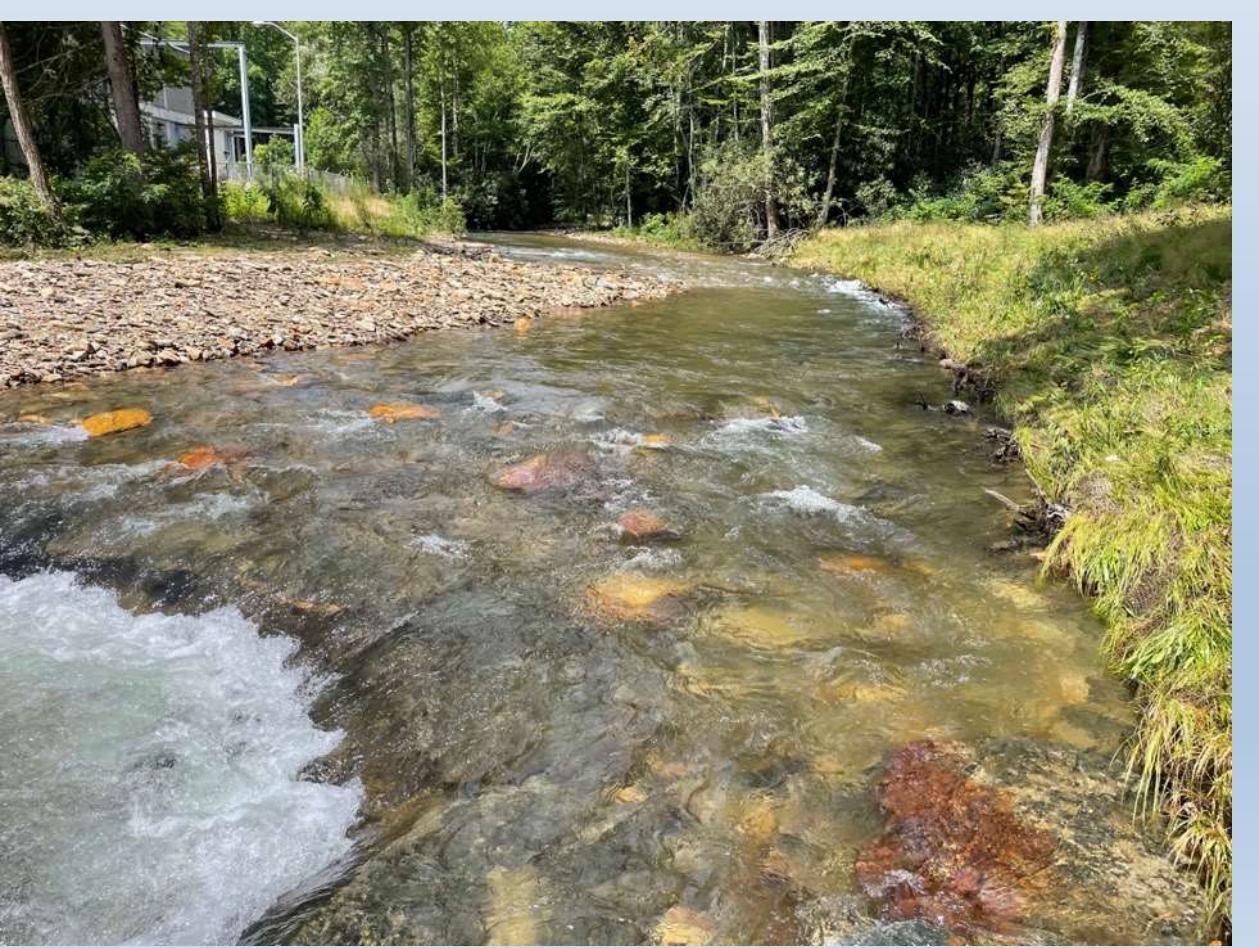
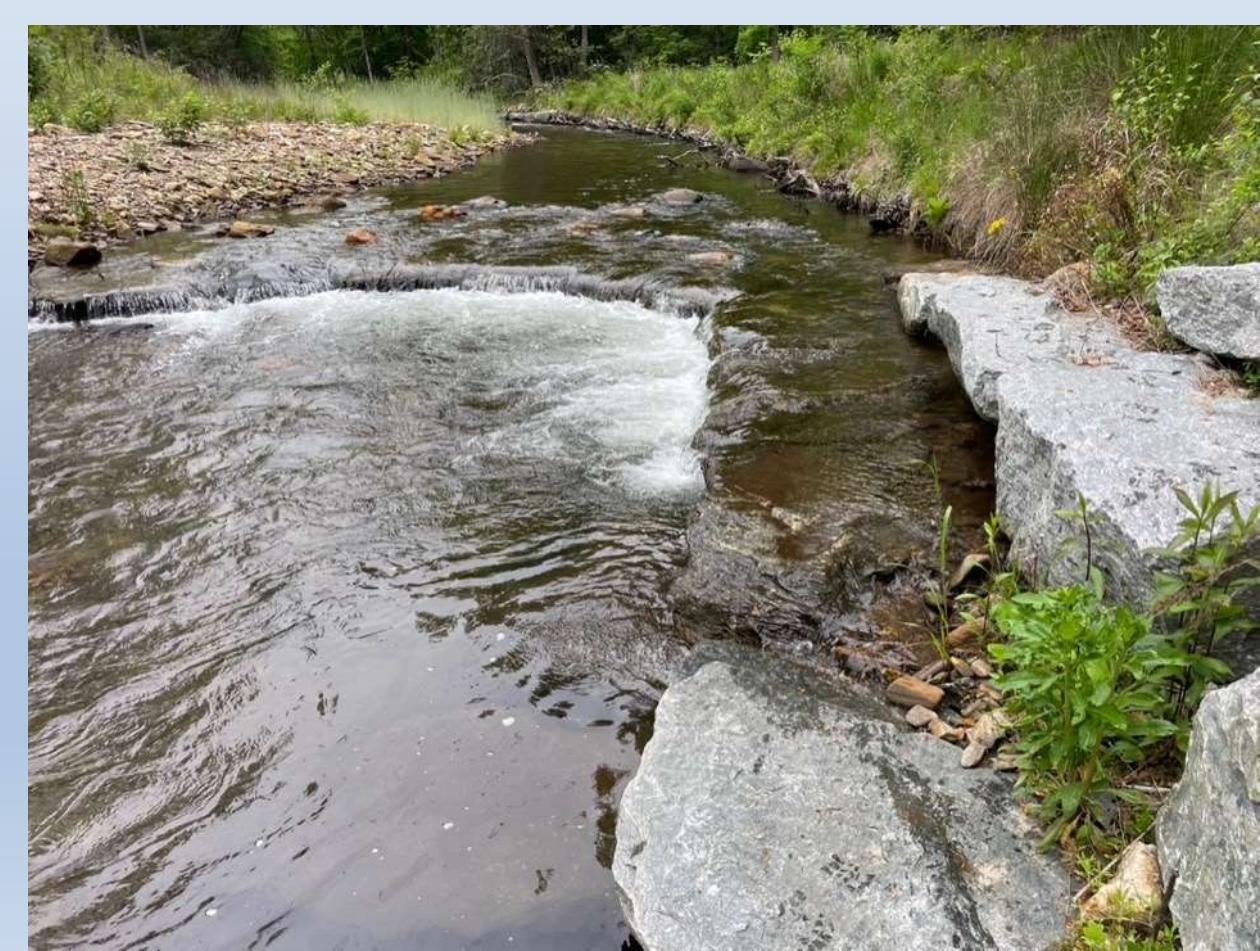
## Catheys Creek Reach 2: Facing Upstream

- Floodplain scour and loss of vegetation
- Sediment deposition on inside bend
