Assessing the Pre-Dam Removal Ecological Functions of Blackwater Creek, 90 Years after the Construction of College Lake Dam: A High Hazard Dam

National Stream Restoration Conference

Brandon Alderman - AECOM

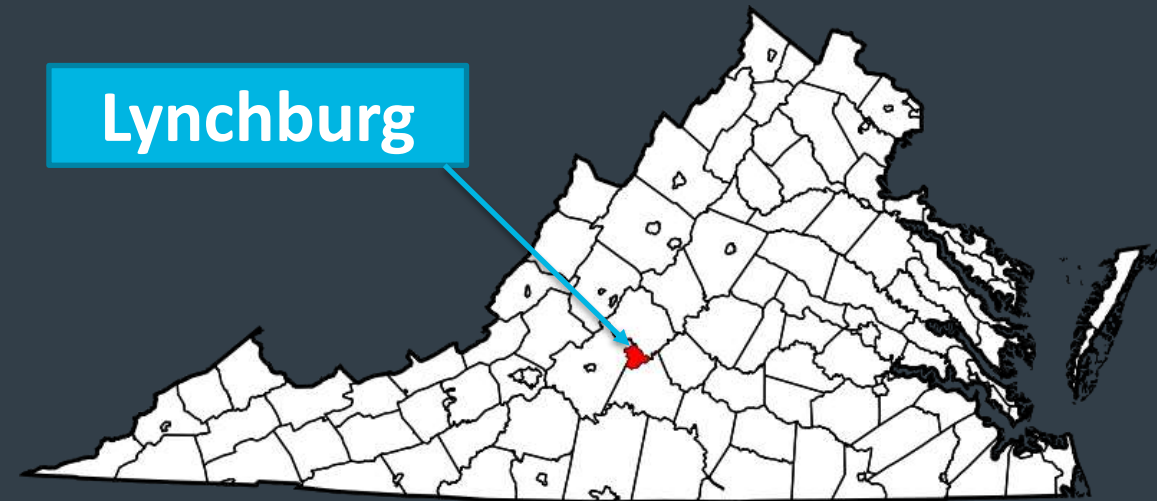
WATERSHED STATS | COLLEGE LAKE

- 21.8 mi² Watershed
- Urban Watershed
- 22.4% Impervious Surface
- Sand Bed Dominated Streams

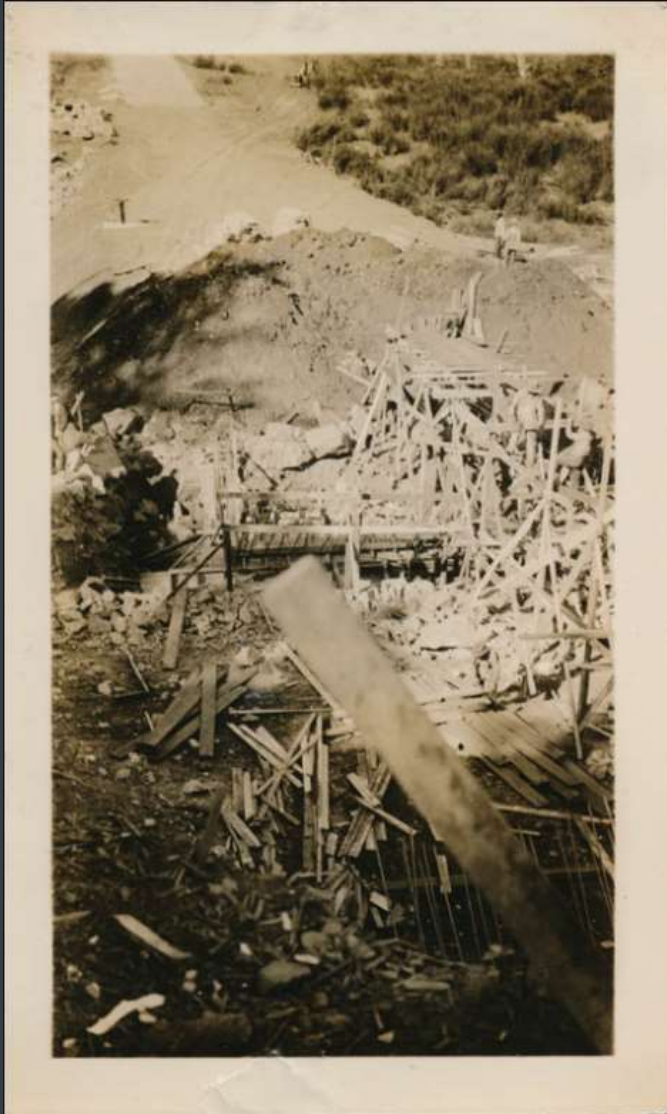
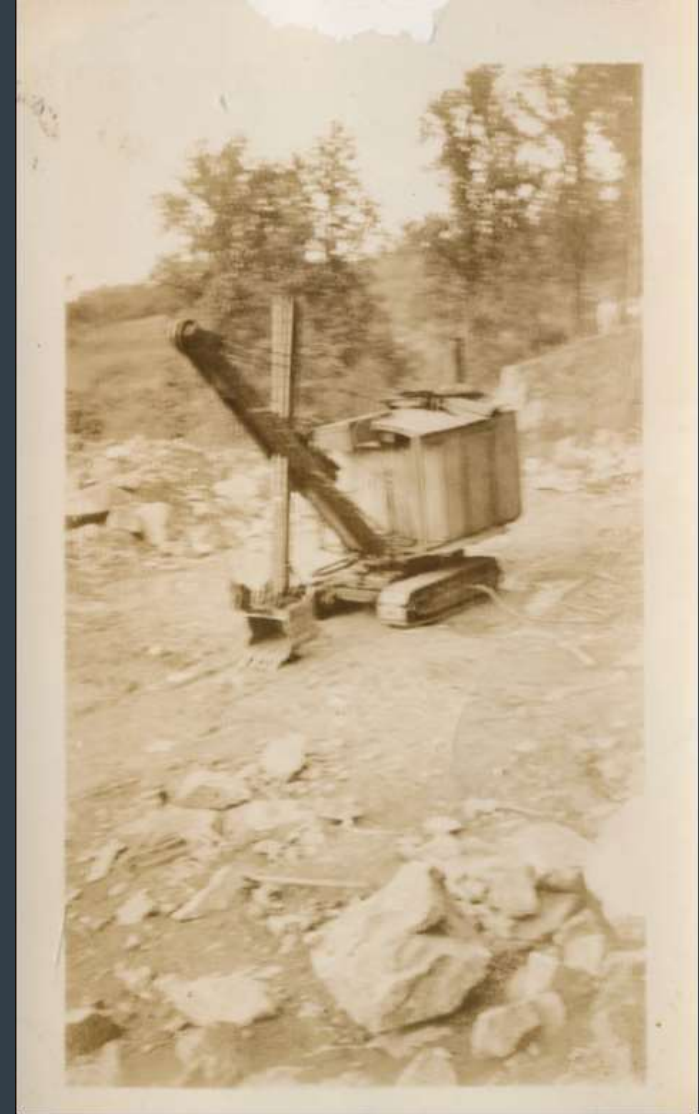
- **Constructed in 1934**
- **Part of Highway Construction for now US 221**
- **Originally 44-acres in size, with depth of 30 feet**

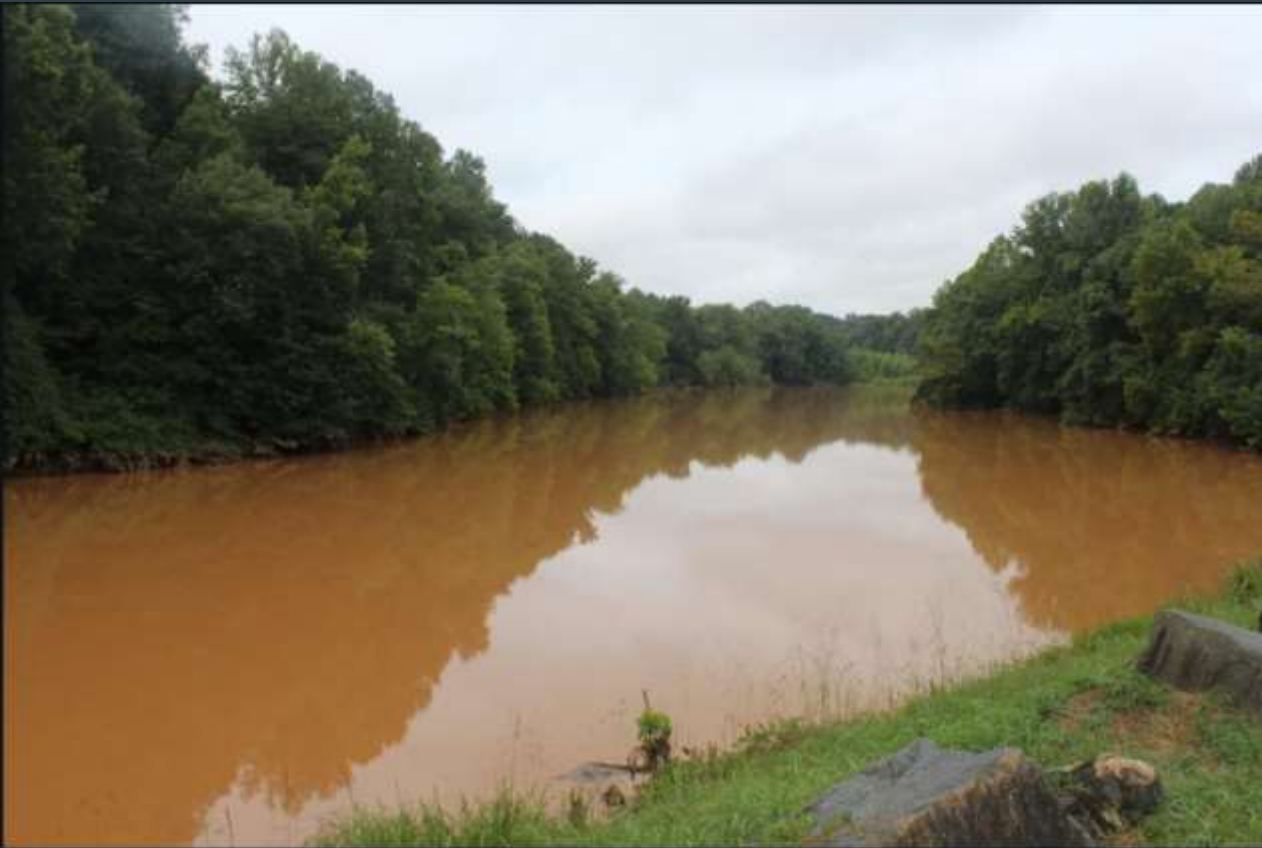
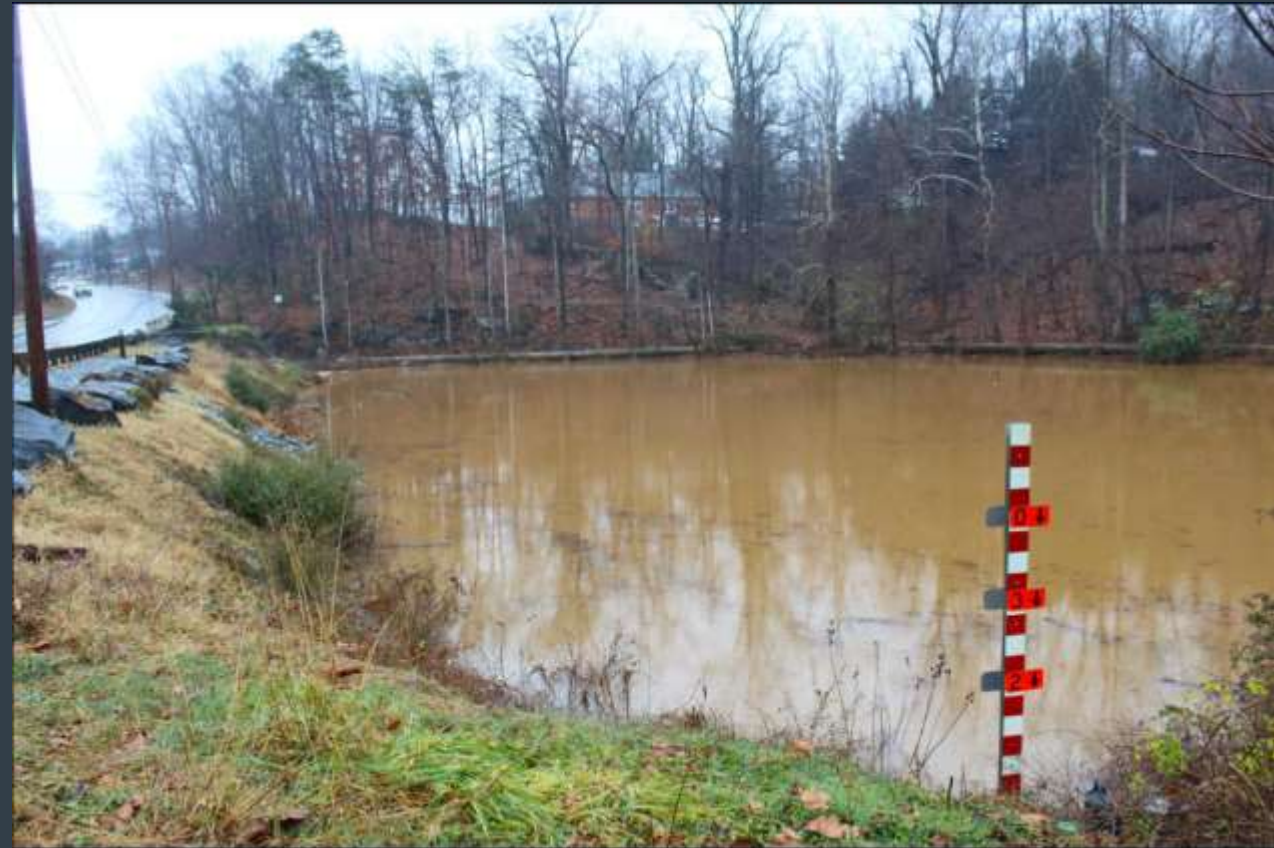
HIGH HAZARD | COLLEGE LAKE DAM

- Operating on a Conditional Dam Safety Permit
- High Hazard Dams – Upon Failure result in Probable Loss of Life or Serious Economic Damage
- Inadequate Spillway Capacity
- In 2014, the City began to assess how to meet the dam safety standards
- In 2017, URS presented the City with 2 options of Dam Removal or Hard-Armoring the Dam

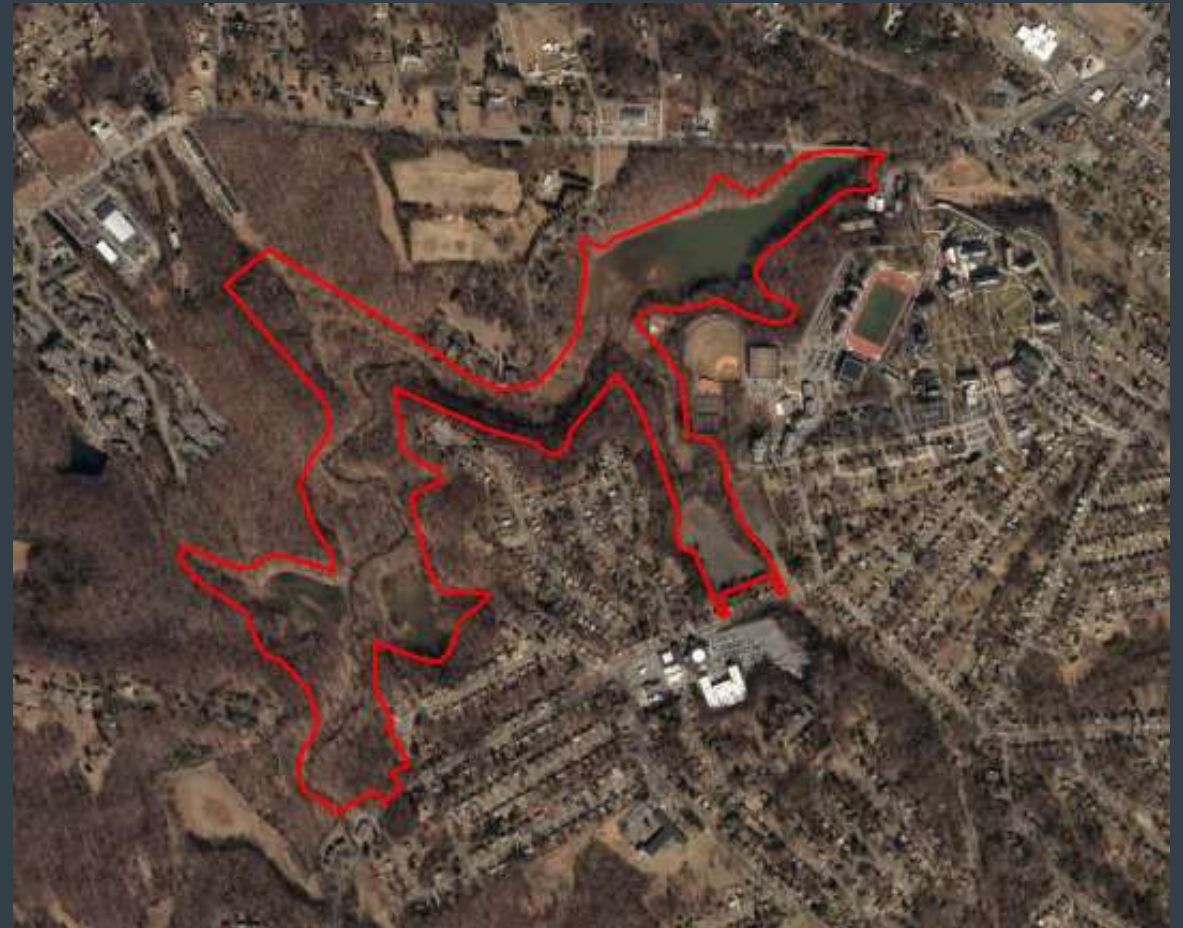
STUDY AREA | COLLEGE LAKE

Study area = 115 acres and includes historic lake extents

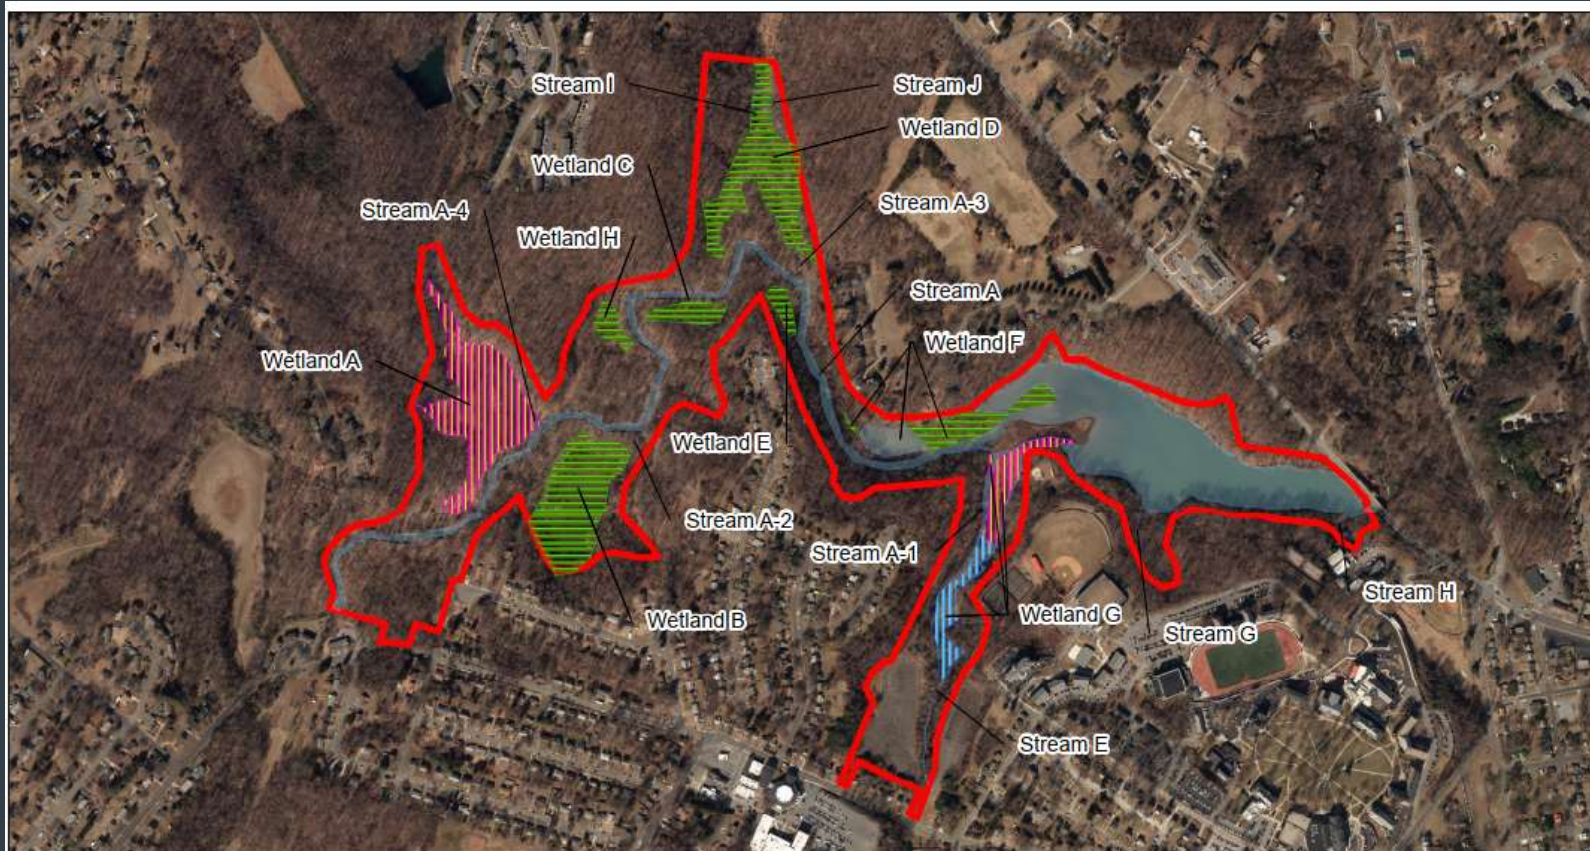
**College Lake Dam
Aerial Imagery Map
Lynchburg, Virginia**
NAD 1983 State Plane
This map is for reference only.

- 11,975 LF Stream
- 18.22 Ac. Wetland
- 5.15 ac. Open Water
- 14.46 ac. College Lake

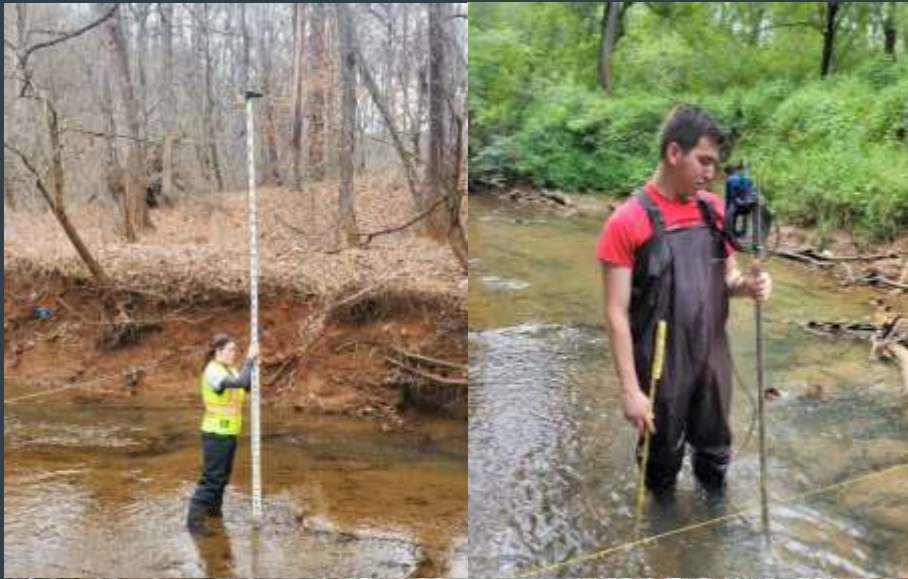
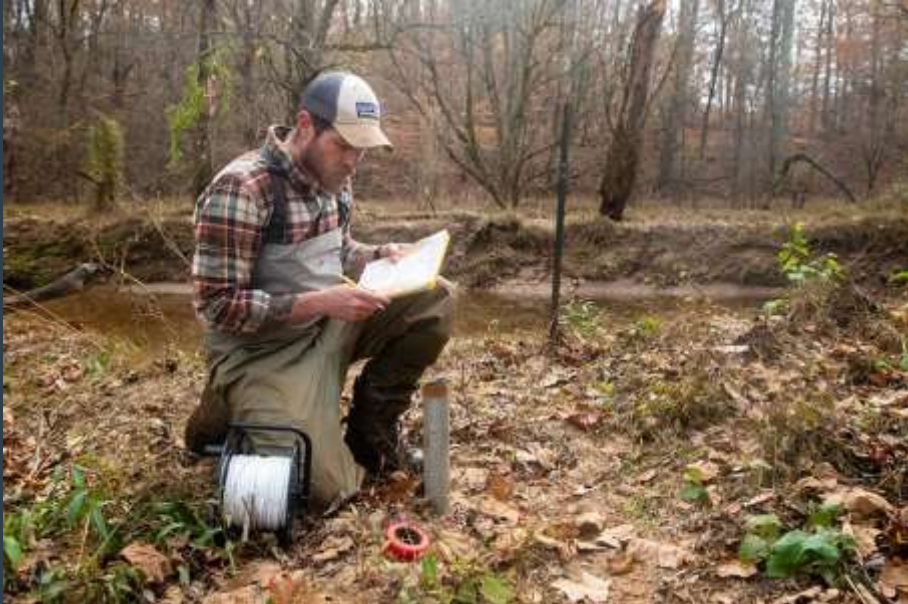
FUNCTIONAL ASSESSMENTS | COLLEGE LAKE

- **Topographic/Bathymetric Survey**
- **Geomorphic Assessments**
- **Surface and Groundwater Level Monitoring**
- **Rapid Bioassessment Protocol (RBPs)**
- **Benthic Macroinvertebrates**
- **Wetland Attributes Assessments**
- **Unified Stream Methodology Assessment**
- **Flow/Discharge Analysis**
- **Water Quality and Bacteria Testing**

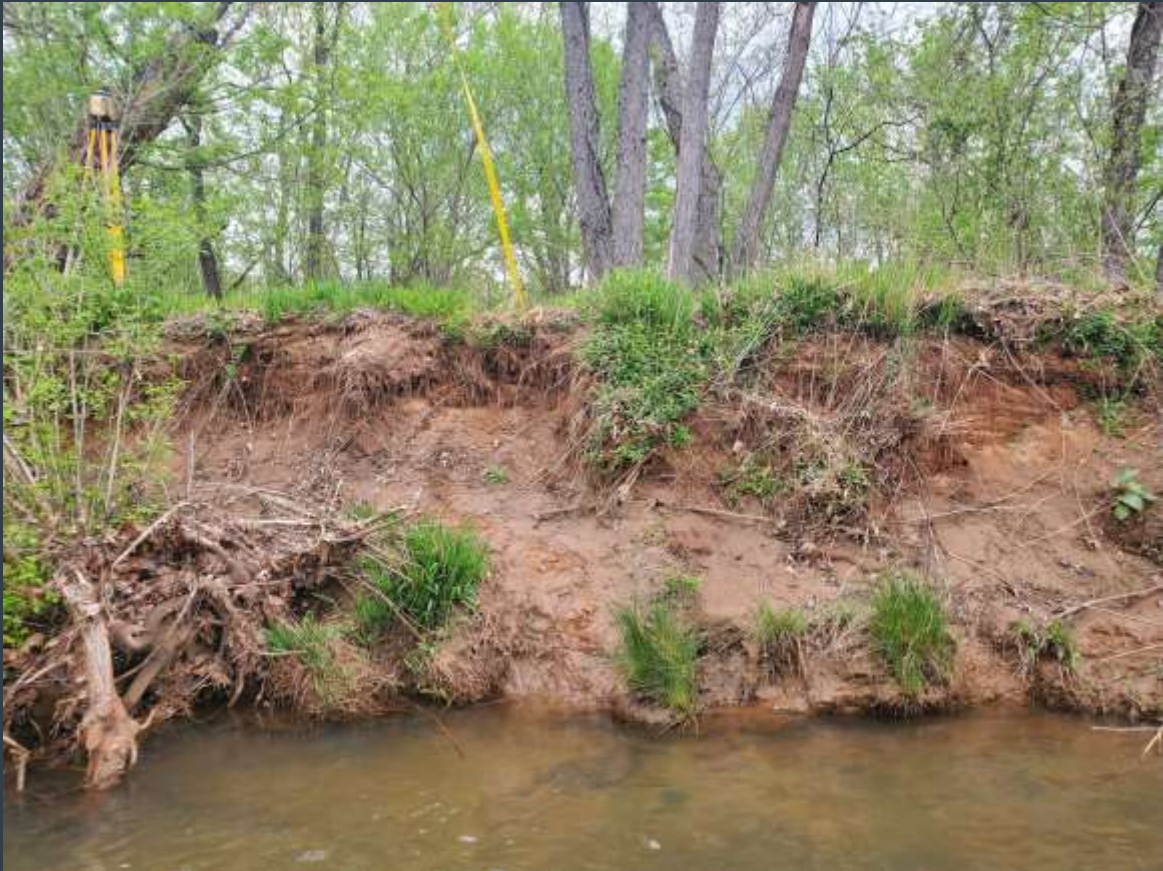
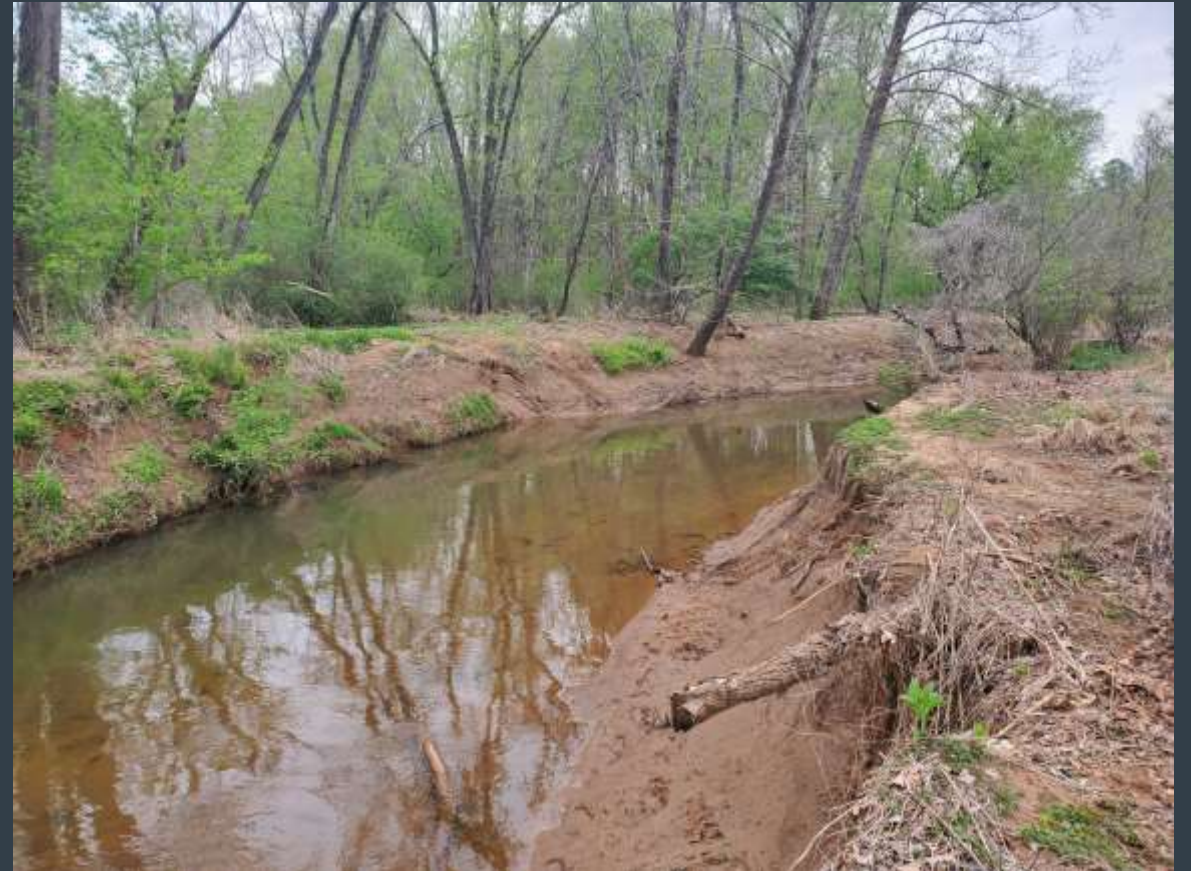
Majority of Stream Banks were classified as Very High/Extreme erodibility.

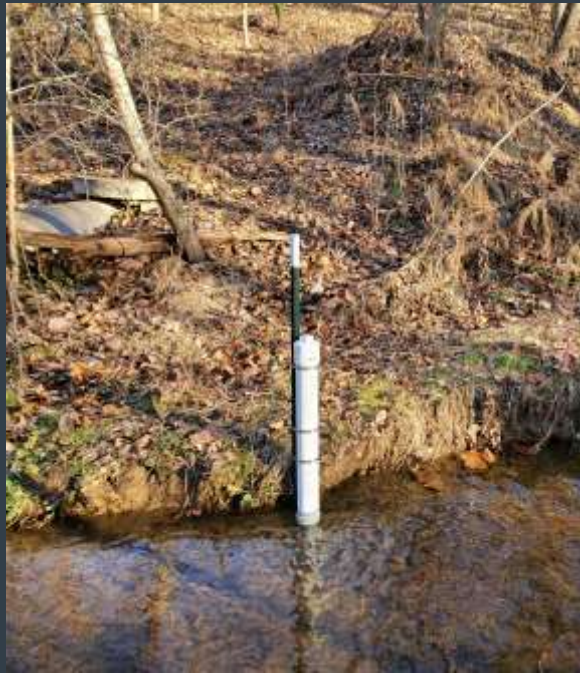
PHYSICAL METRICS | COLLEGE LAKE

- Multiple HOBOTM Data Loggers
- 18 Events Exceeded Bankfull Depth in 12 months

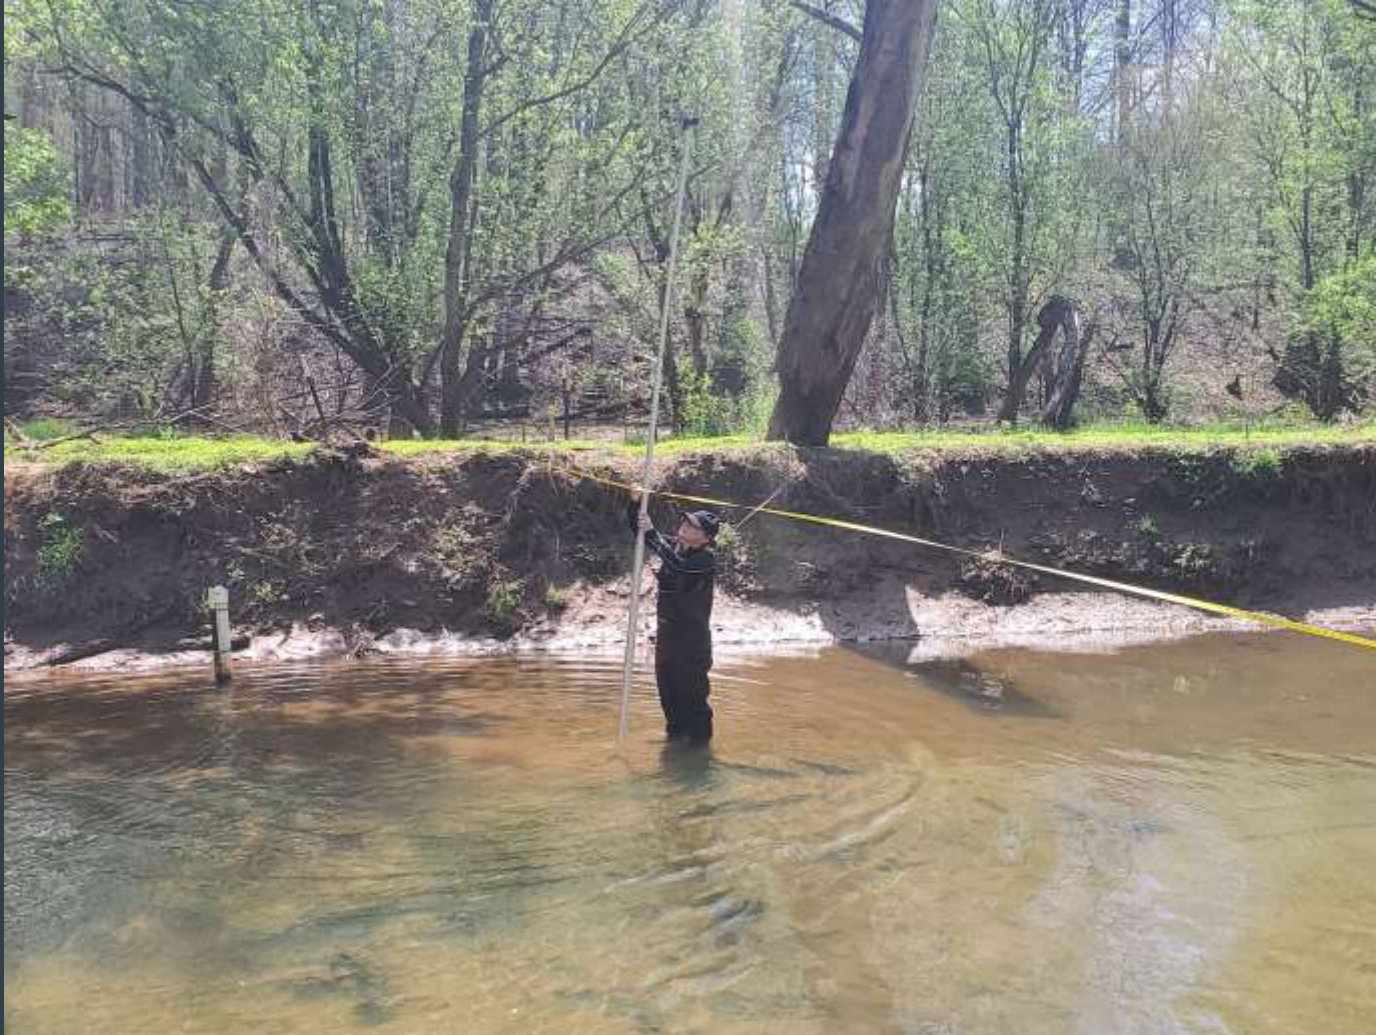
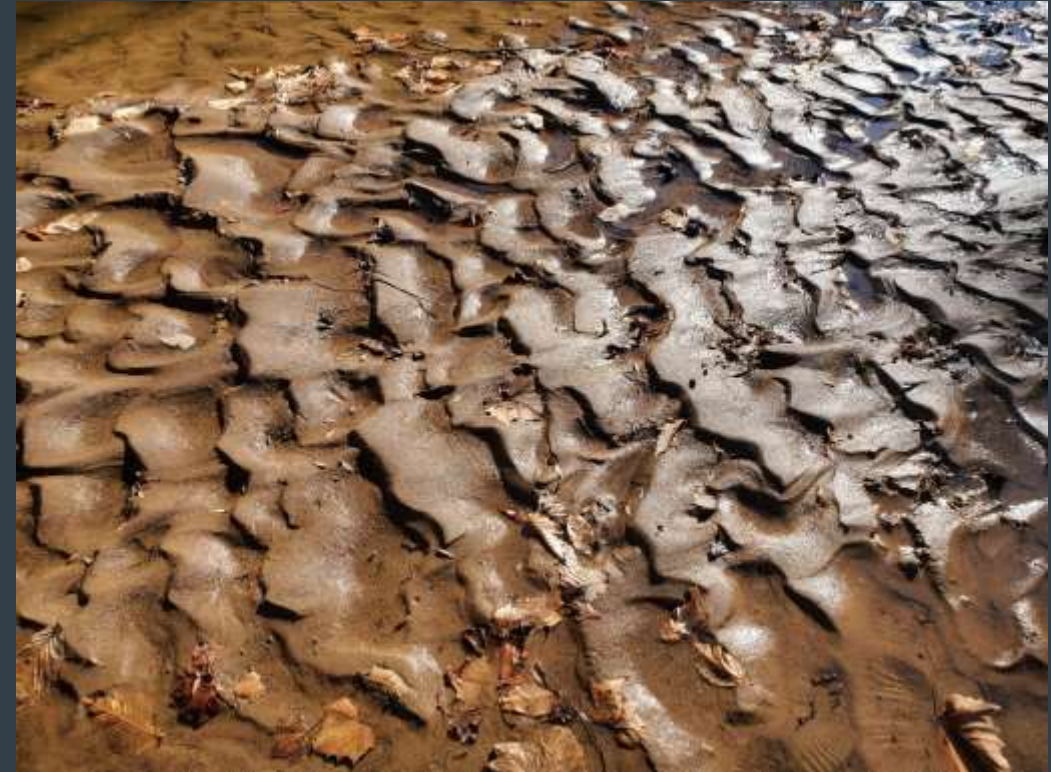
- Incised Channel
- Sand Dominated Channel

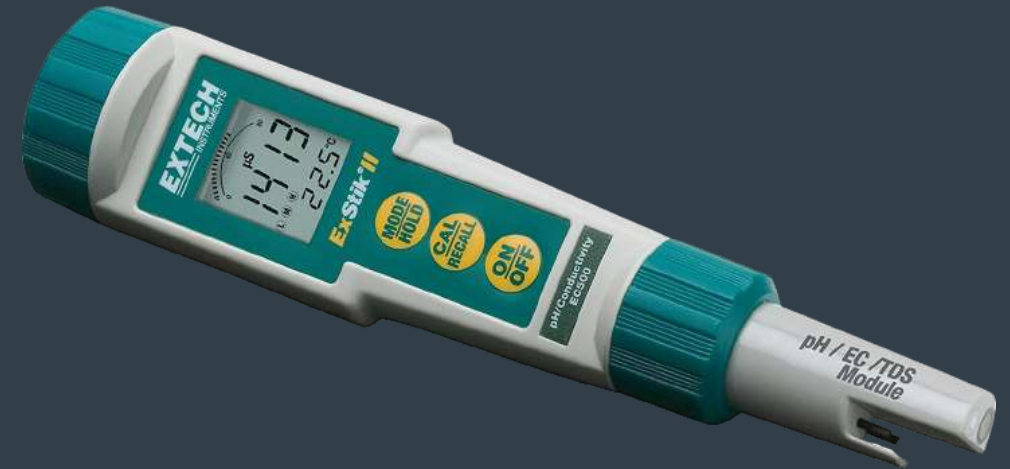
WATER QUALITY METRICS | COLLEGE LAKE

pH	Specific Conductance ($\mu\text{s}/\text{cm}$)	Dissolved Oxygen (ppm)	Total Dissolved Solids (mg/L)
7.55	203	8.02	209

- Good water quality
- Absent of odors, surface oils, with no significant turbidity.
- Elevated Bacteria Levels were observed in the Study Area

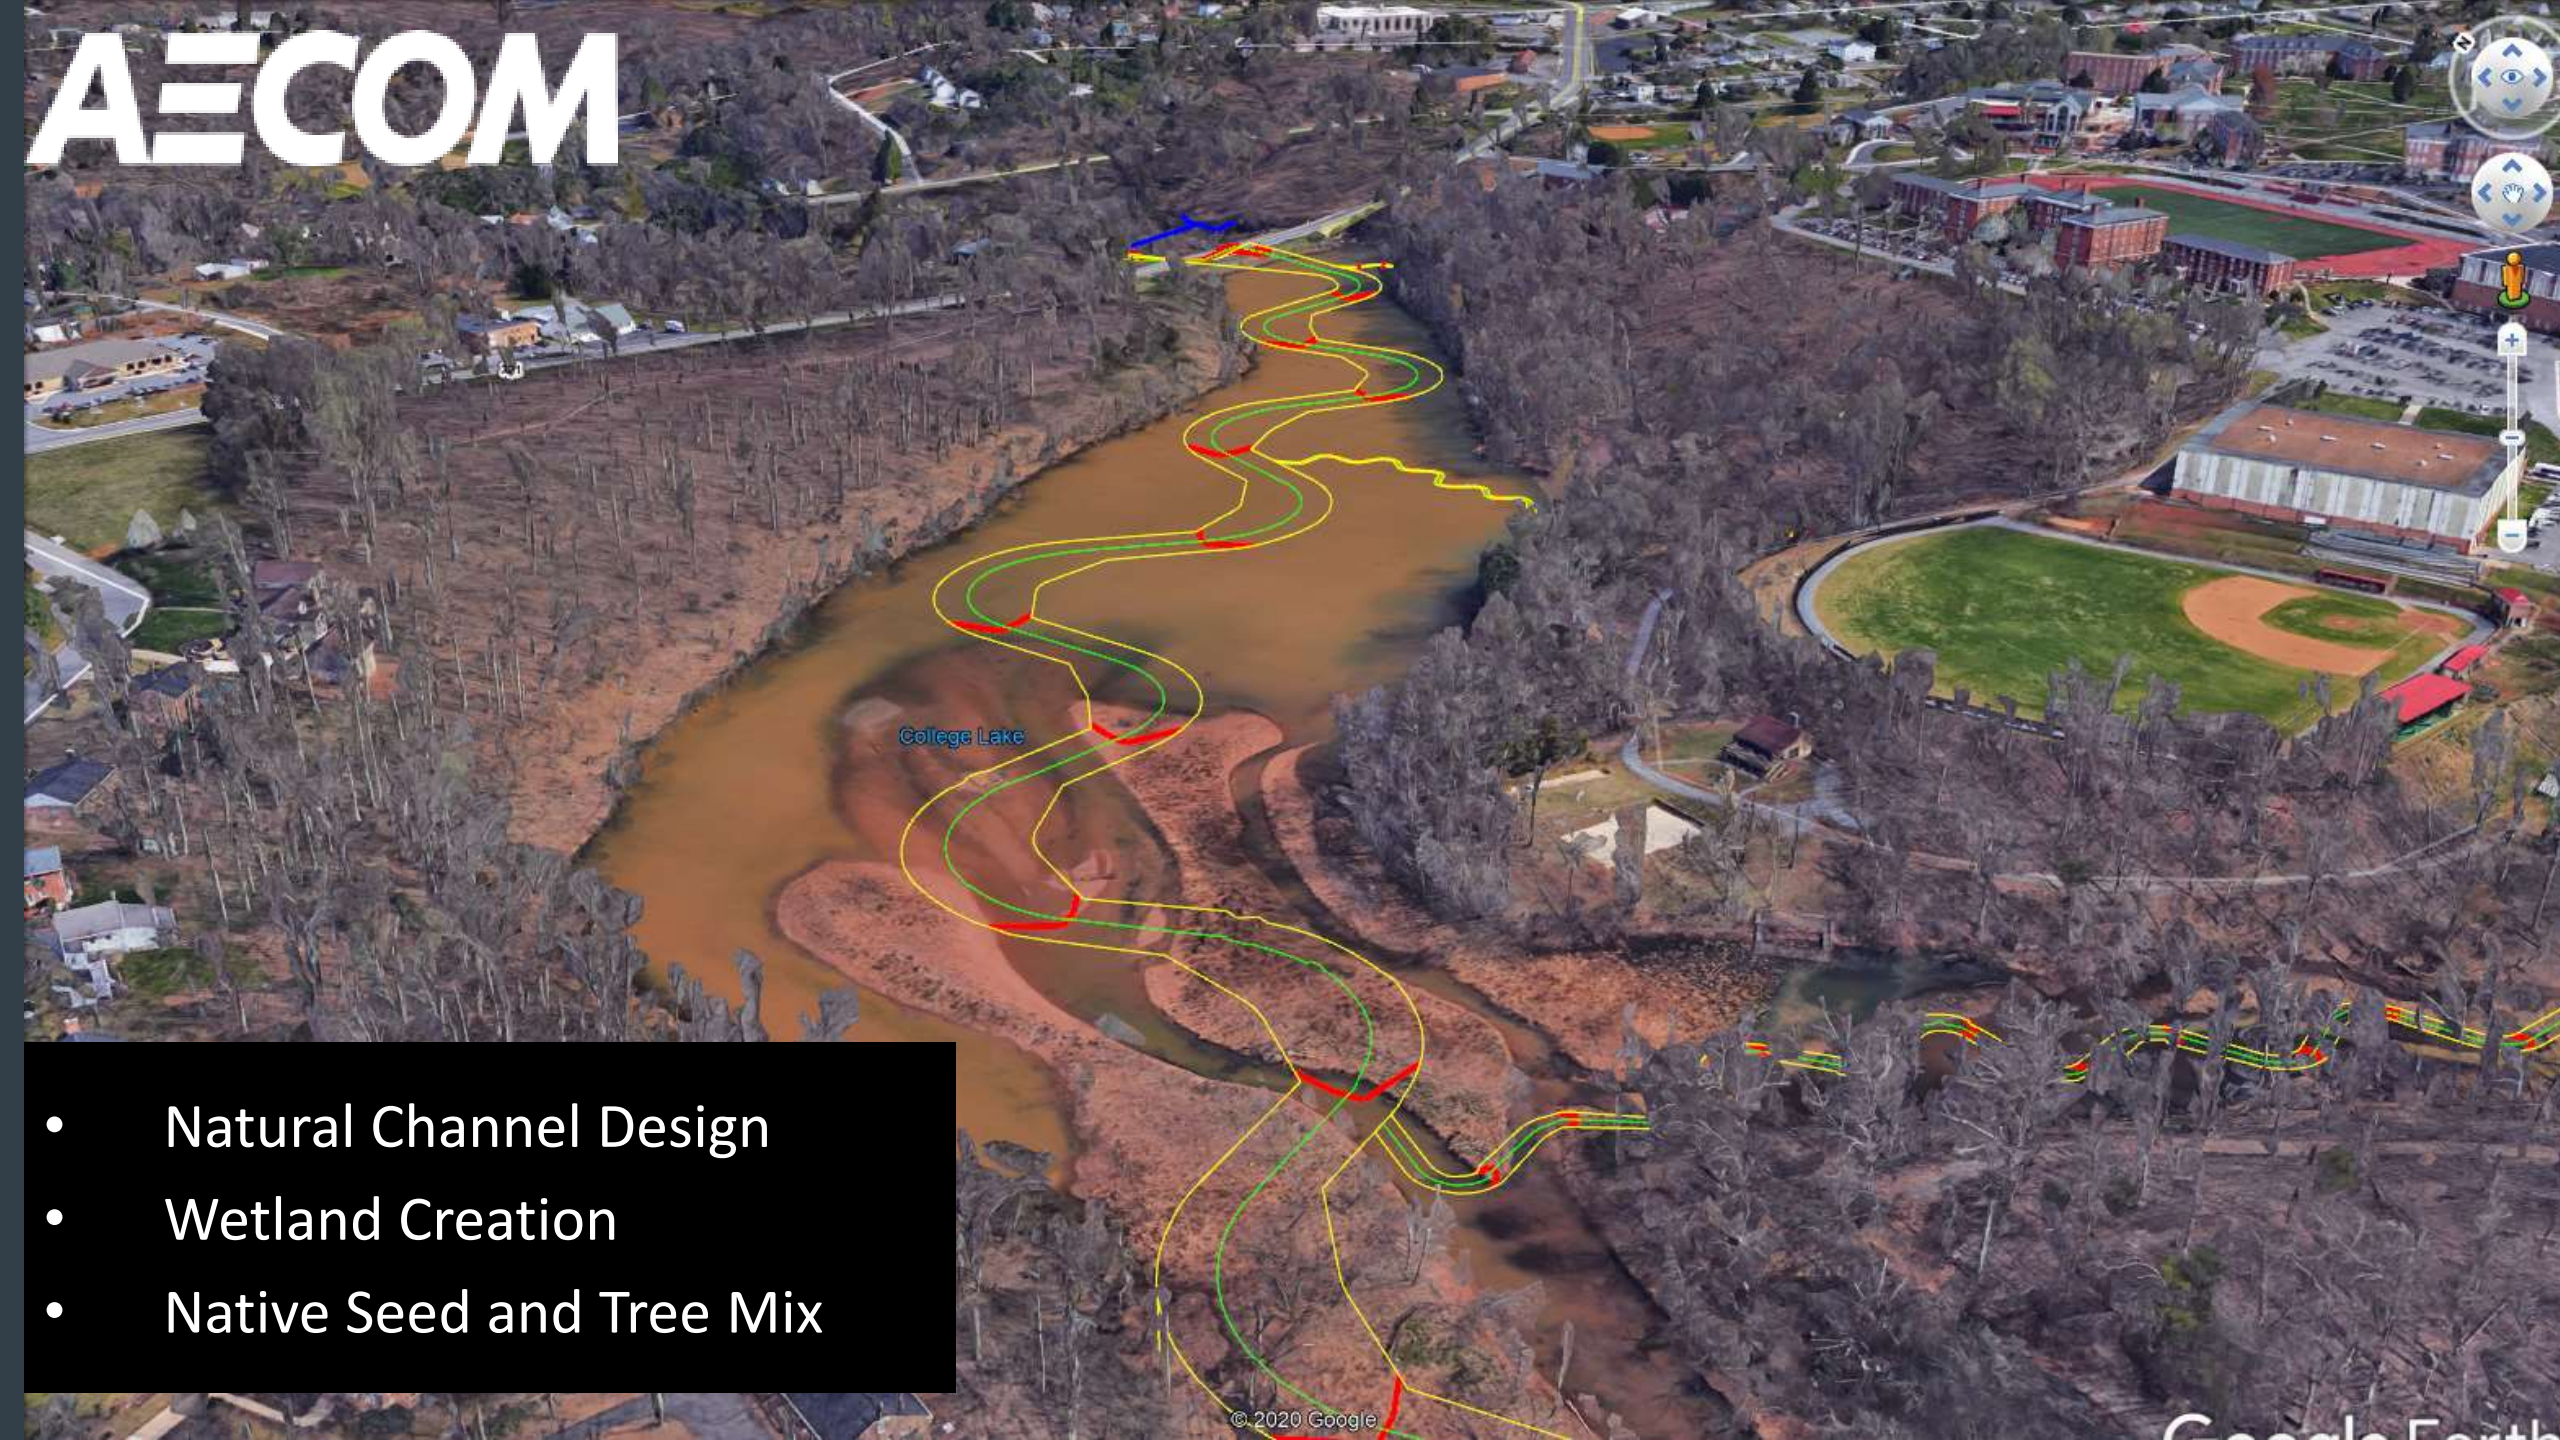
PROPOSED CONDITIONS

- Natural Channel Design
- Wetland Creation
- Native Seed and Tree Mix

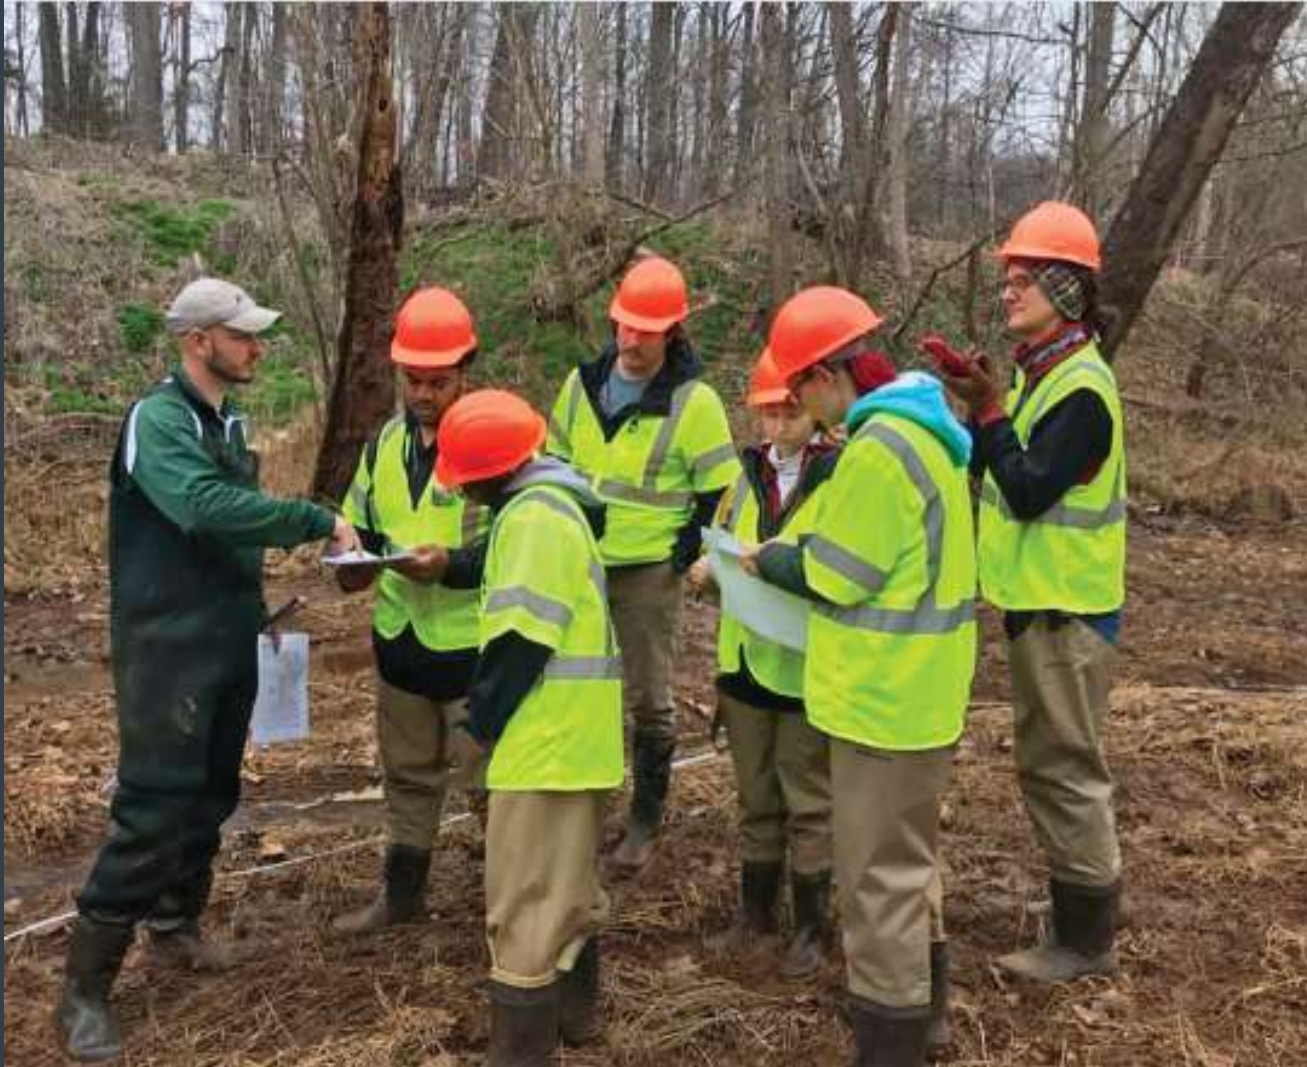
- UofL Faculty and Student Research/Classroom
- In-Situ Aqua TROLL[®] 500 and VuLink Data Logger
- 5 Year Compliance Monitoring
