Alleviating Flood Damage to Critical Hospital Infrastructure through Stream Restoration At Jewish Hospital and St. Mary's Foundation in Louisville, Kentucky

Session B

Brad Anderson, PE, CPESC, LEED AP

August 22, 2023

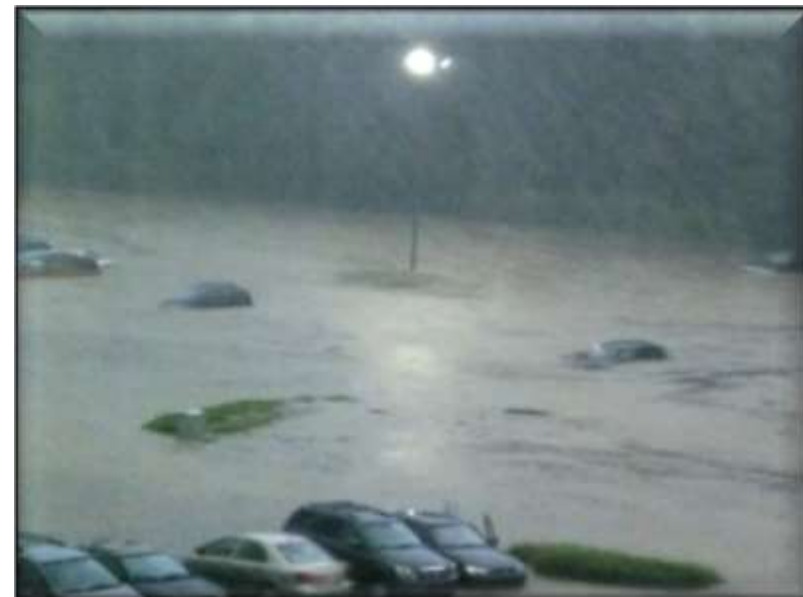
The Flood

- August 2009 – JHSMF experienced near 100-year flood event
- Flooded hospital basement housing mechanical/electrical
- Shut down hospital and required patients to be transferred
- Flooded southwest parking lot damaging numerous vehicles

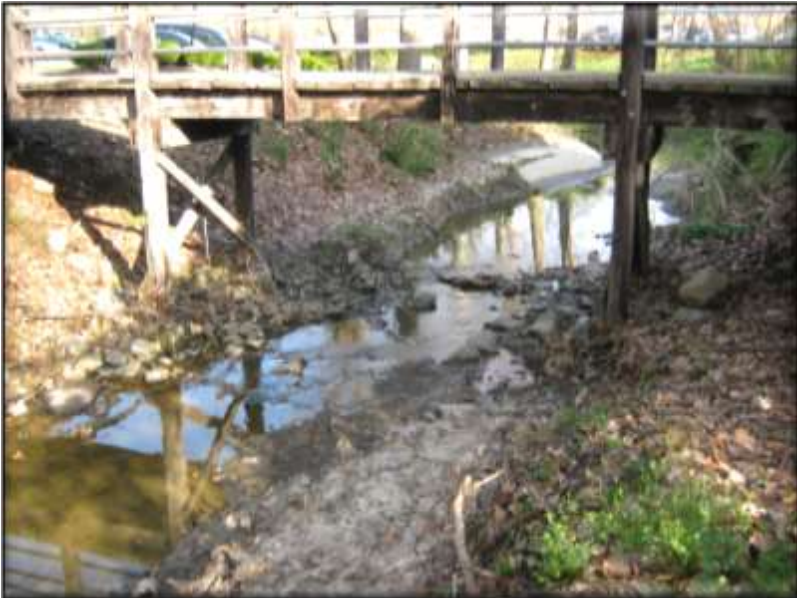
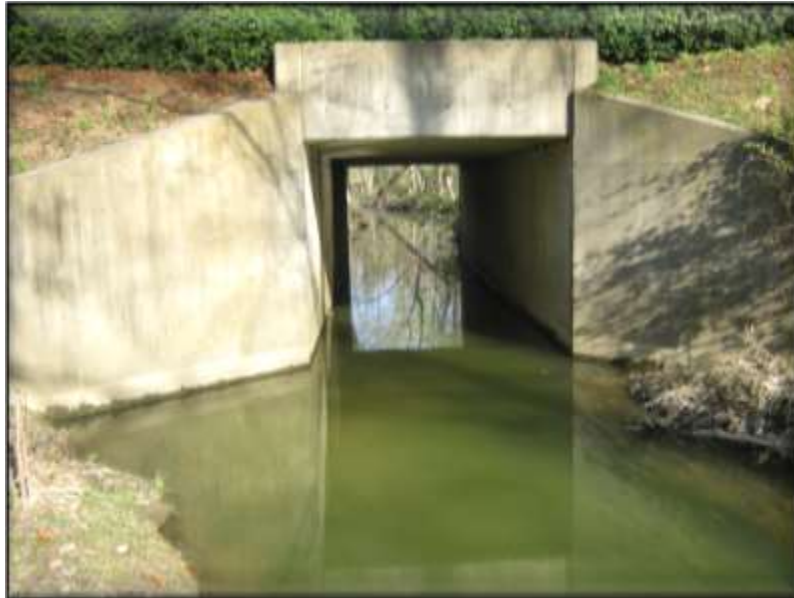
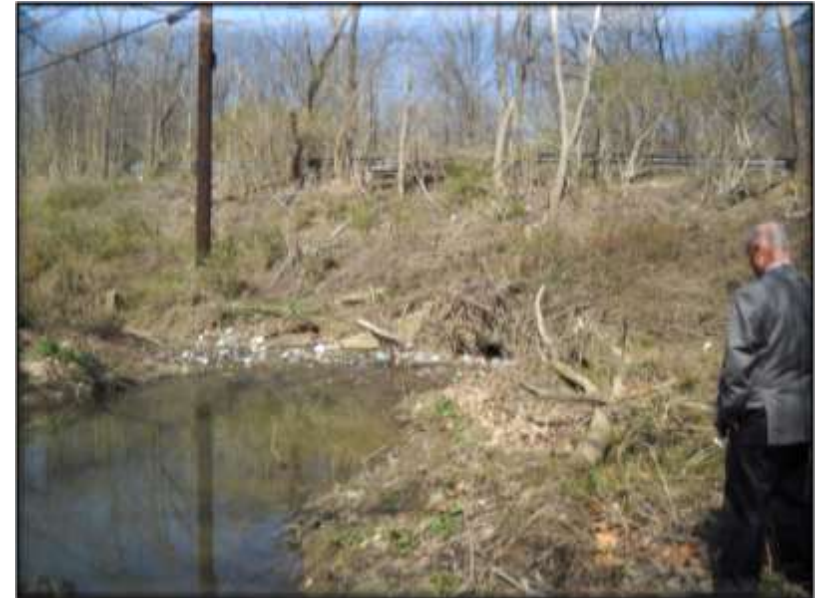
Existing Conditions - Hydraulic Constraints

- Wooden pedestrian bridge
- Small 7'6"x9' box culvert for parking lot access crossing
- Mostly blocked 12'x7' box culvert at Bluegrass Avenue
- Elevated streambed downstream of 12'x7' box culvert

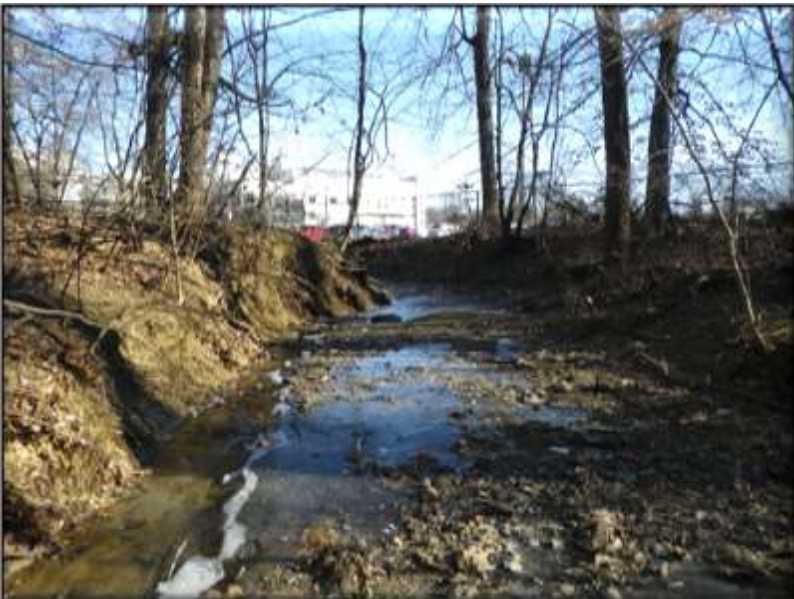
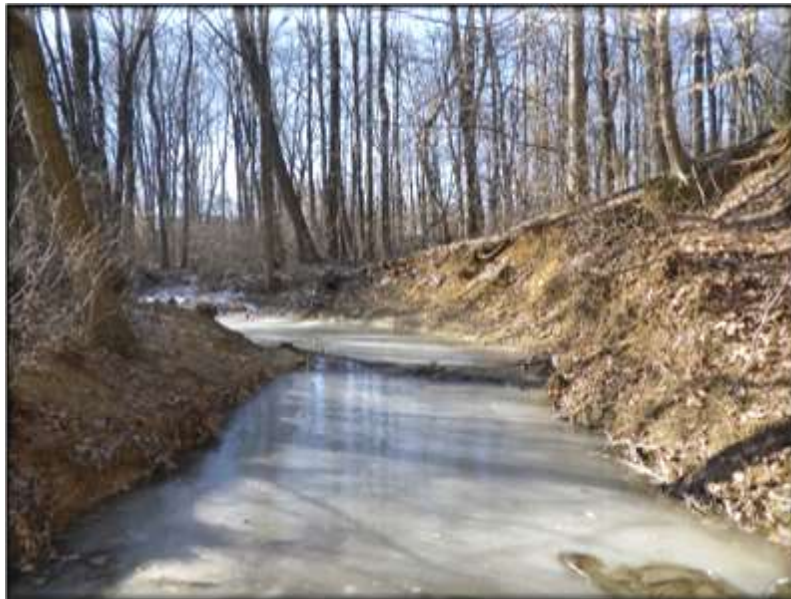
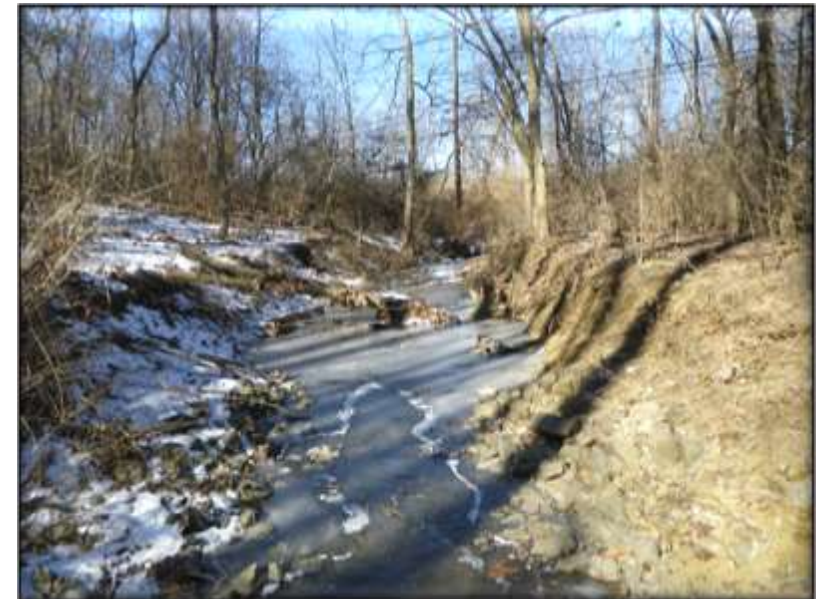
Existing Conditions - Stream

- Intermittent streams with 260 to 510-acre drainage areas
- Low stream slopes from 0.3% to 0.5%
- Streams overwidened, incised and entrenched with vertical eroding banks
- Stream corridor overgrown with invasive shrub species

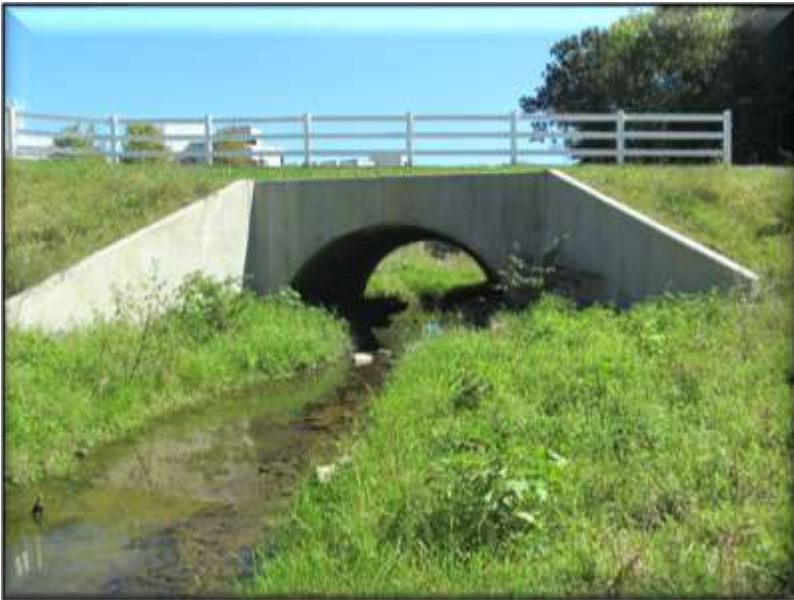
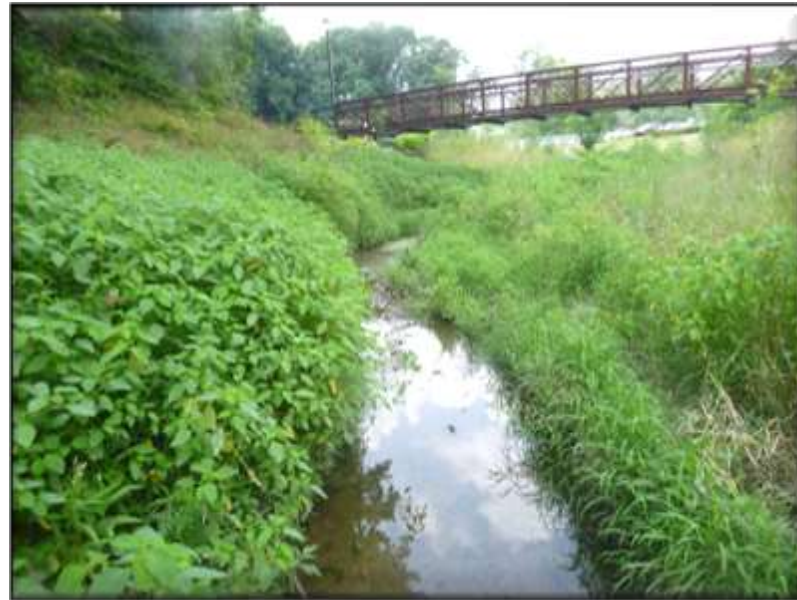
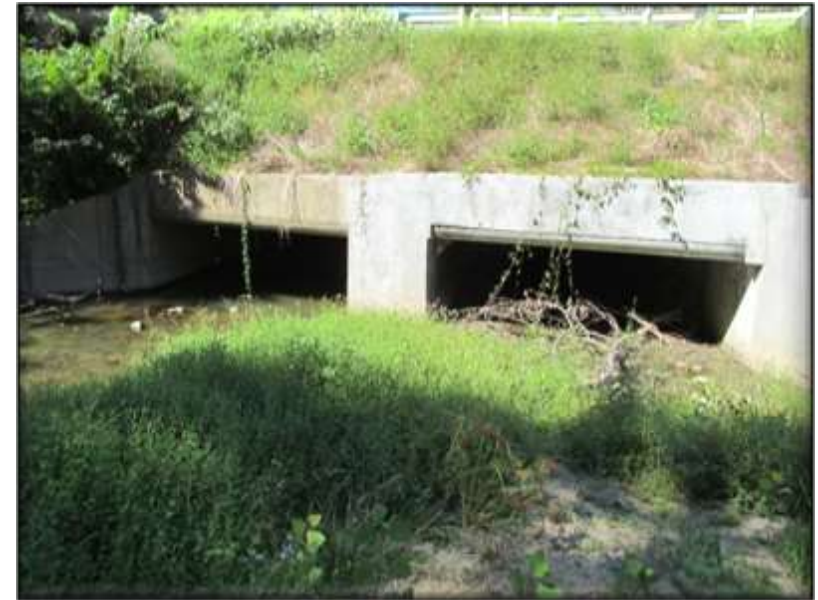
Proposed Solution

- Restore 1,530 lf of stream utilizing NCD principles with floodprone benches
- Replace 7'6"x9' RCBC with 16'10"x8'3" arched open bottom culvert
- Replace existing pedestrian bridge with elevated wider spanning bridge
- Install additional 12'x4' floodflow conveyance box culvert
- Elevate south parking lot
- Construct concrete floodwall adjacent to utility building

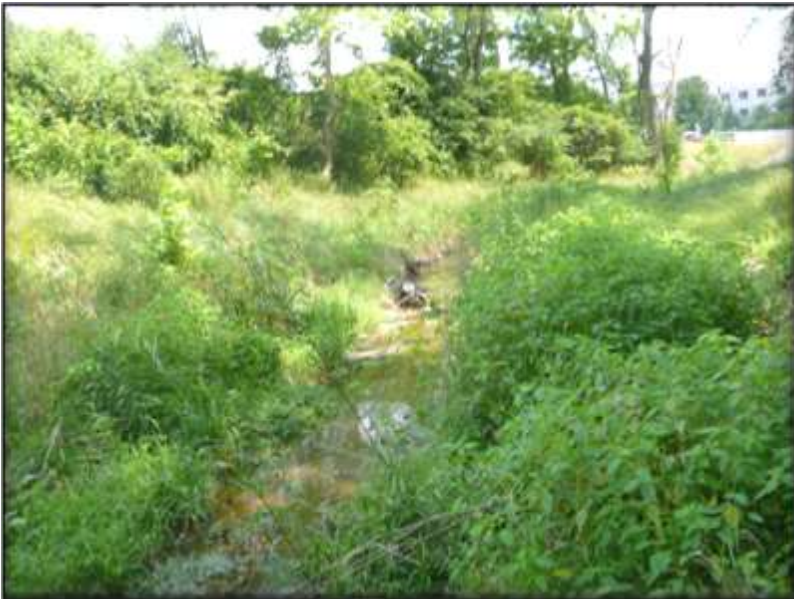
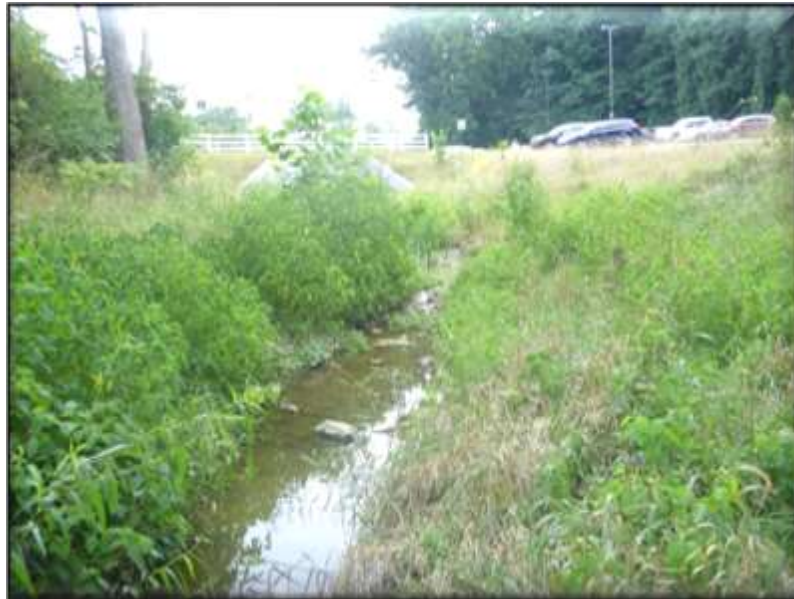
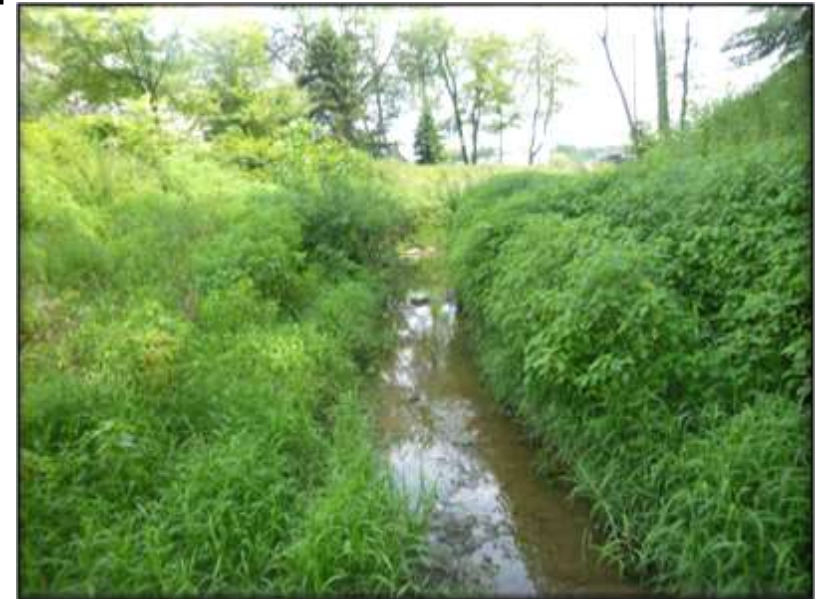
Stream Restoration

- Establish bankfull channel with riffle/pool morphology and stable planform/geometry
- Increase channel slope
- Create floodprone benches for flood flow conveyance
- Utilize in-channel structures such as boulder j-hooks and log vanes
- Utilize bioengineering techniques
- Stream restoration construction activities completed in Fall 2015

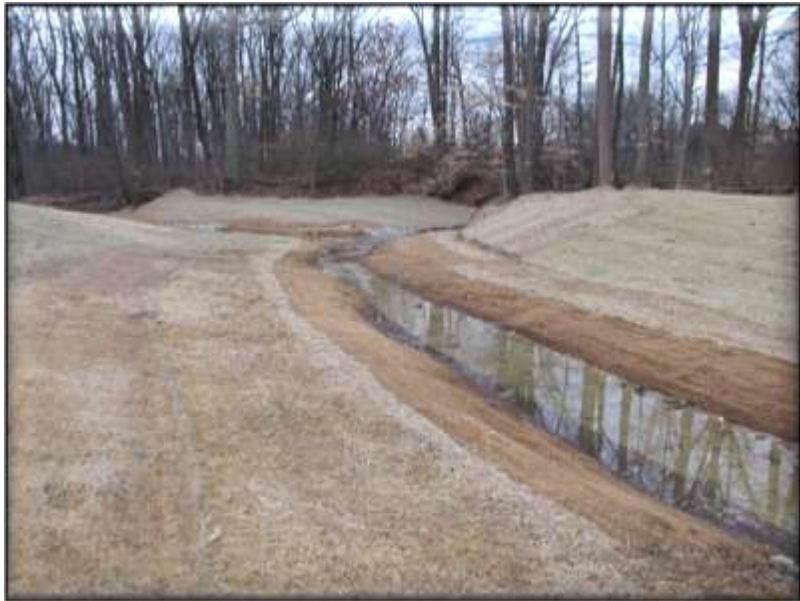
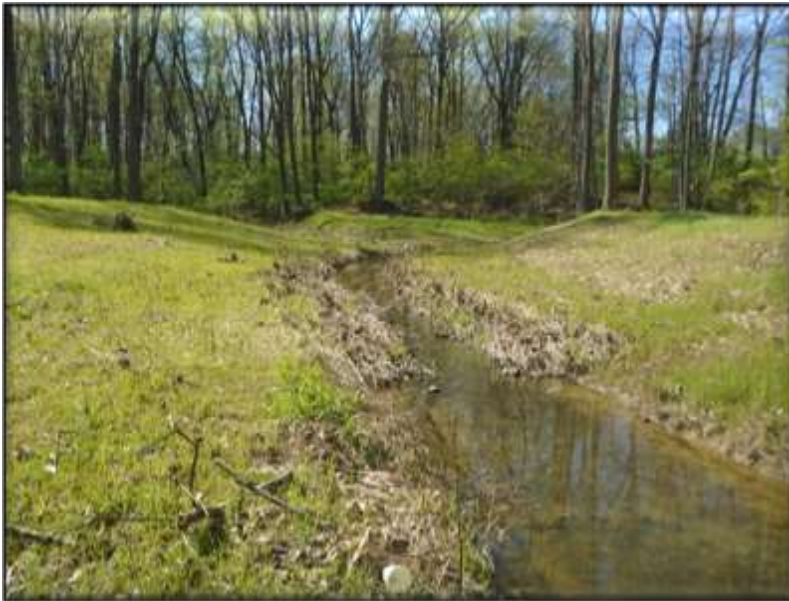
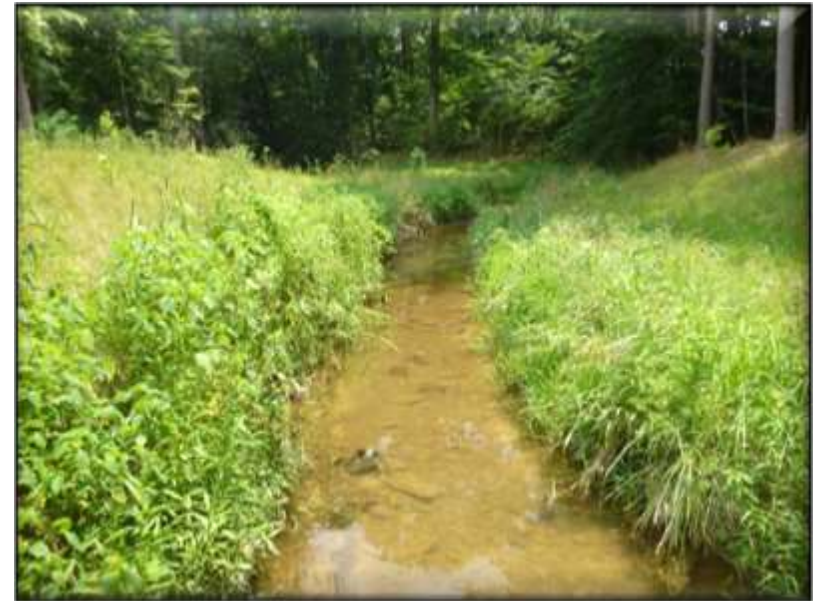
Bankfull Channel with Floodprone/Floodplain Benches

- Provides low flow channel to prolong and maintain deeper base flow
- Allows frequent overbanking to reduce in-channel shear stress
- Vegetated floodprone/floodplain benches allow for filtering of overbank flows

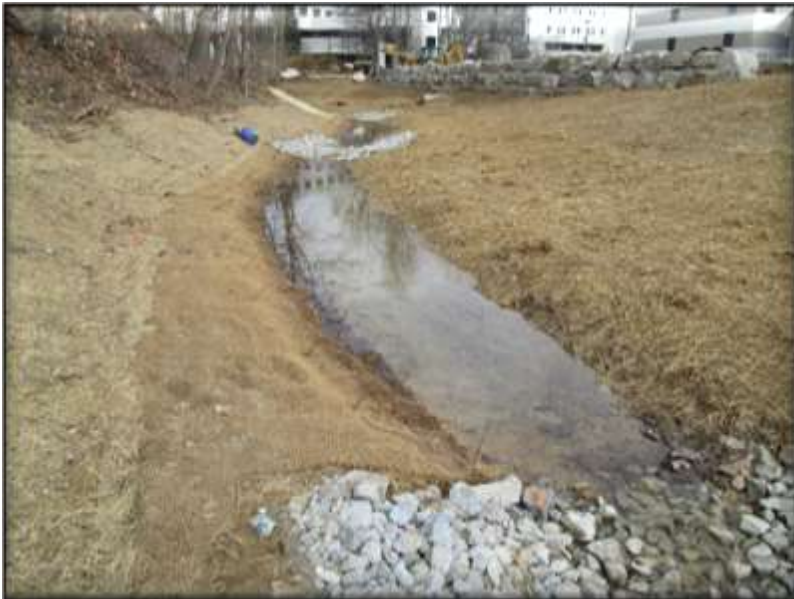
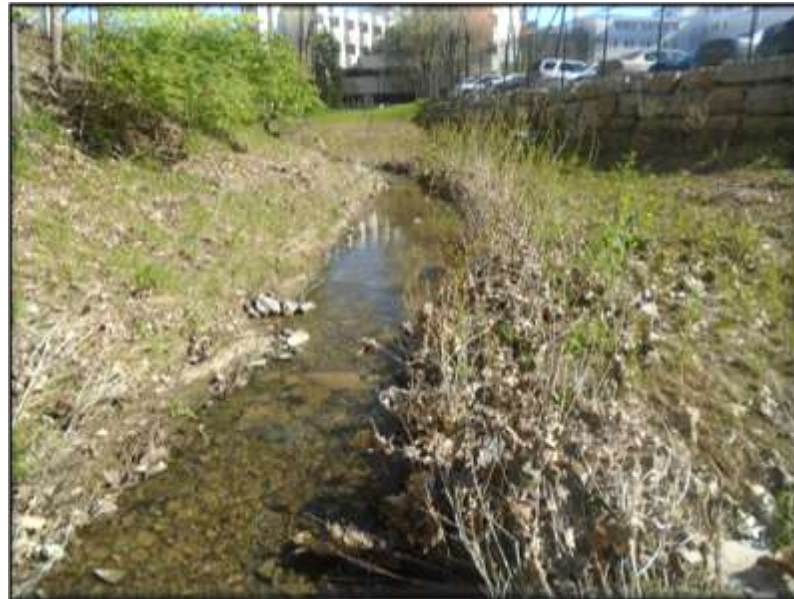
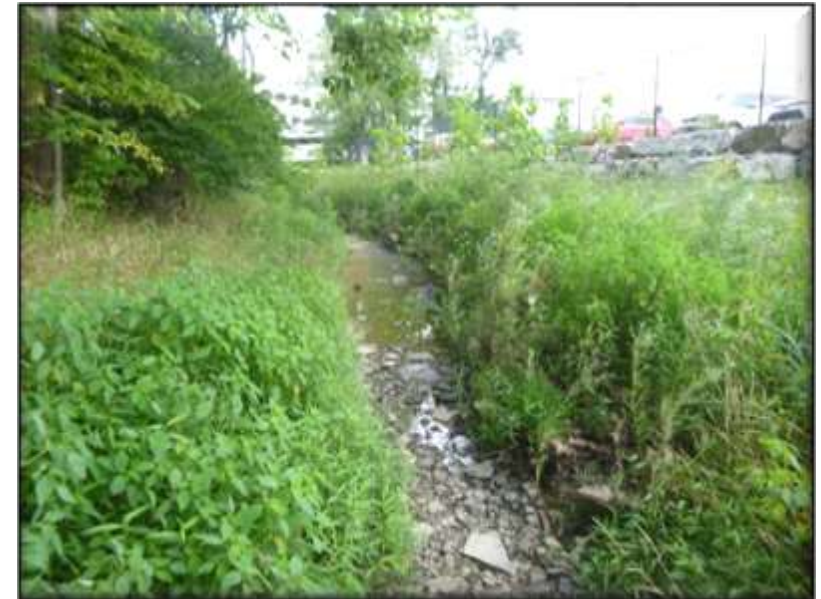
Riffle/Pool Morphology

- Riffles provide both grade control and in-channel aquatic habitat
- Turbulent flow through riffles increase dissolved oxygen in water
- Pools provide slower velocities and allow organics to settle and provide food for aquatic organisms
- Pools provide deeper water aquatic habitat

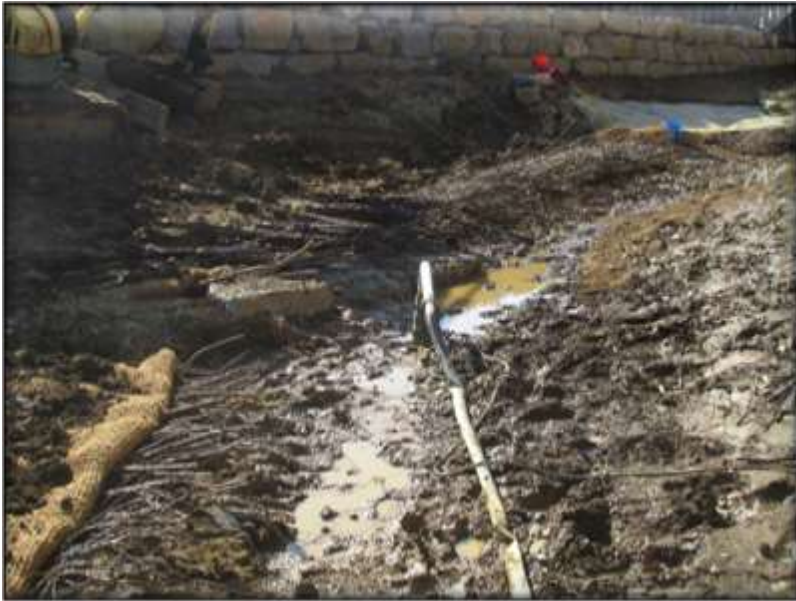
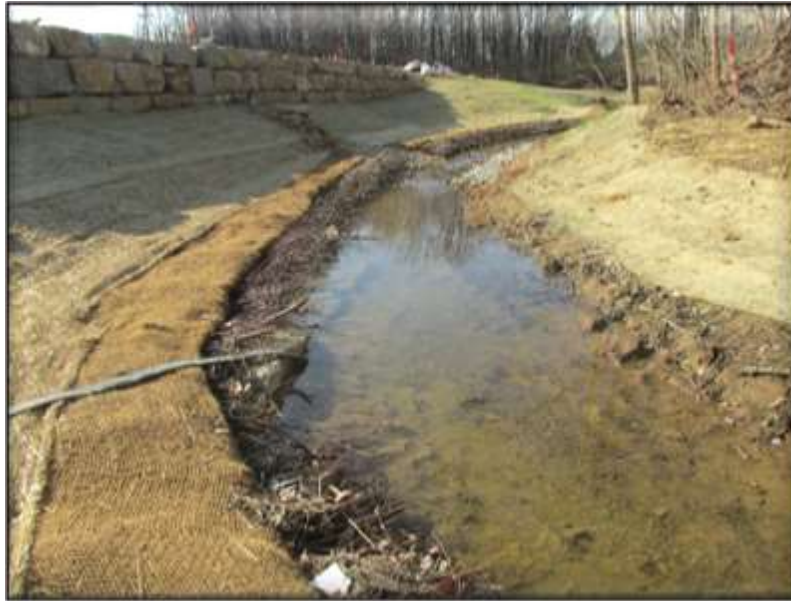
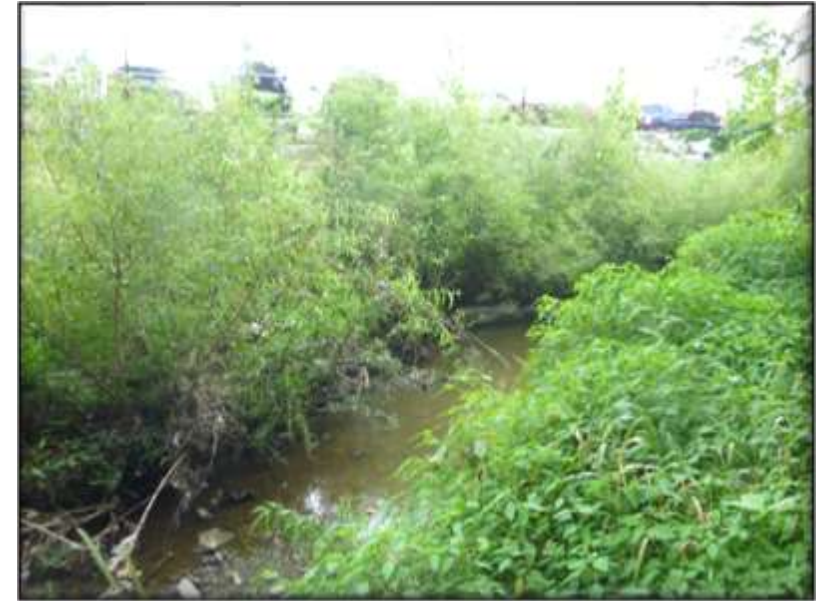
Boulder J-Hooks and Log Vanes

- Provide both vertical and horizontal grade control
- Provide in-channel aquatic habitat
- Reduce near-bank shear stress and protects outer streambanks from erosion

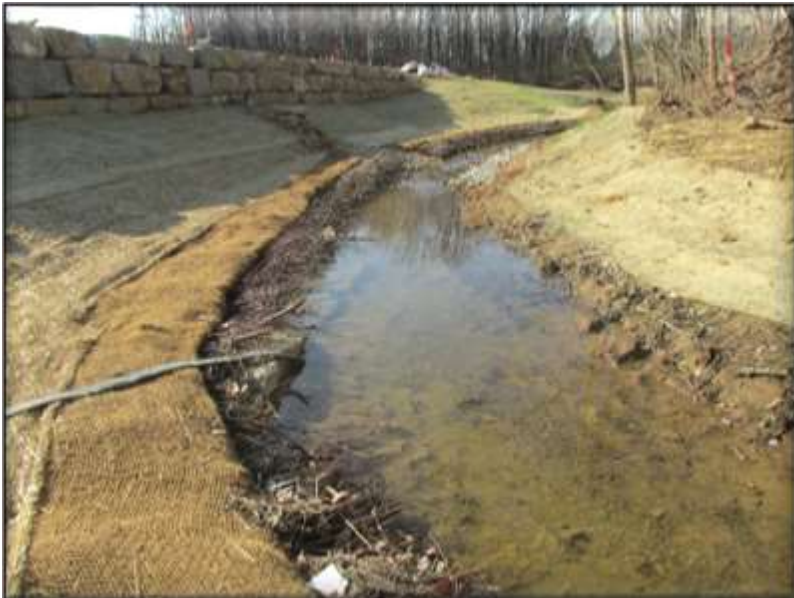
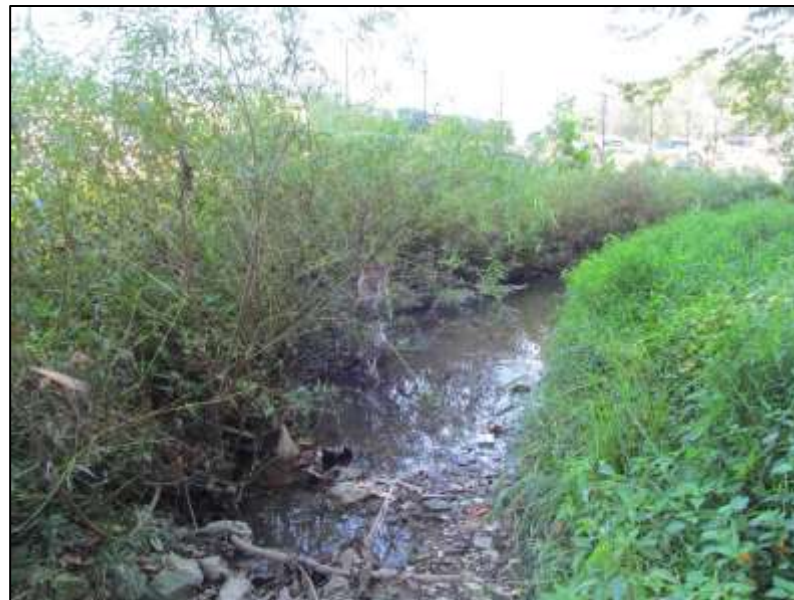
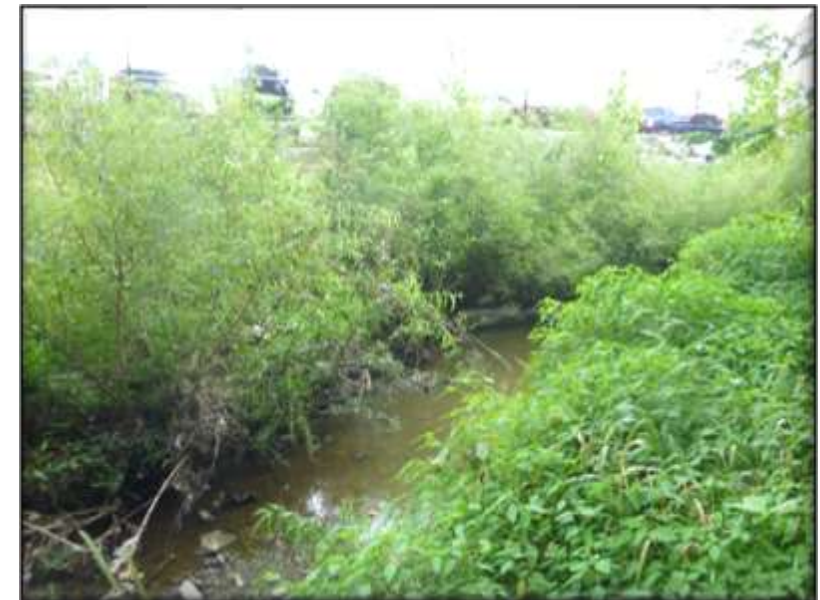
Branch Layering and Live Staking

- Uses quick growing, natural woody cuttings to provide streambank stability and outer streambank protection
- Provides natural armorment of streambanks and protects against streambank erosion
- Provides shading of stream channel and aquatic habitat
