Brent Run Creek: A case study of stream relocation on a tributary of the Flint River in Michigan

**Presented by:
Emma Giese
GEI Consultants**

Brent Run Creek Relocation

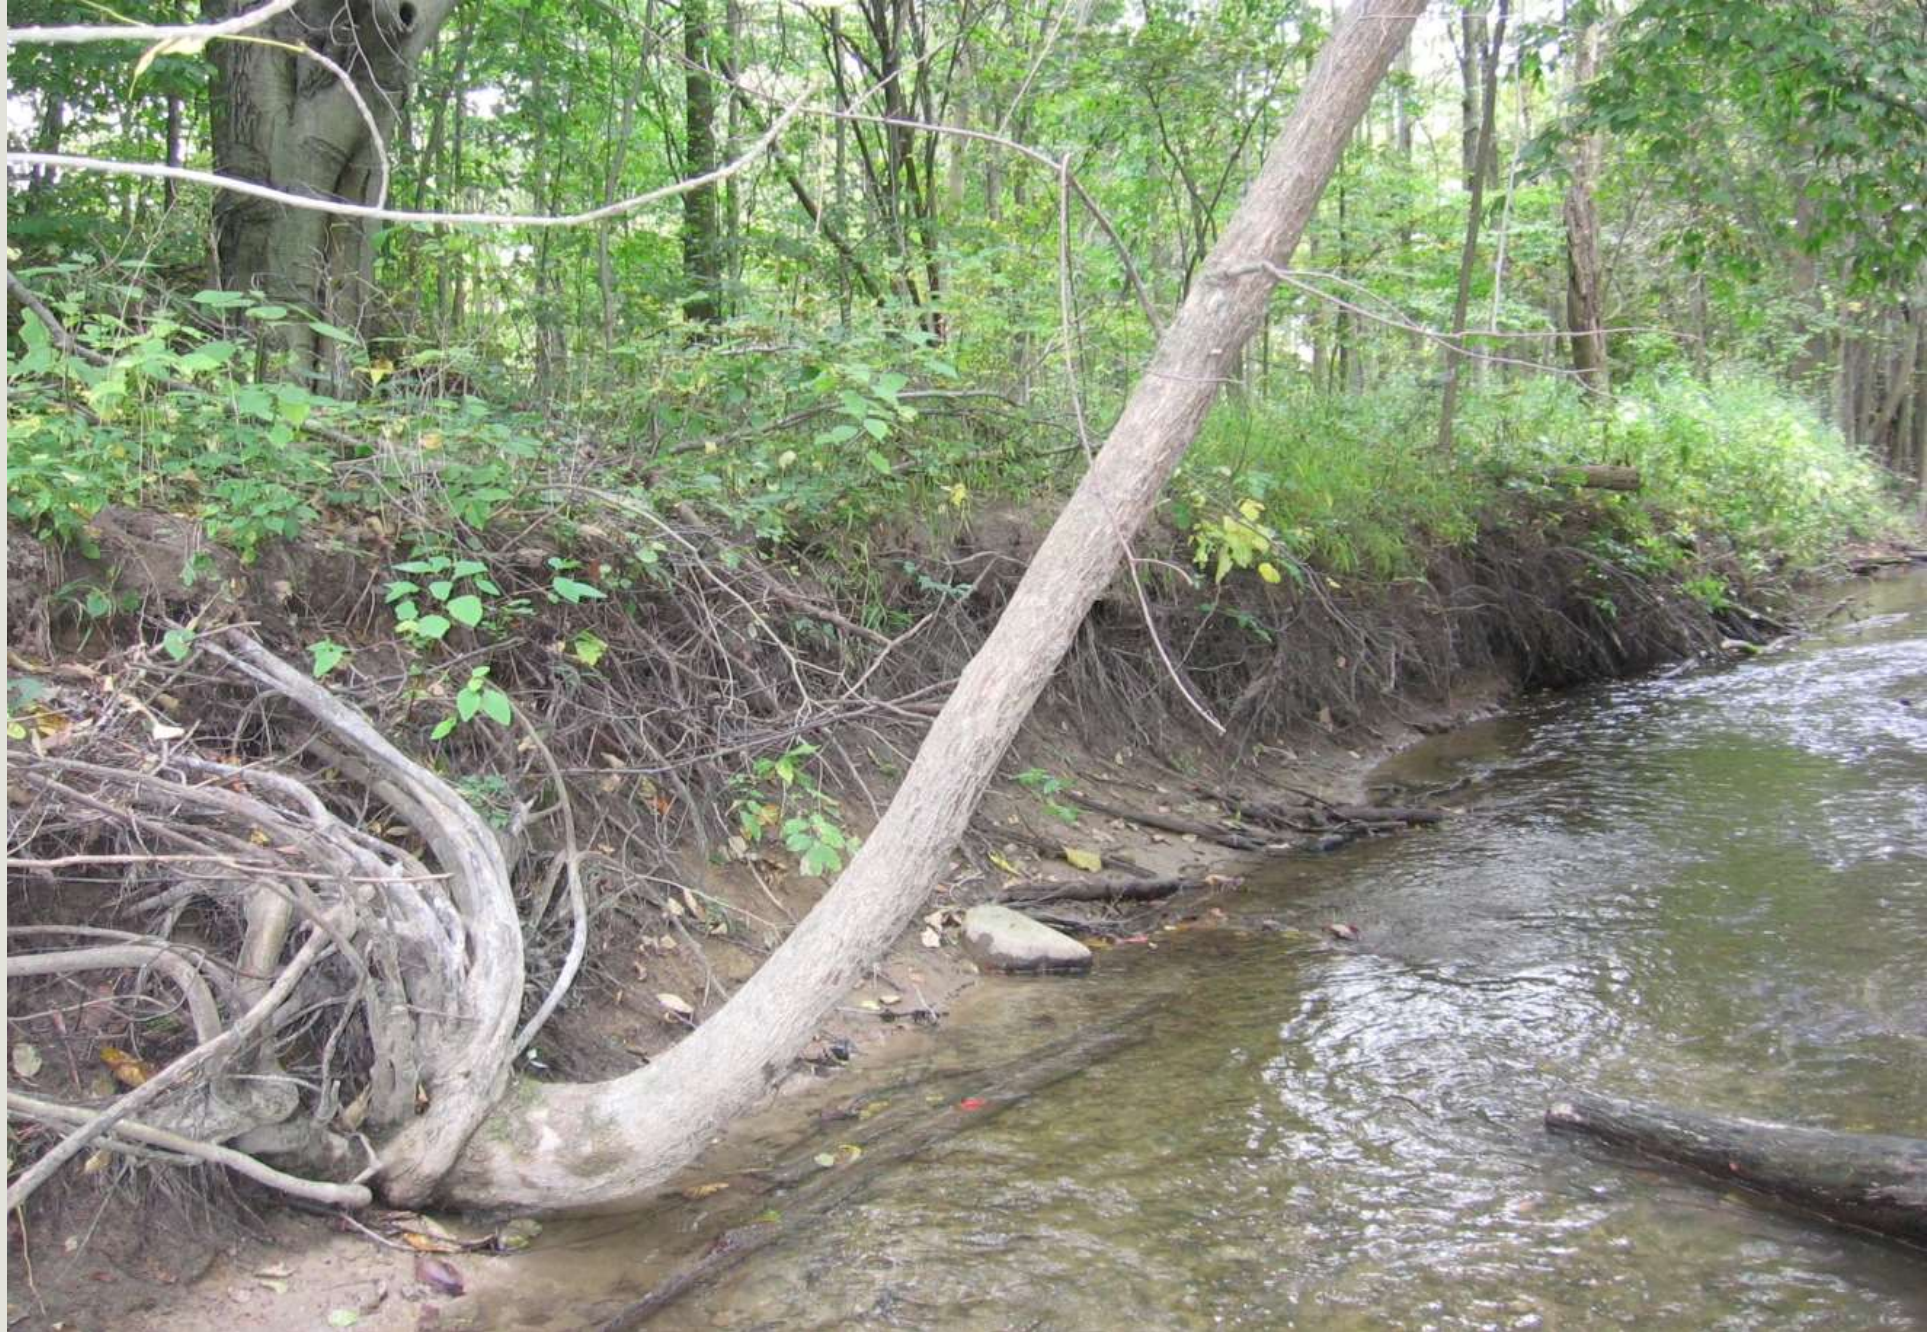
Existing Stream

- Steep banks
- Bank erosion, undercut banks
- Top of bank 1-2ft higher than bankfull elevation

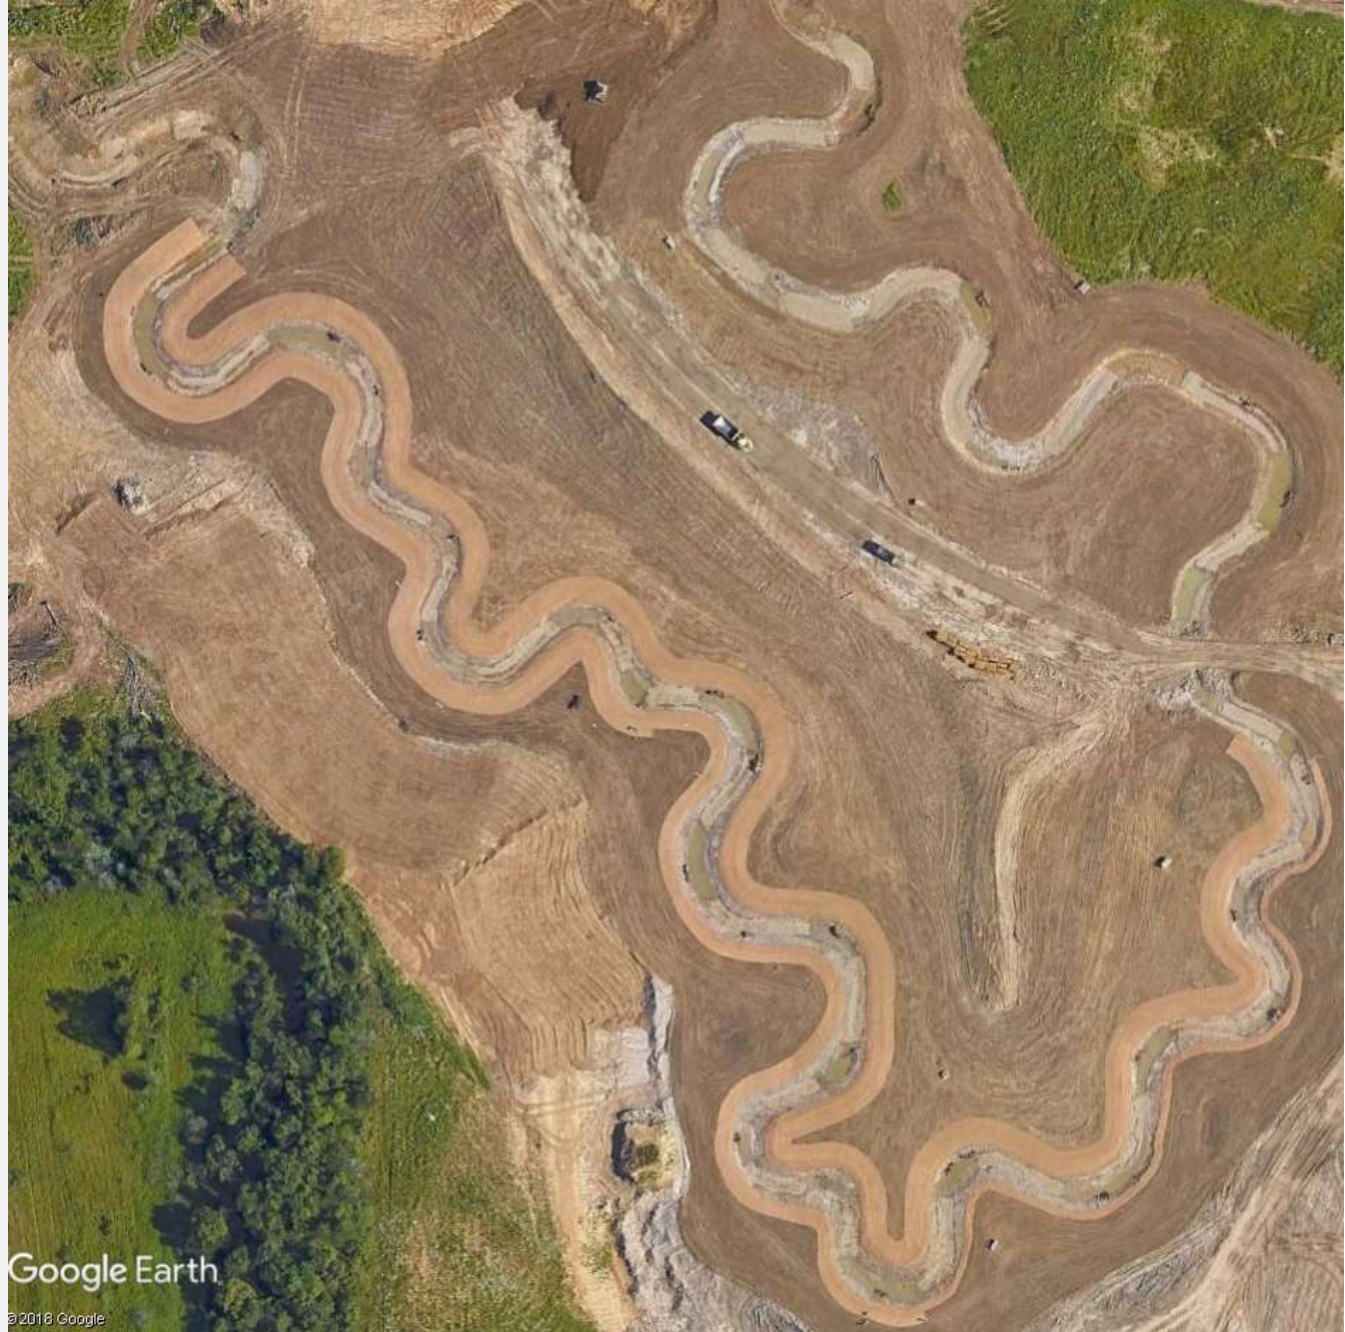
2015

Aerial of relocated channel during construction

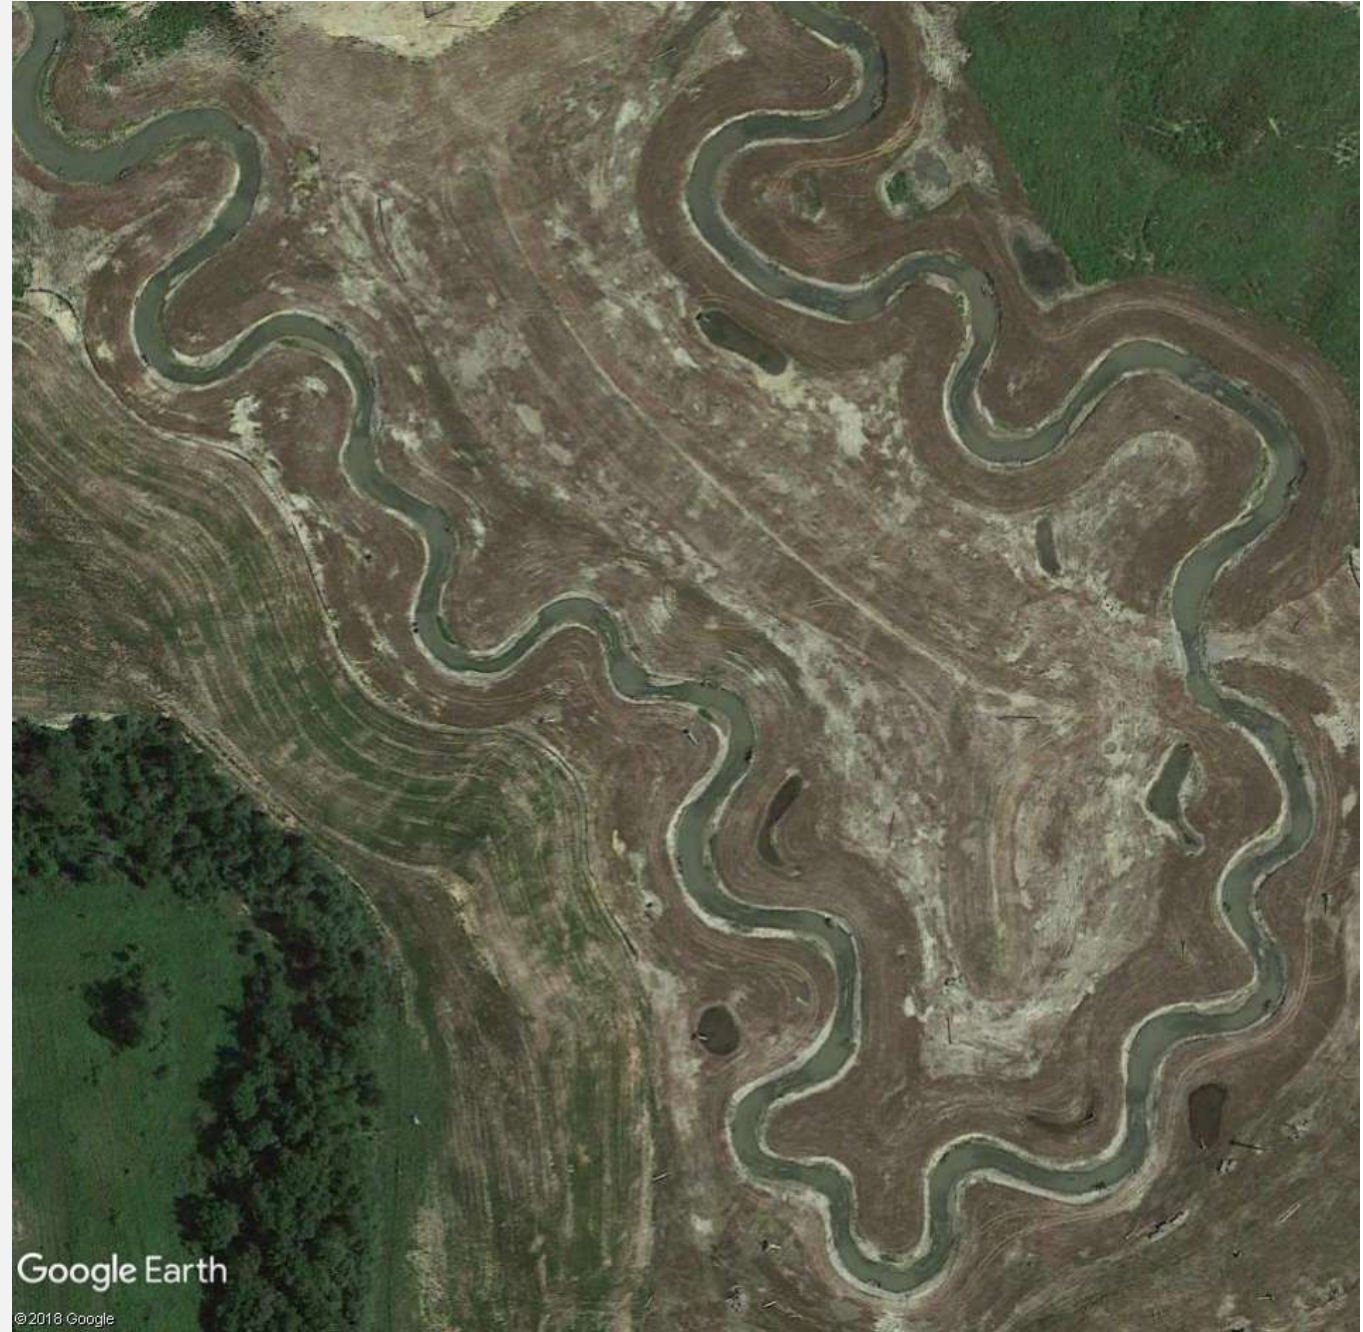
2016

Aerial of relocated channel

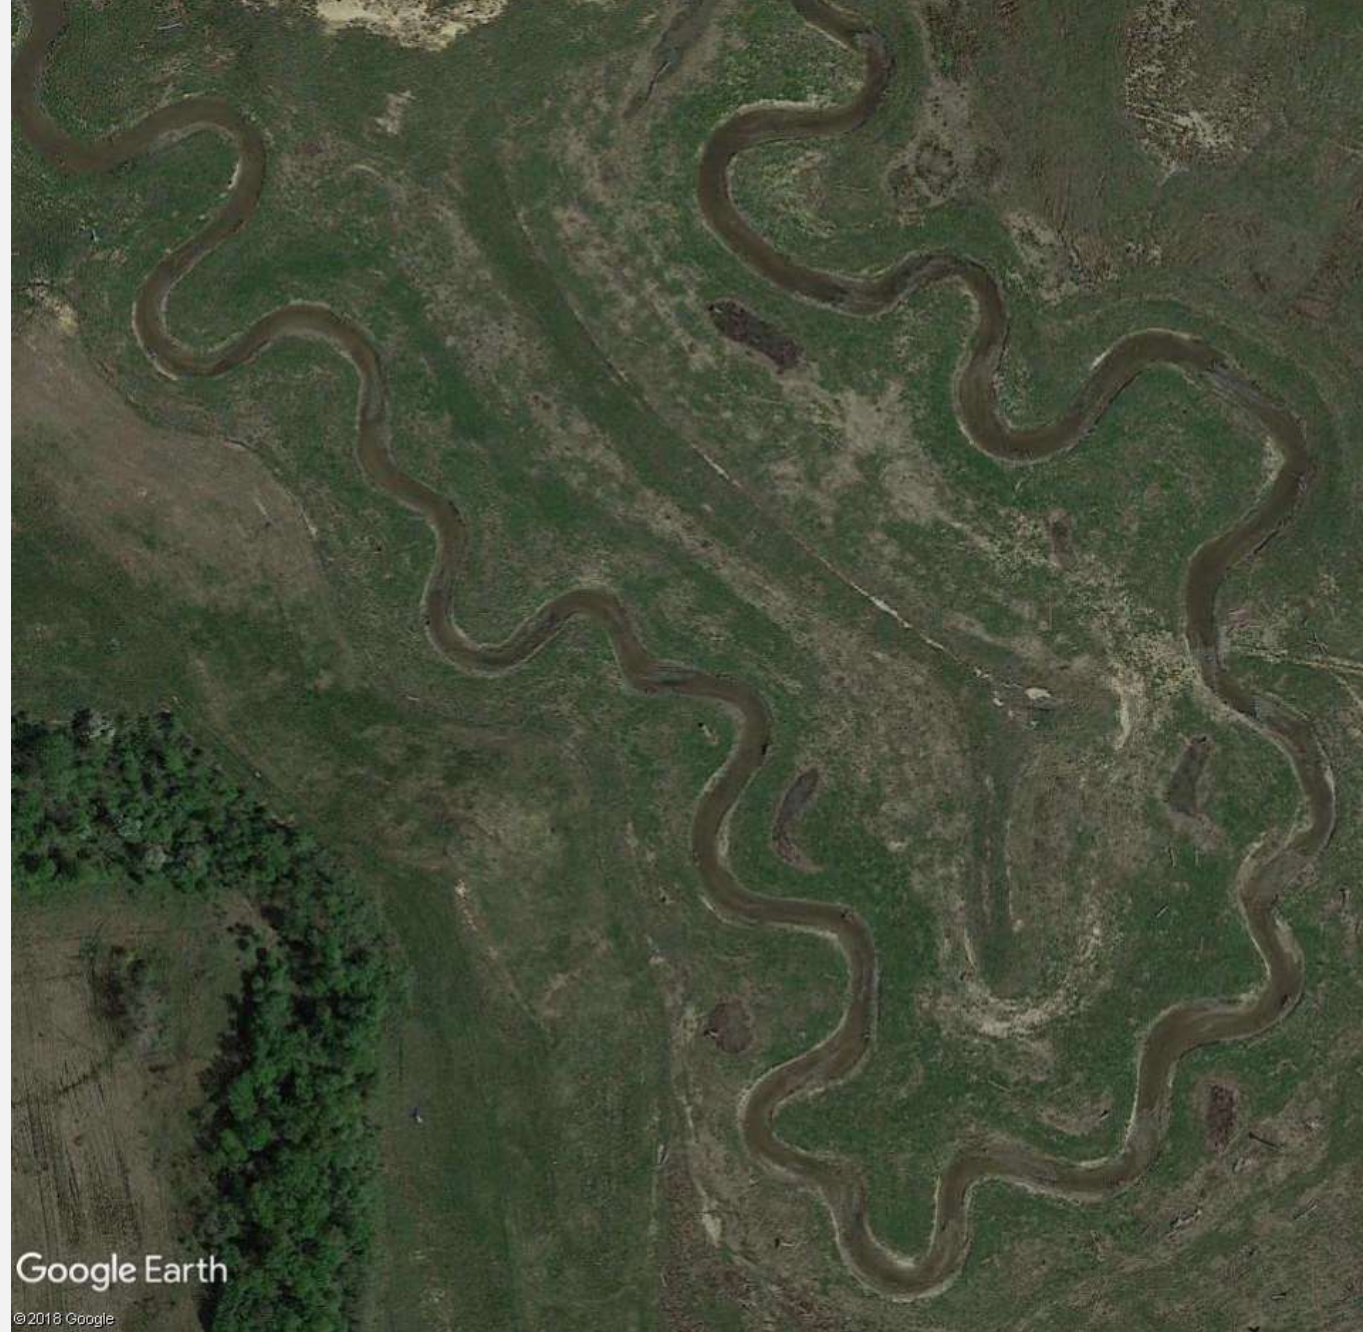
2018

Aerial of relocated channel

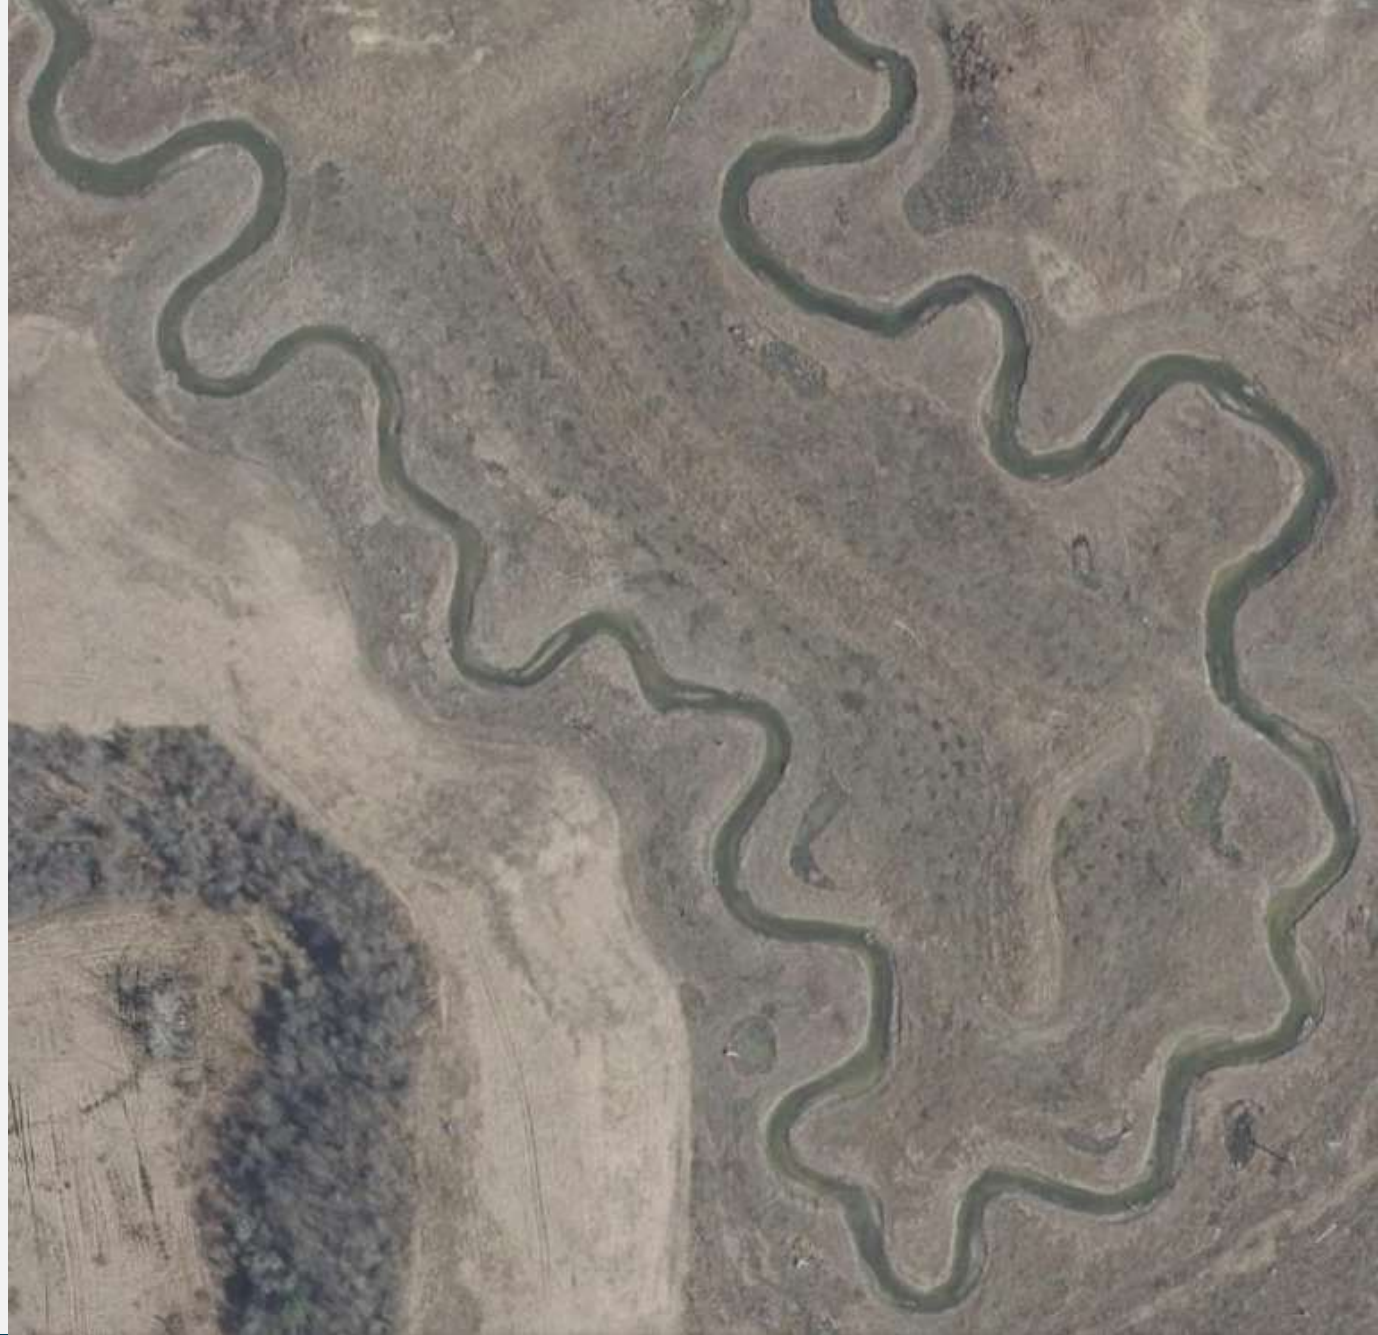
2020

Aerial of relocated channel

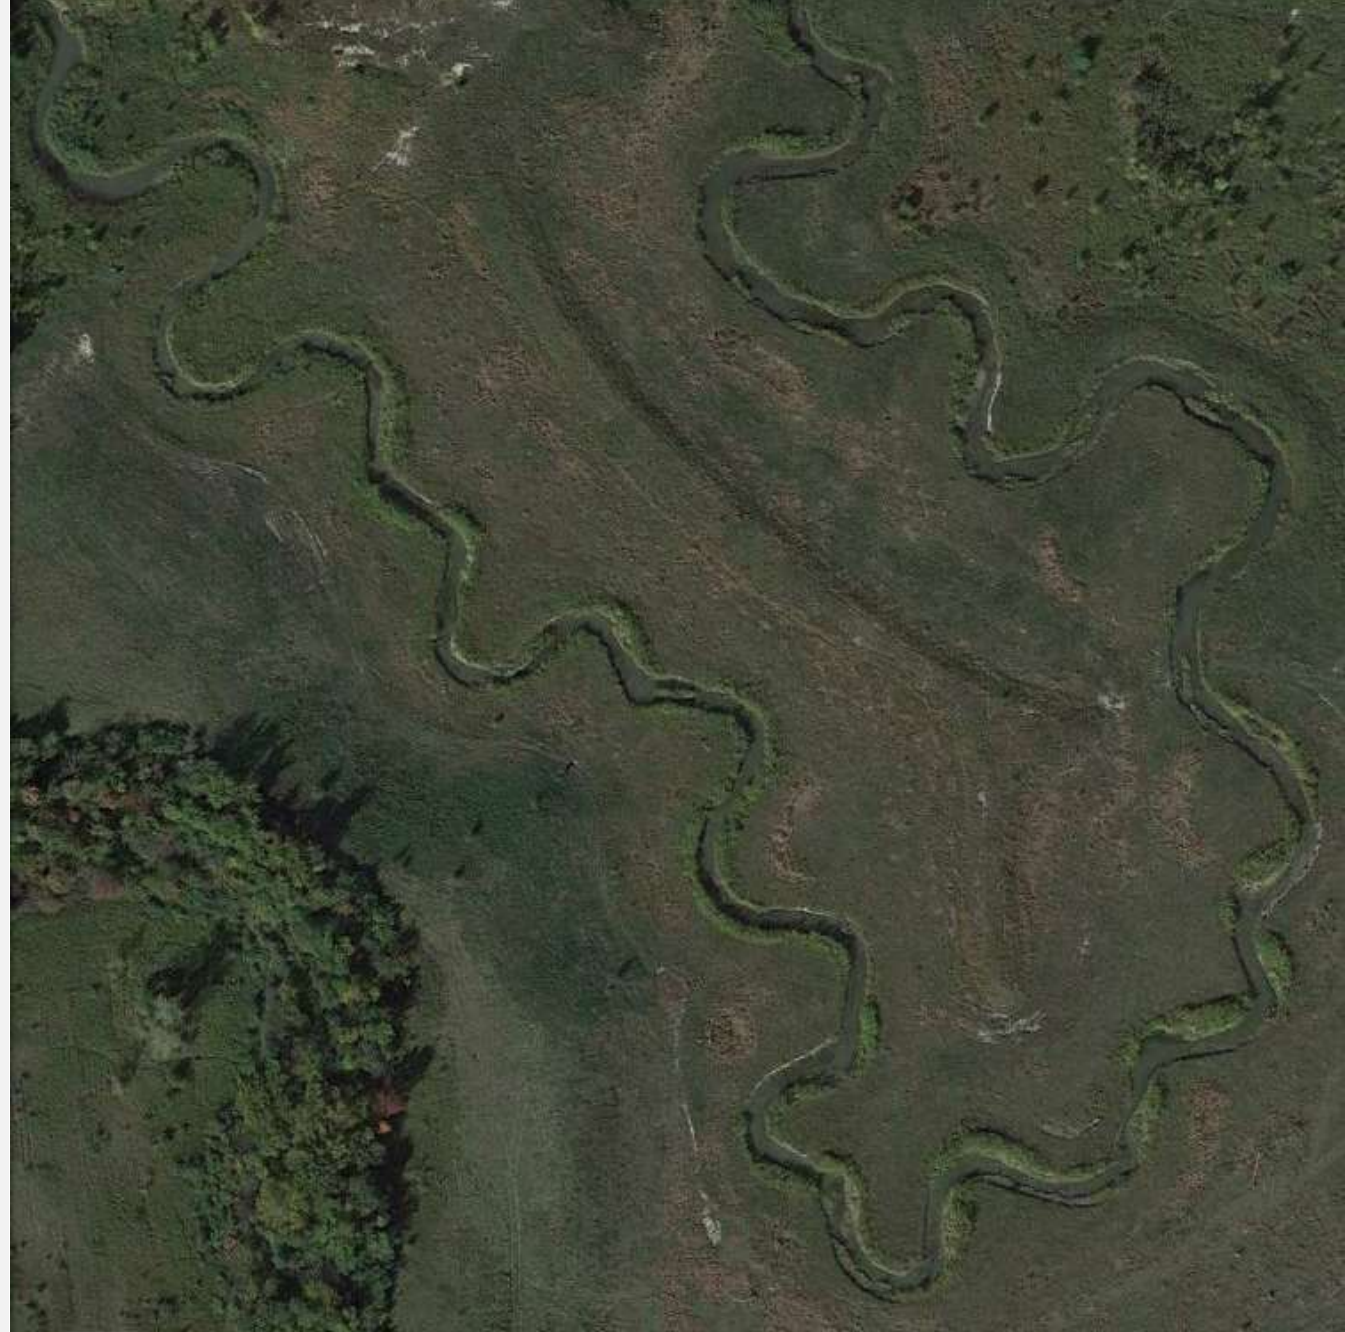
2022

Aerial of relocated channel

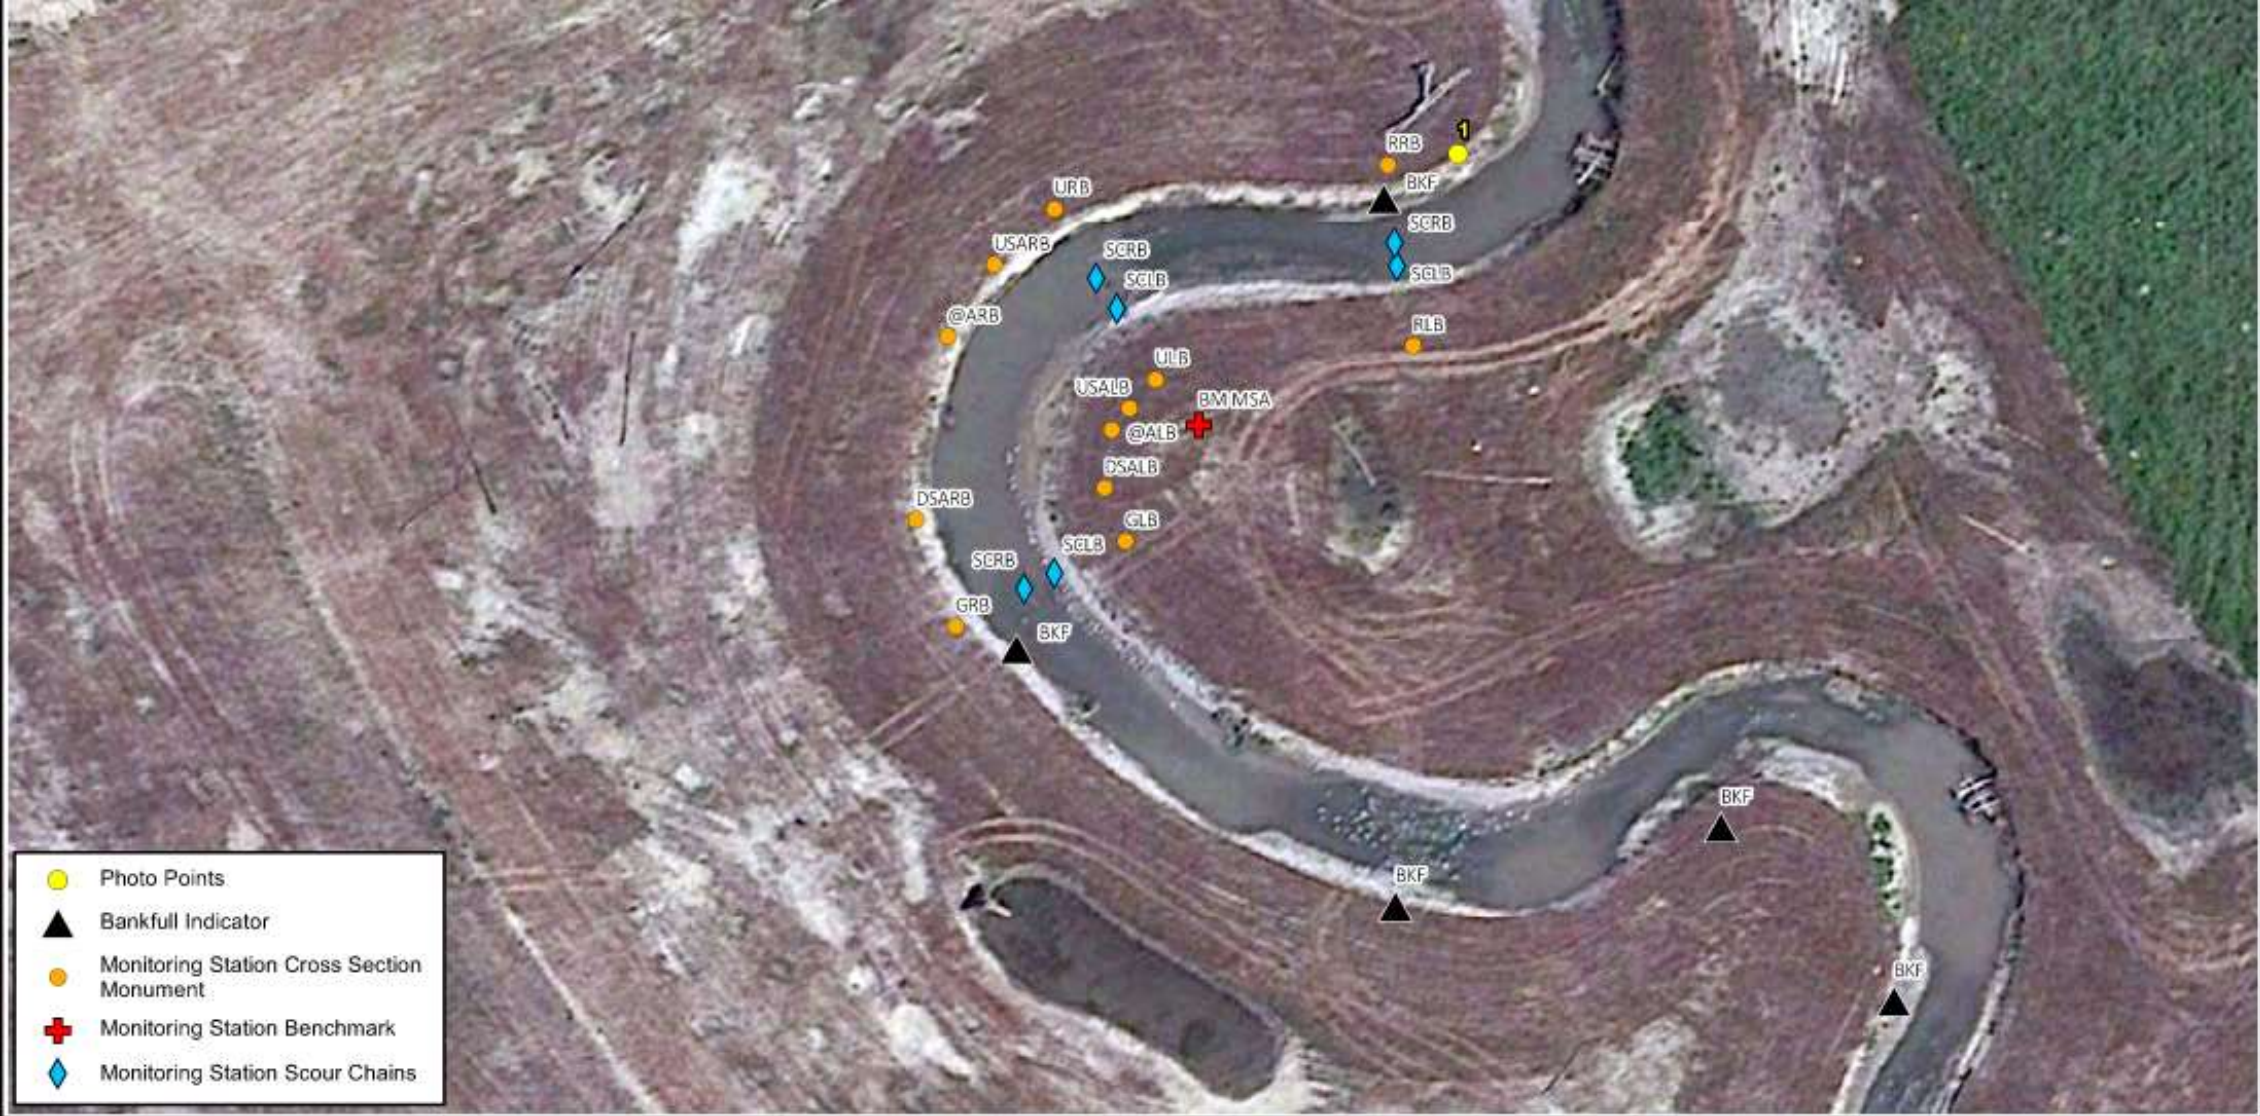
Monitoring Station A

MONITORING STATIONS

- Photo Points
- ▲ Bankfull Indicator
- Monitoring Station Cross Section Monument
- + Monitoring Station Benchmark
- ◆ Monitoring Station Scour Chains

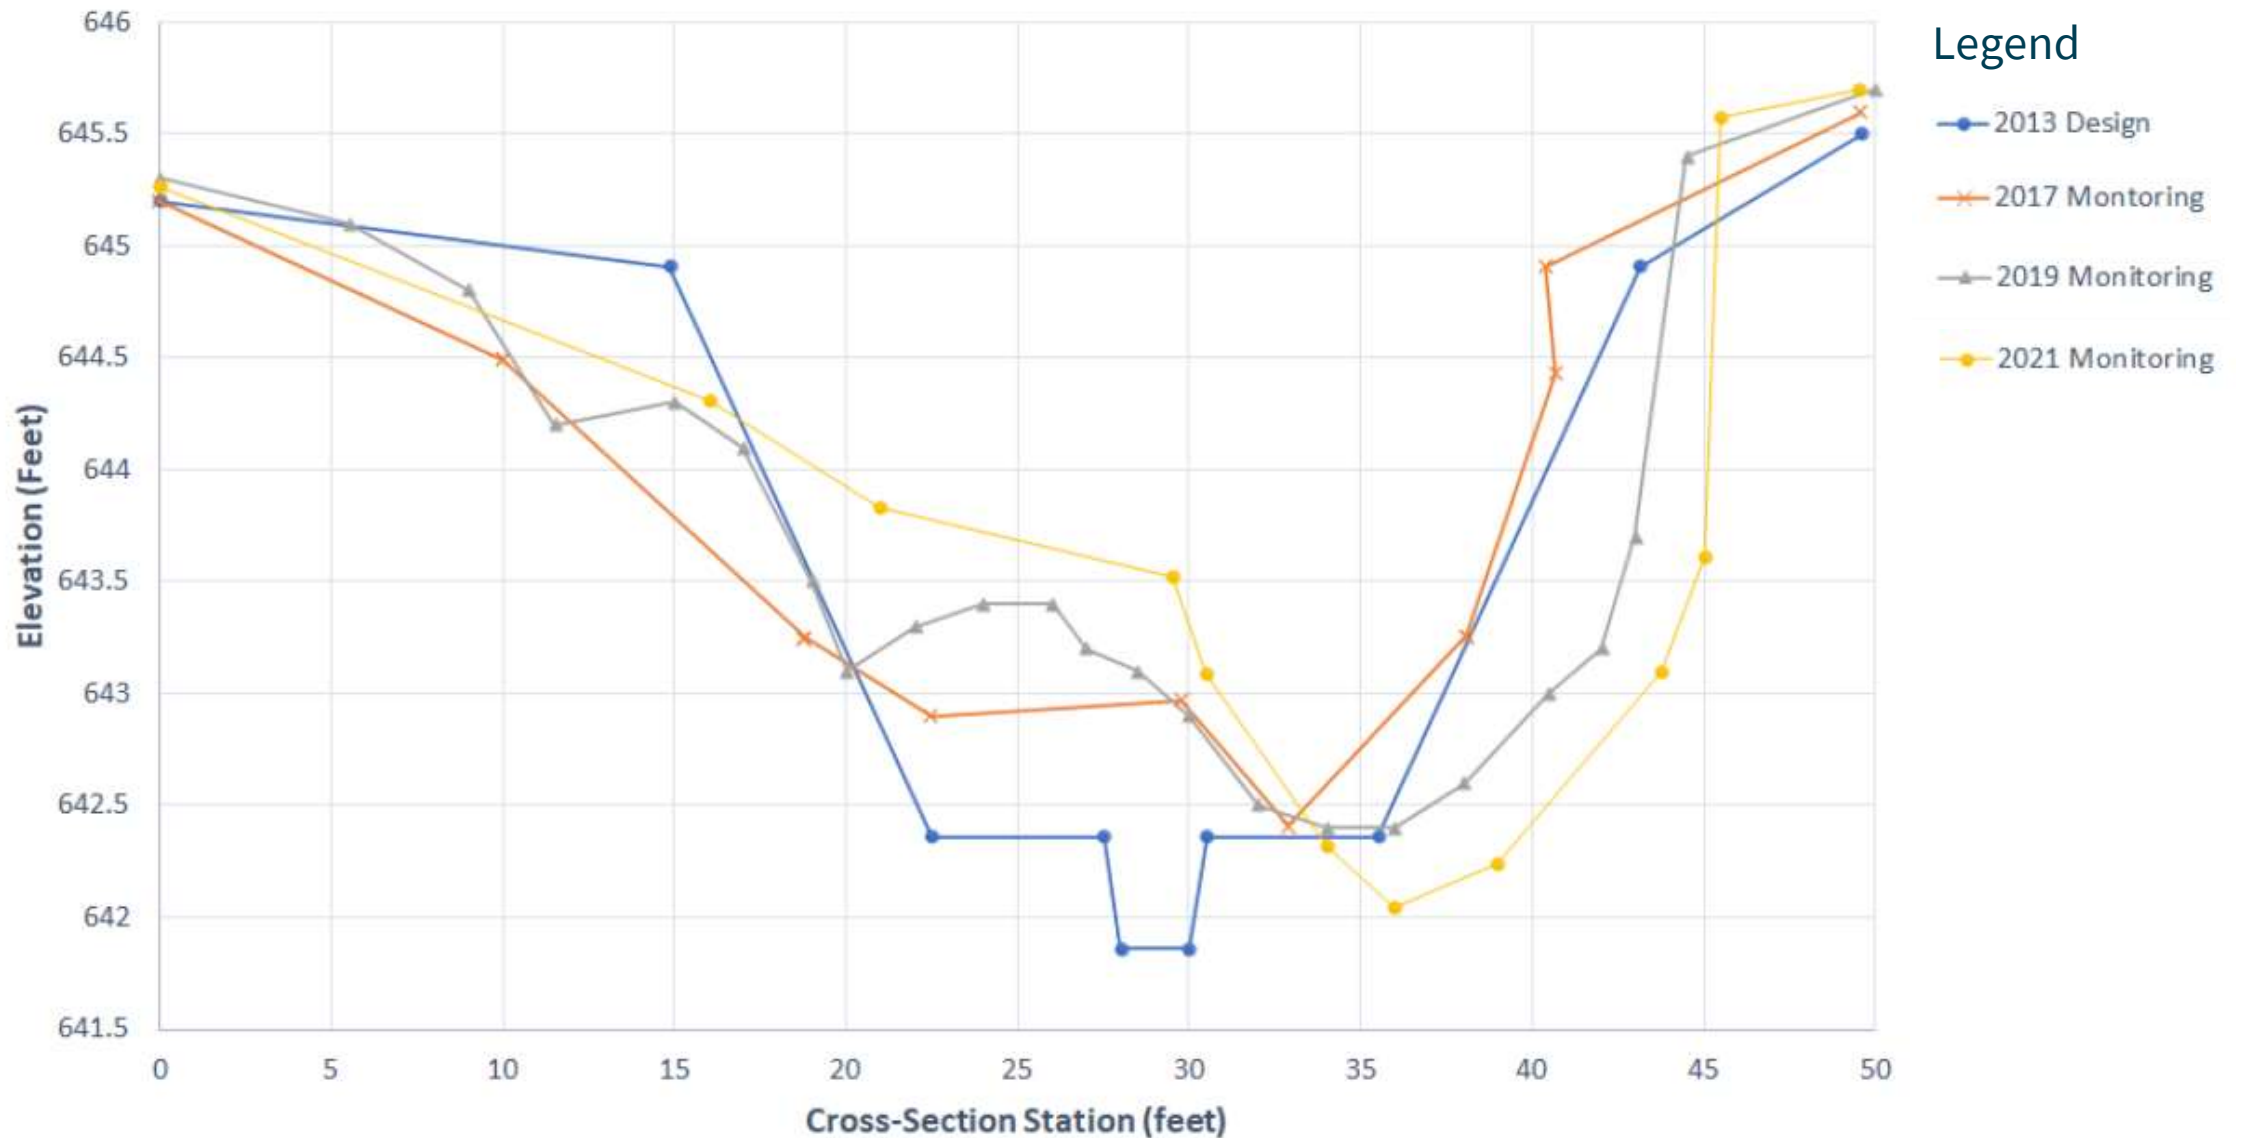
Surveyed Cross Sections

SURVEYING CROSS SECTIONS

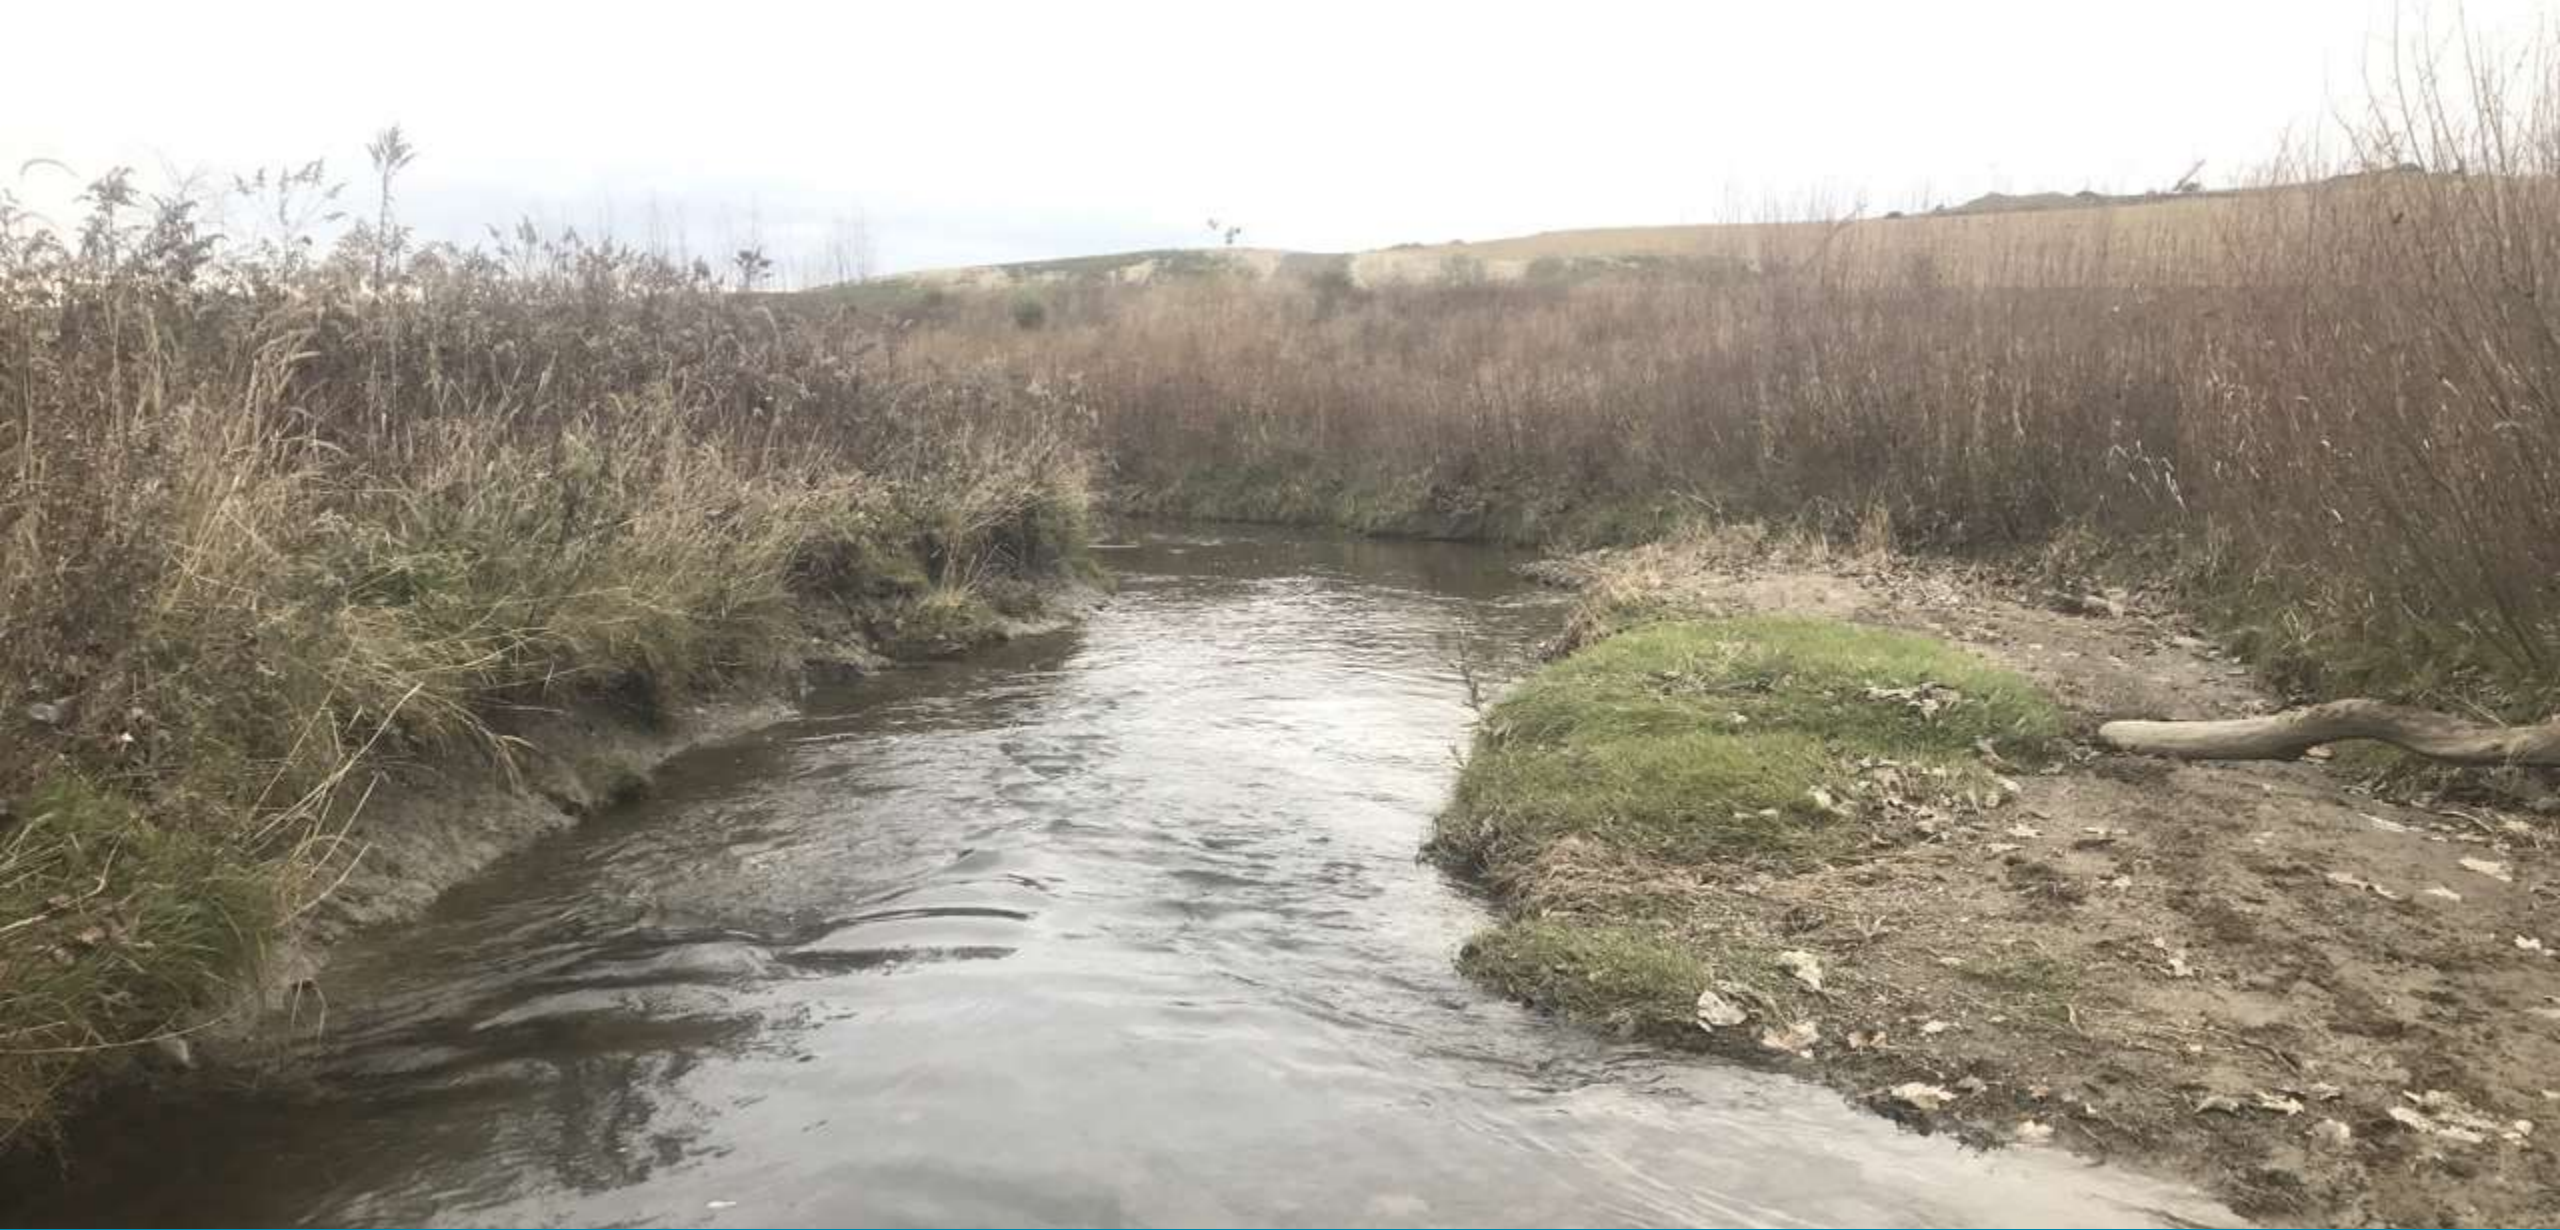
INNER BERM FORMATION AND BANK EROSION

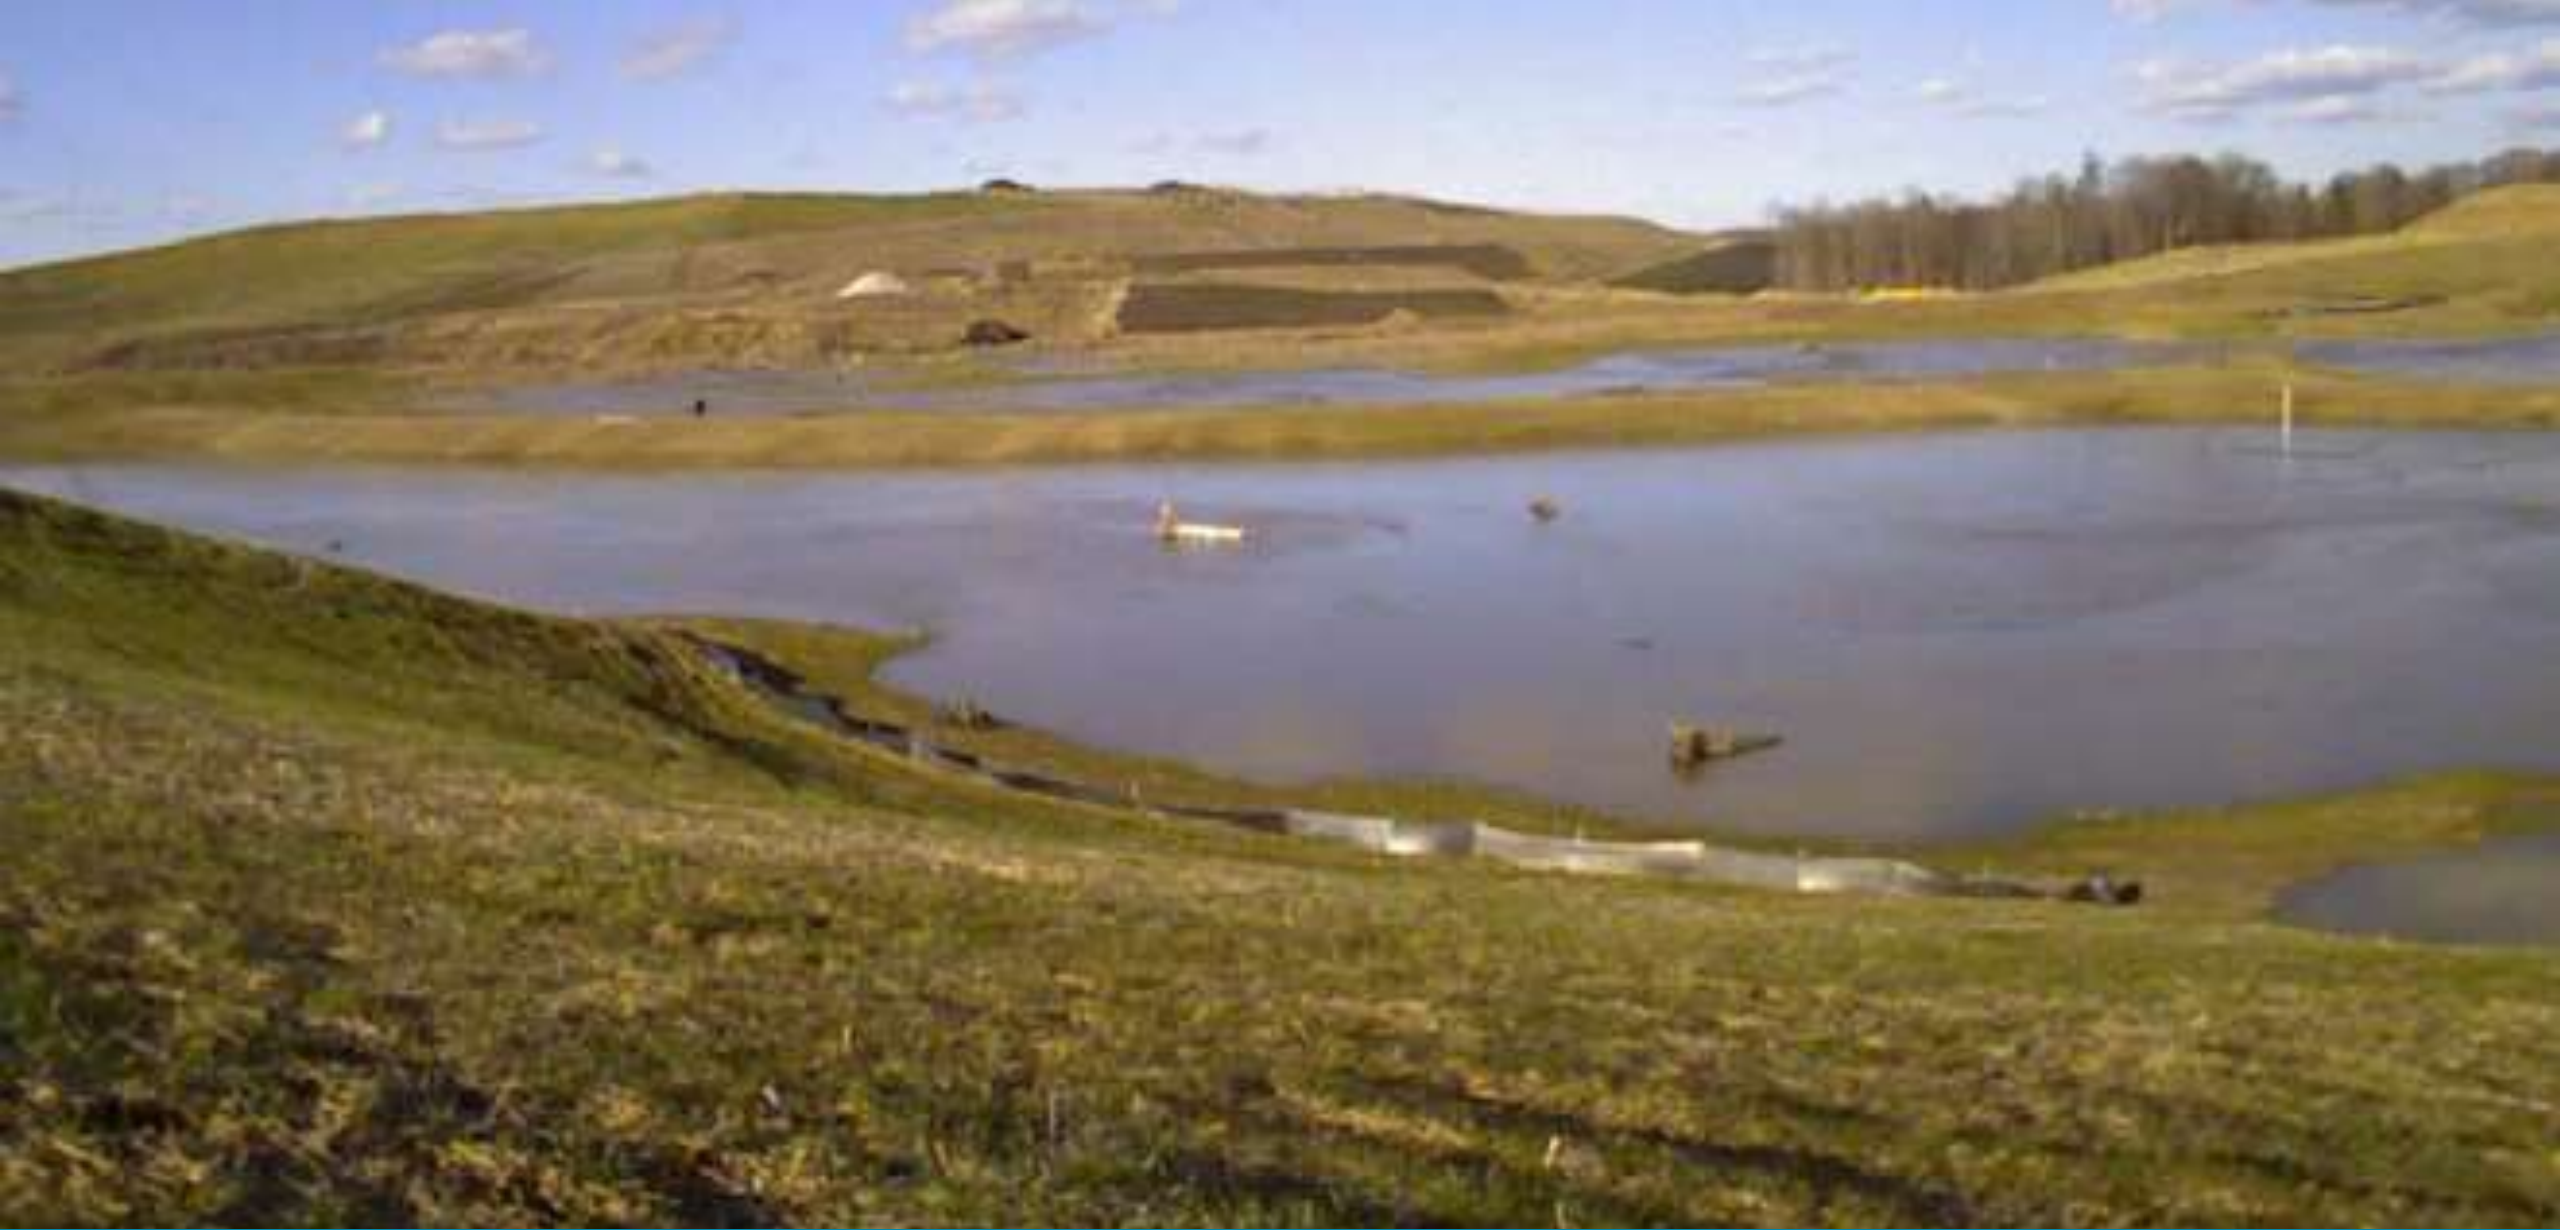
FLOODPLAIN CONNECTIVITY
