Brent Run Creek: A case study of stream relocation on a tributary of the Flint River in Michigan

**Presented by:
Emma Giese
GEI Consultants**

Brent Run Creek Relocation

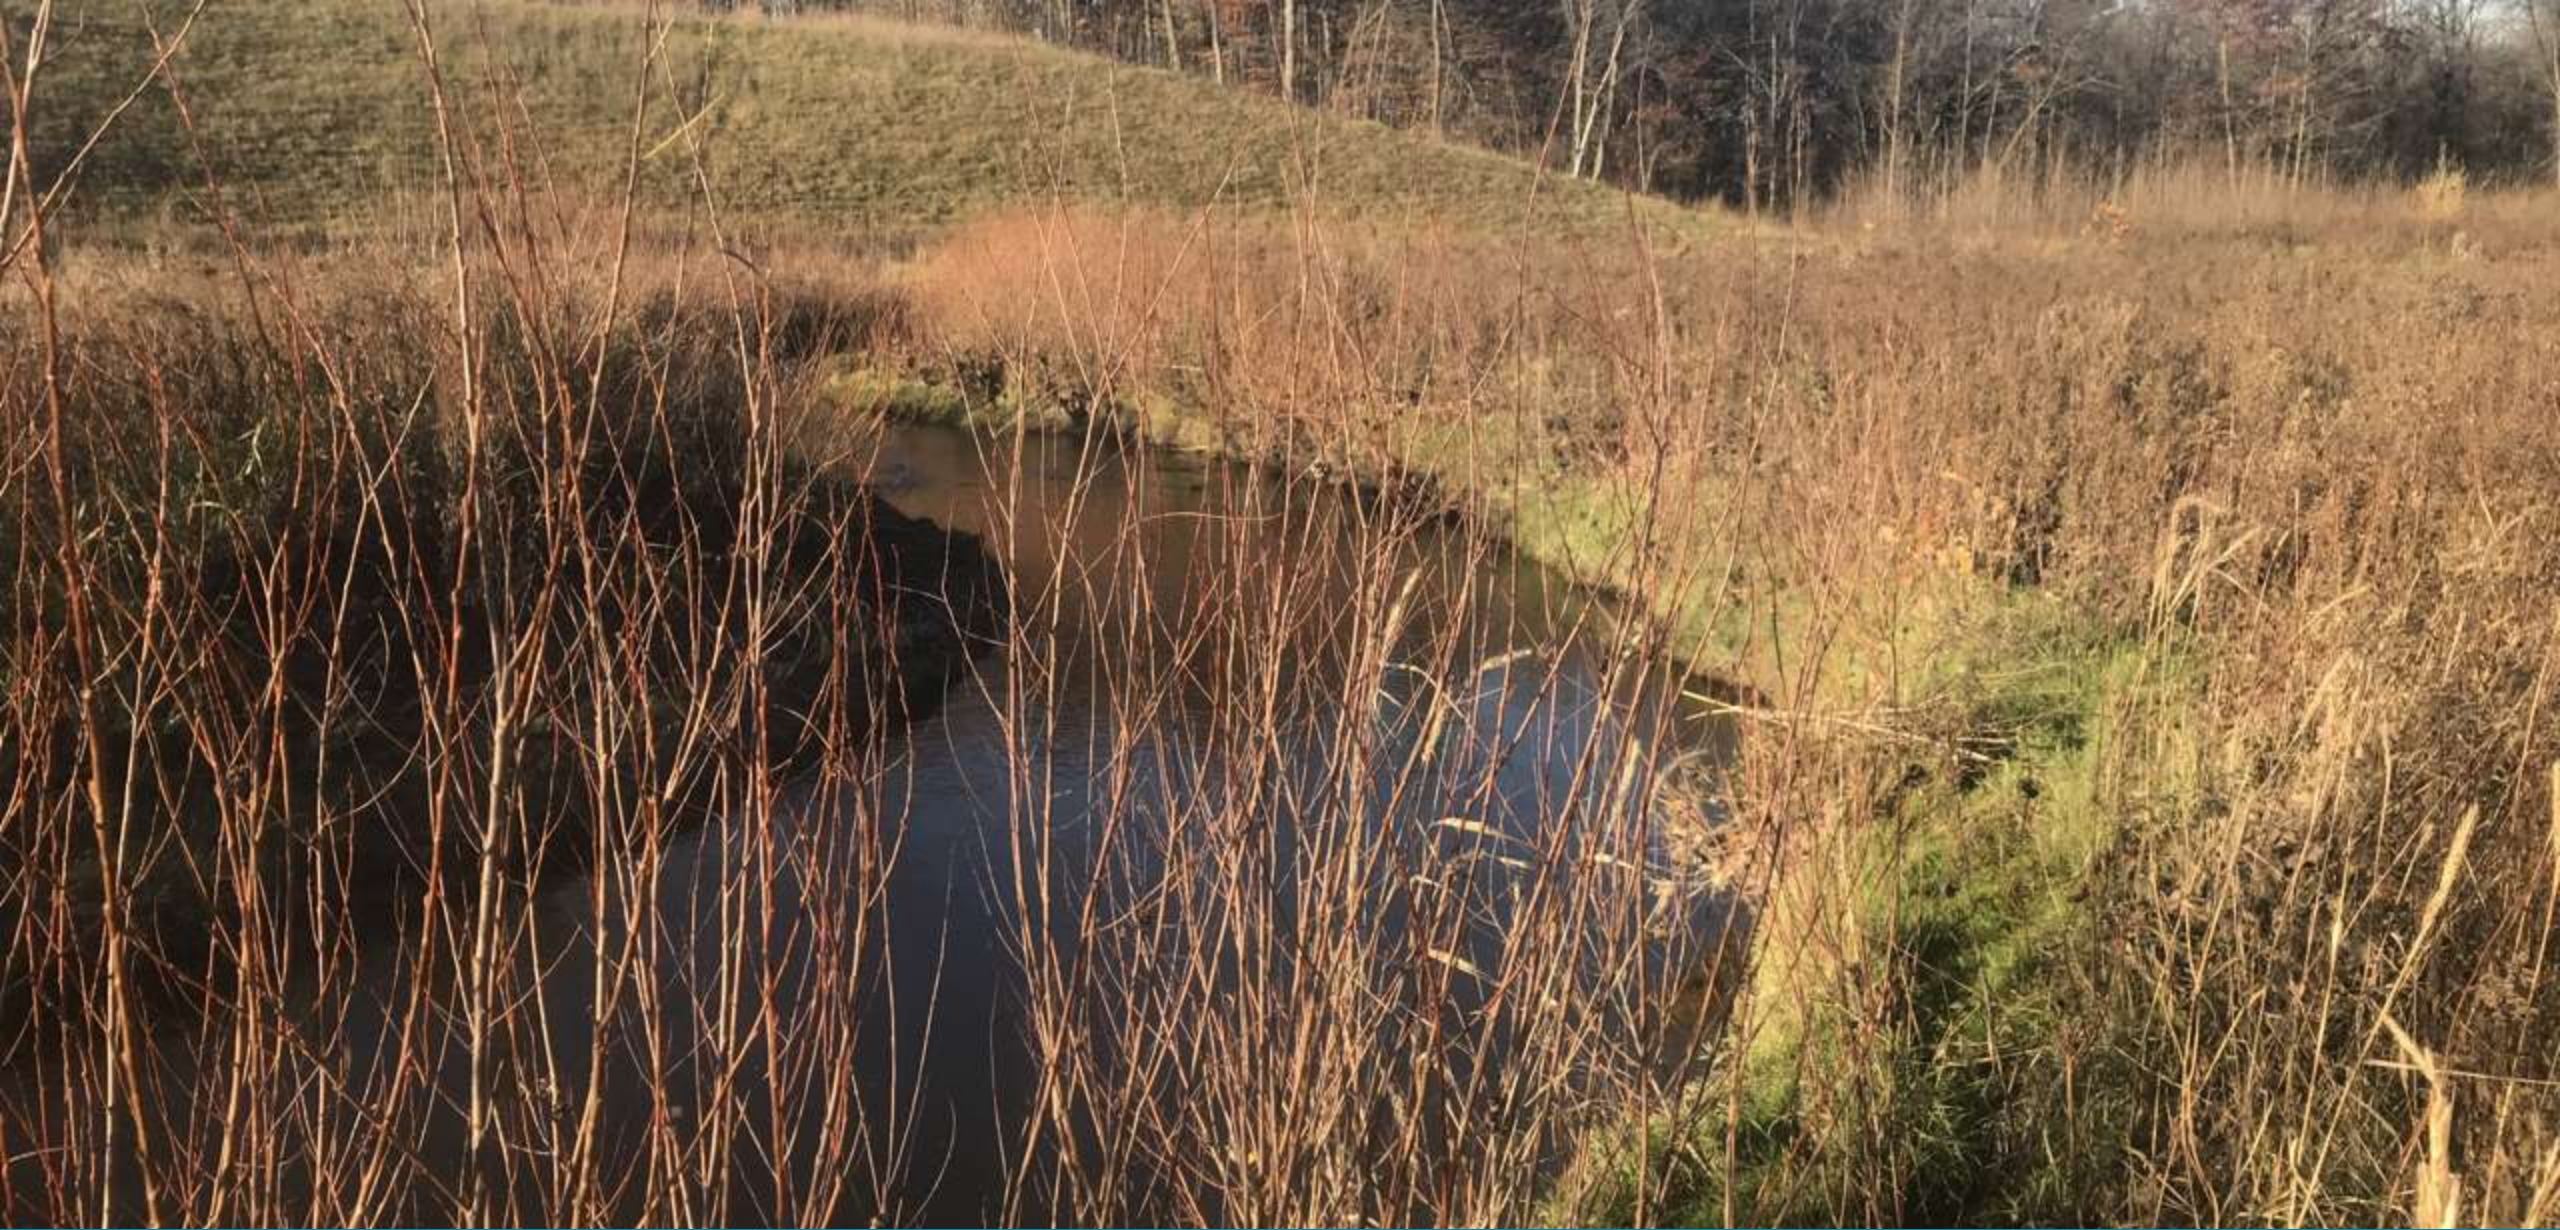
STABLE OUTER BEND WITH VEGETATION ESTABLISHED
