# Long-term Study of the Effectiveness of In-stream Structures near Bridges for Streambank Stability

**Jason R. Vogel, Ph.D., P.E.**

Civil Engineering and Environmental Science  
University of Oklahoma

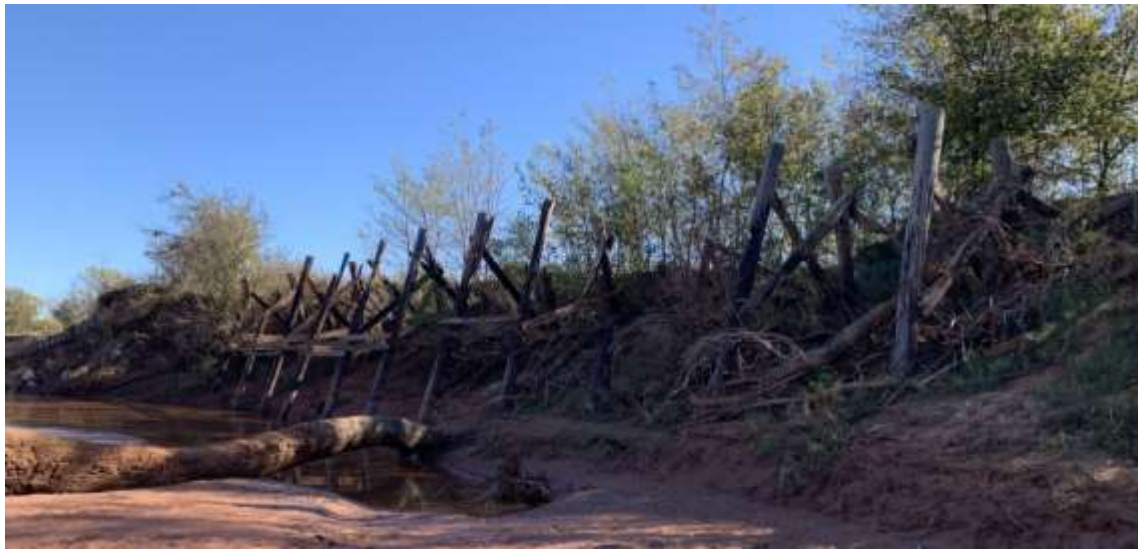
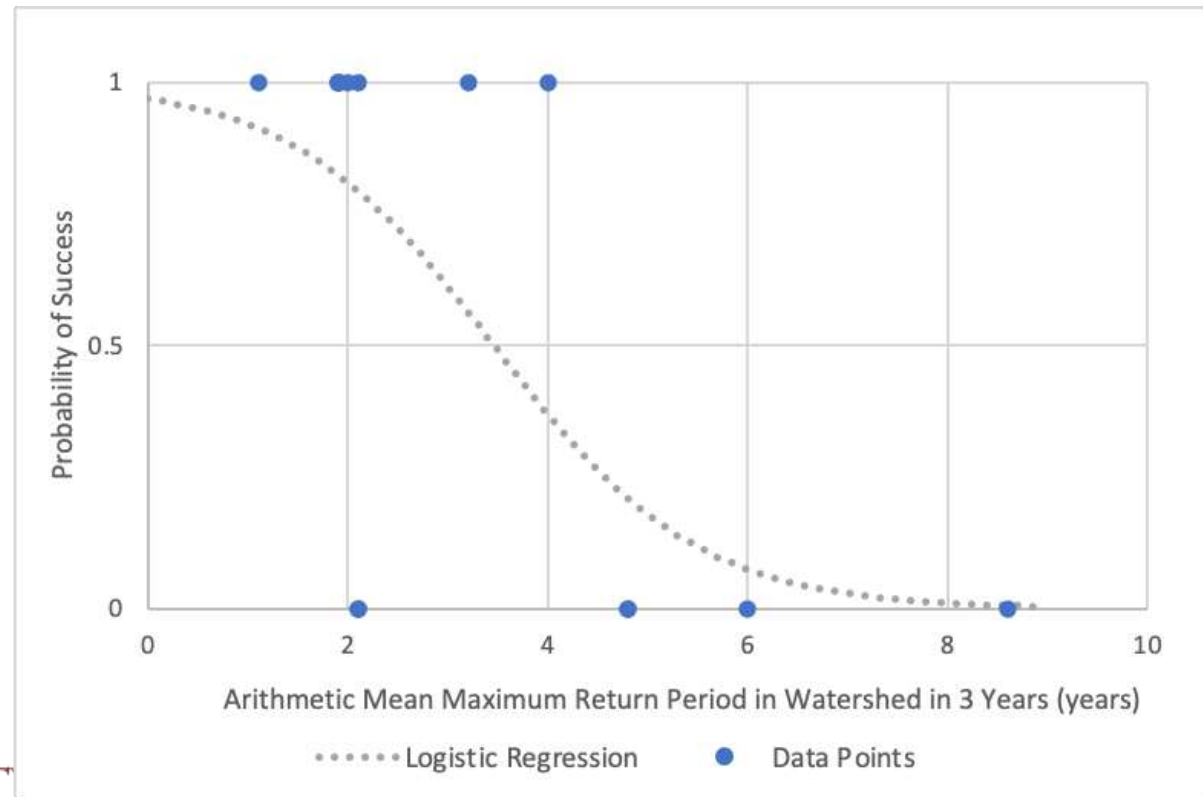
# Pile Diversions

Coefficient	p Value
Intercept	3.42	0.047
Arithmetic Mean Maximum Return Period in the Watershed within Three Years of Installation (years)	-0.99	0.065

- Precipitation events cause damage to pile diversions
- Storms within 3 years of installation lead to failure
- Maximum mean return period = 8.6 years

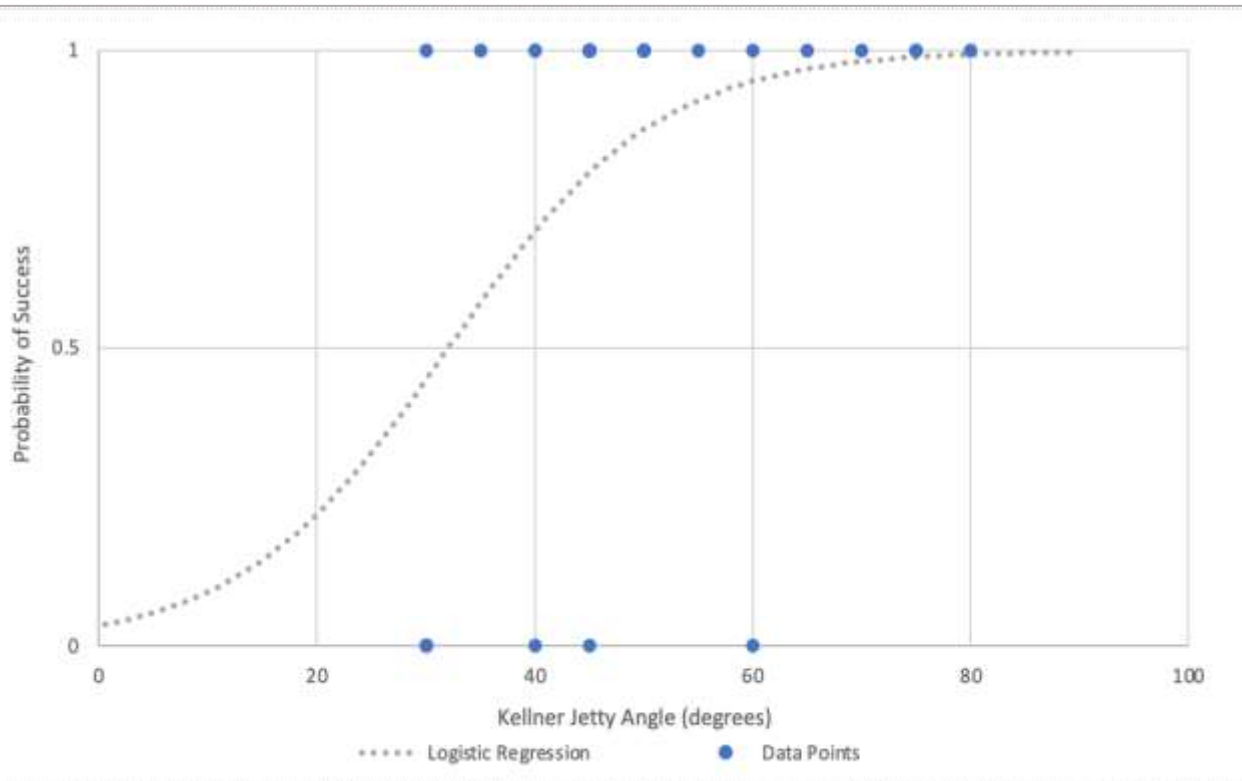
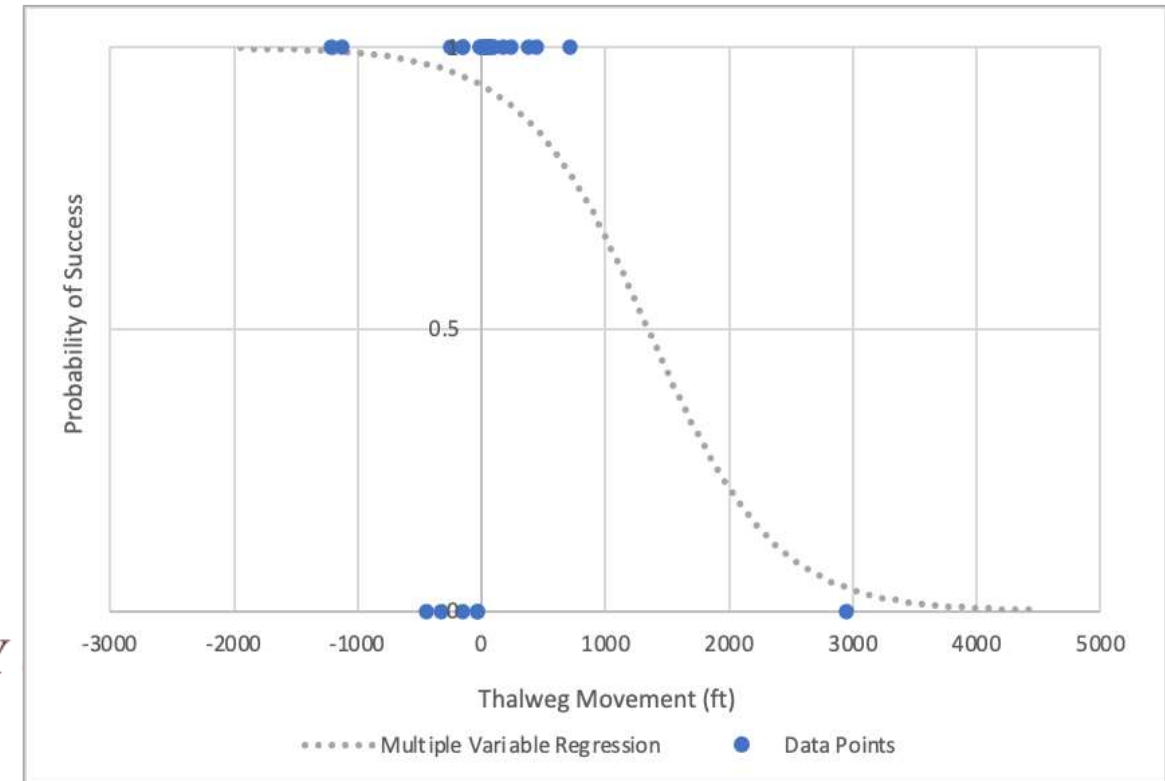
# Kellner Jetties with Site 21

- 22 sites, 28 installations
- 17-94 years old, 61 years old on average
- Deemed failure if stream eroded through jetty field
- 79% successful (22/28 successful)
- Site 21 had largest thalweg movement
  - Kellner jetties washed away
  - Bridge washout

Site	Oldest KJ Angle (degrees)	Thalweg Movement (ft)
5	30	-440
6	30	-30
8	30	-150
11	40	-30
17	45	-320
21	60	2950

Coefficient	p Value
Intercept	-3.35	0.17
Oldest Kellner Jetty Angle (degrees)	0.104	0.068

Coefficient	p Value
Intercept	-3.33	0.062
Oldest Kellner Jetty Angle (degrees)	0.101	0.057
Thalweg Movement	-0.0013	0.035

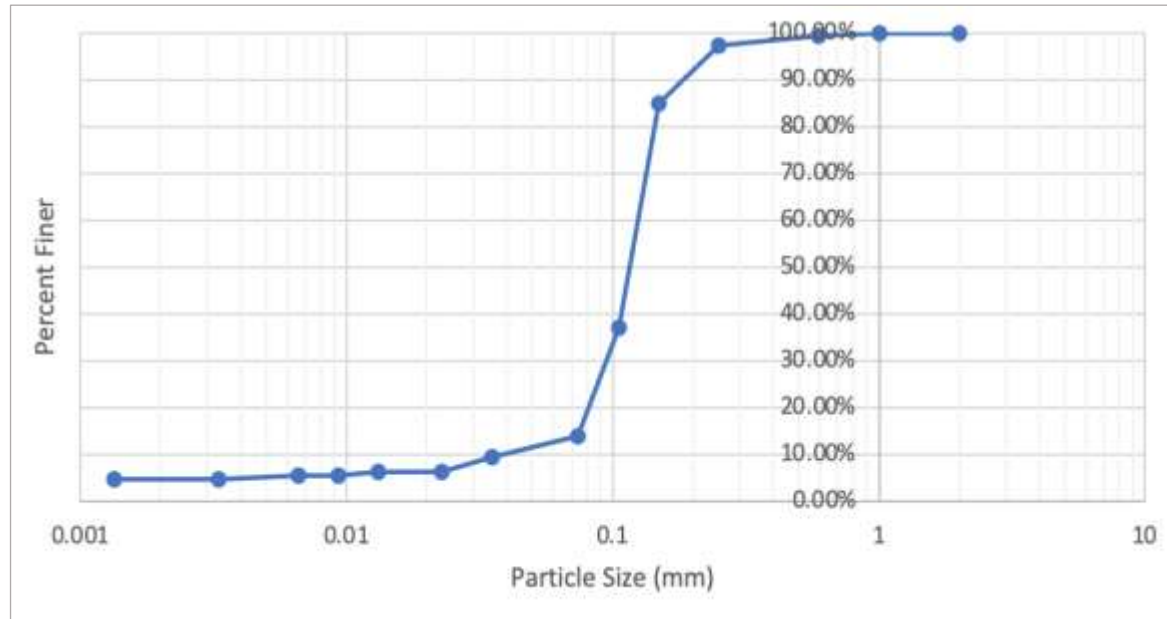
Site 25 – North Canadian River and S.H. 48 North of Bearden, Okfuskee county

$d_{10}$ (mm)	$d_{40}$ (mm)	$C_u$	$C_c$
0.04	0.11	3.5	1.4

Loamy Sand

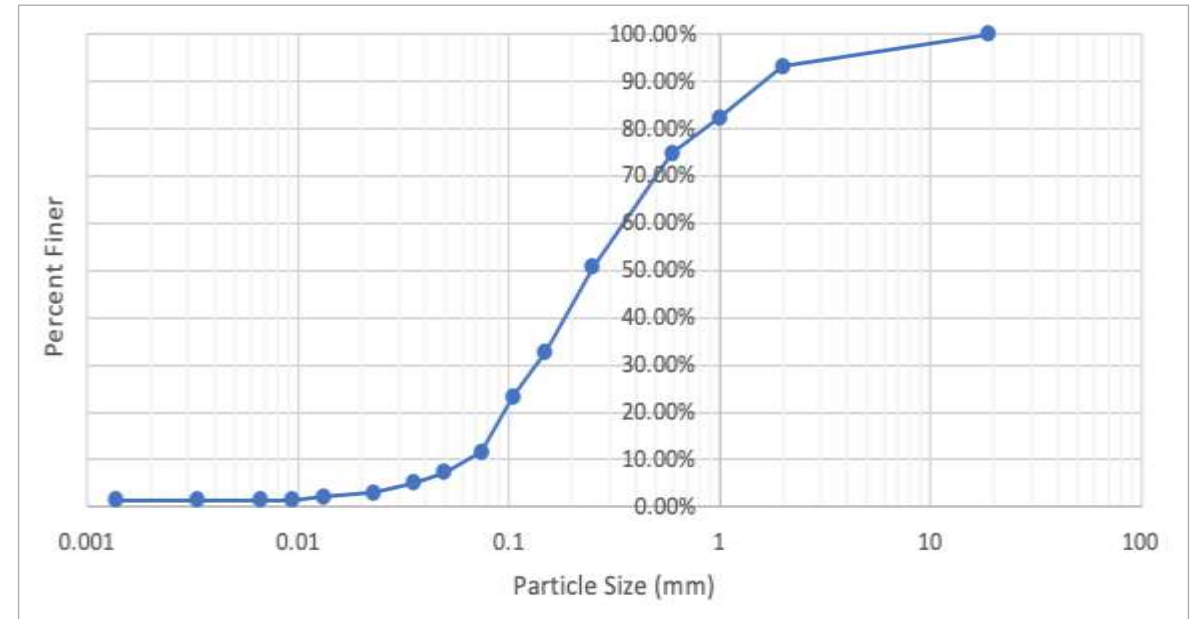
Site 12 – Cimarron River and S.H. 33 North of Coyle, Logan county

$d_{10}$ (mm)	$d_{40}$ (mm)	$C_u$	$C_c$
0.07	0.19	5.9	0.7

Sand

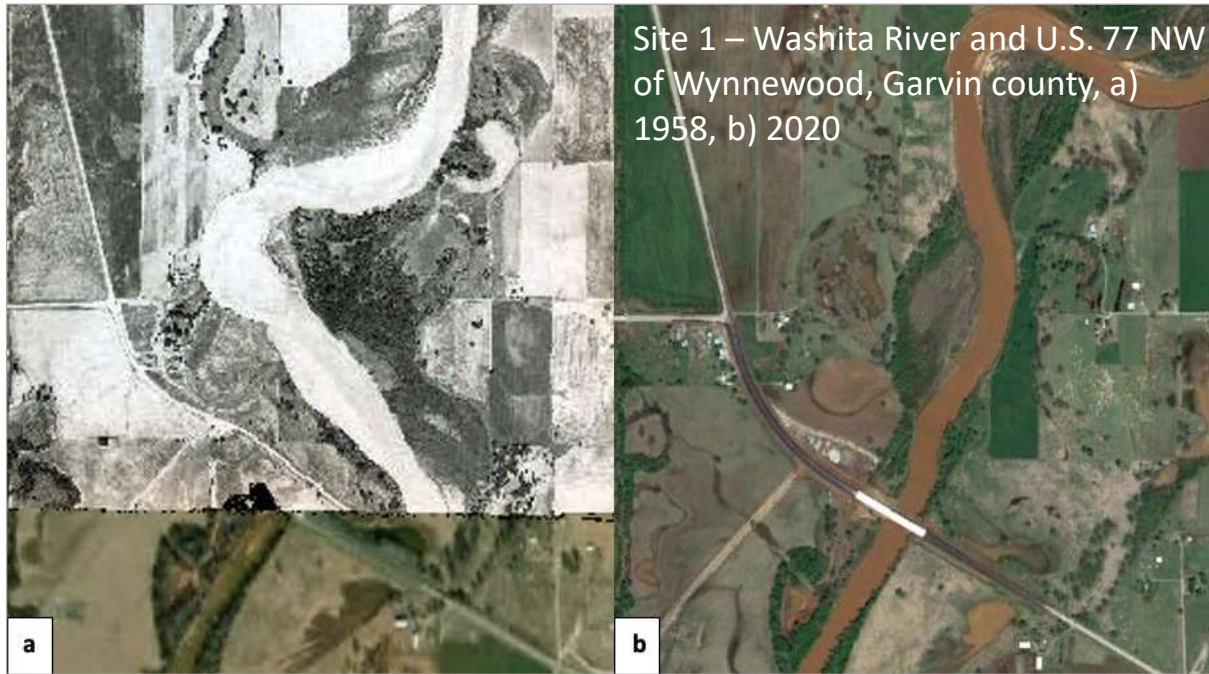
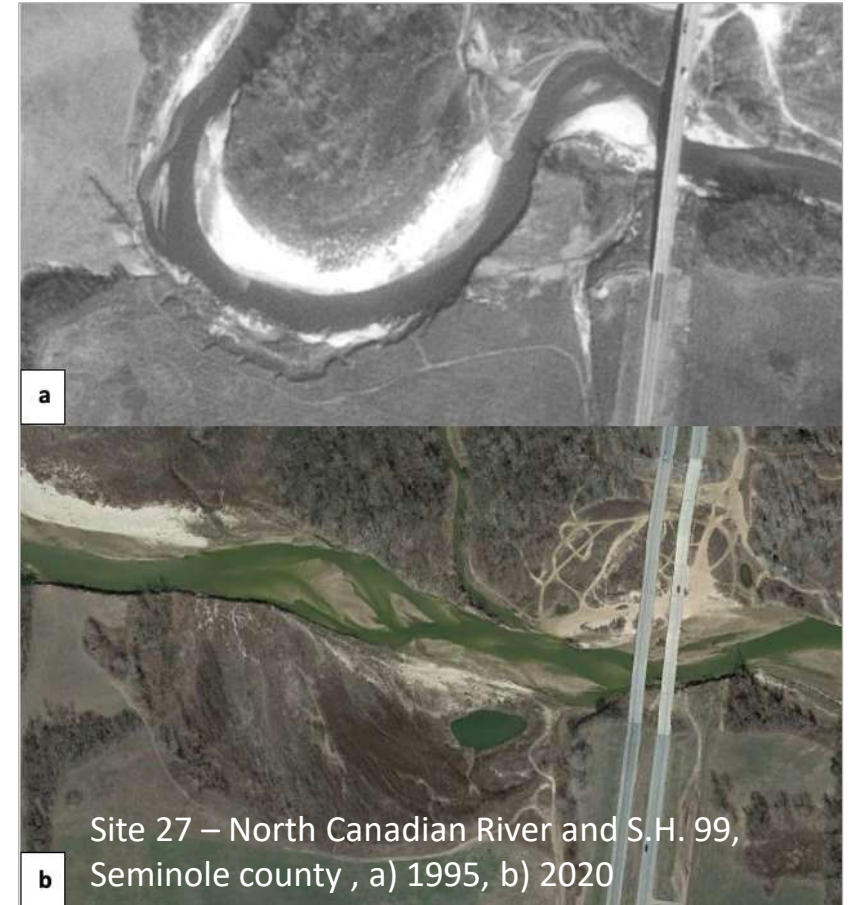
# Historical Photos and Lateral Thalweg Movement

Average	Minimum	Maximum	Minimum Absolute Value
98 ft	-1210 ft	2950 ft	10 ft
