Catheys Creek Restoration and Water Intake Rehabilitation

Achieving Multiple Objectives in a Water Supply Watershed

# Catheys Creek Project: 2018-2022

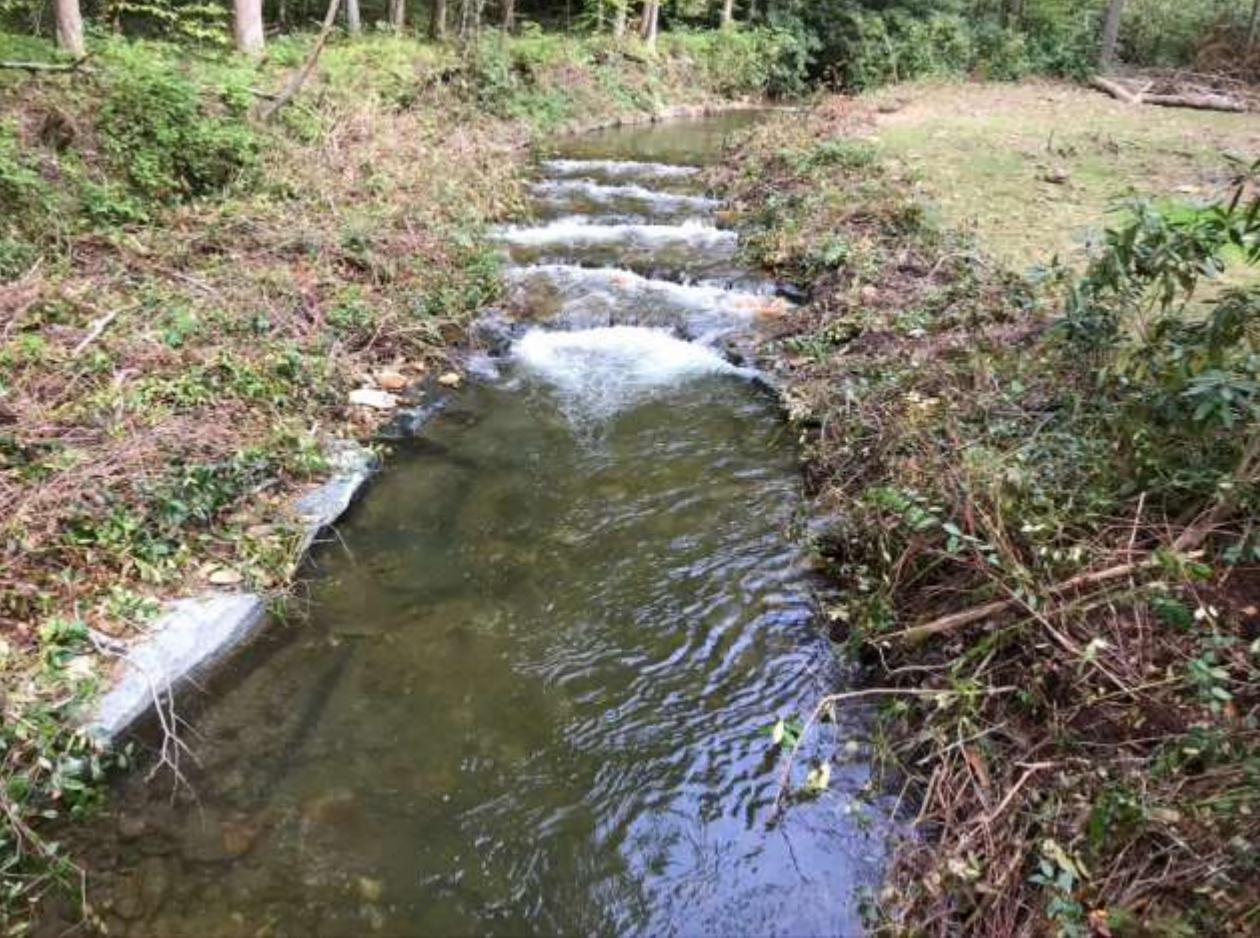
#### As-Built in October 2020

# Kuykendall Creek: Tributary with DA = 3.0 sq mi

- Eroding bank on outside bend threatening archaeological site
- Floodplain Connection, Log J-Hook Vane, Boulder Cascade, Riparian Vegetation

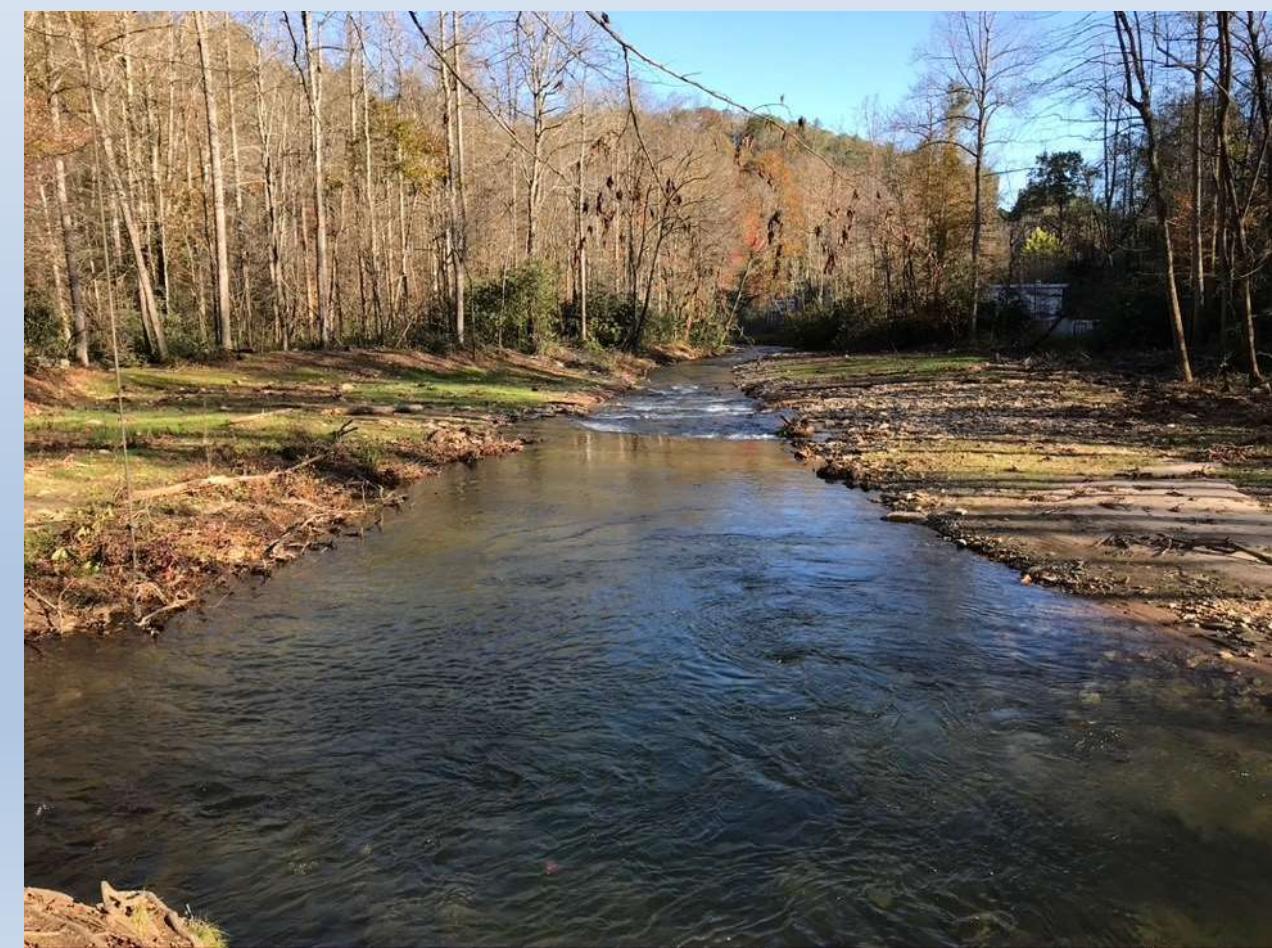
#### As-Built in October 2020

## Catheys Creek Reach 2: Downstream of Confluence with Kuykendall Creek

- Eroding banks on outside bends
- Floodplain Connection, Log J-Hook Vanes, Wood Toe Revetments, Riparian Vegetation

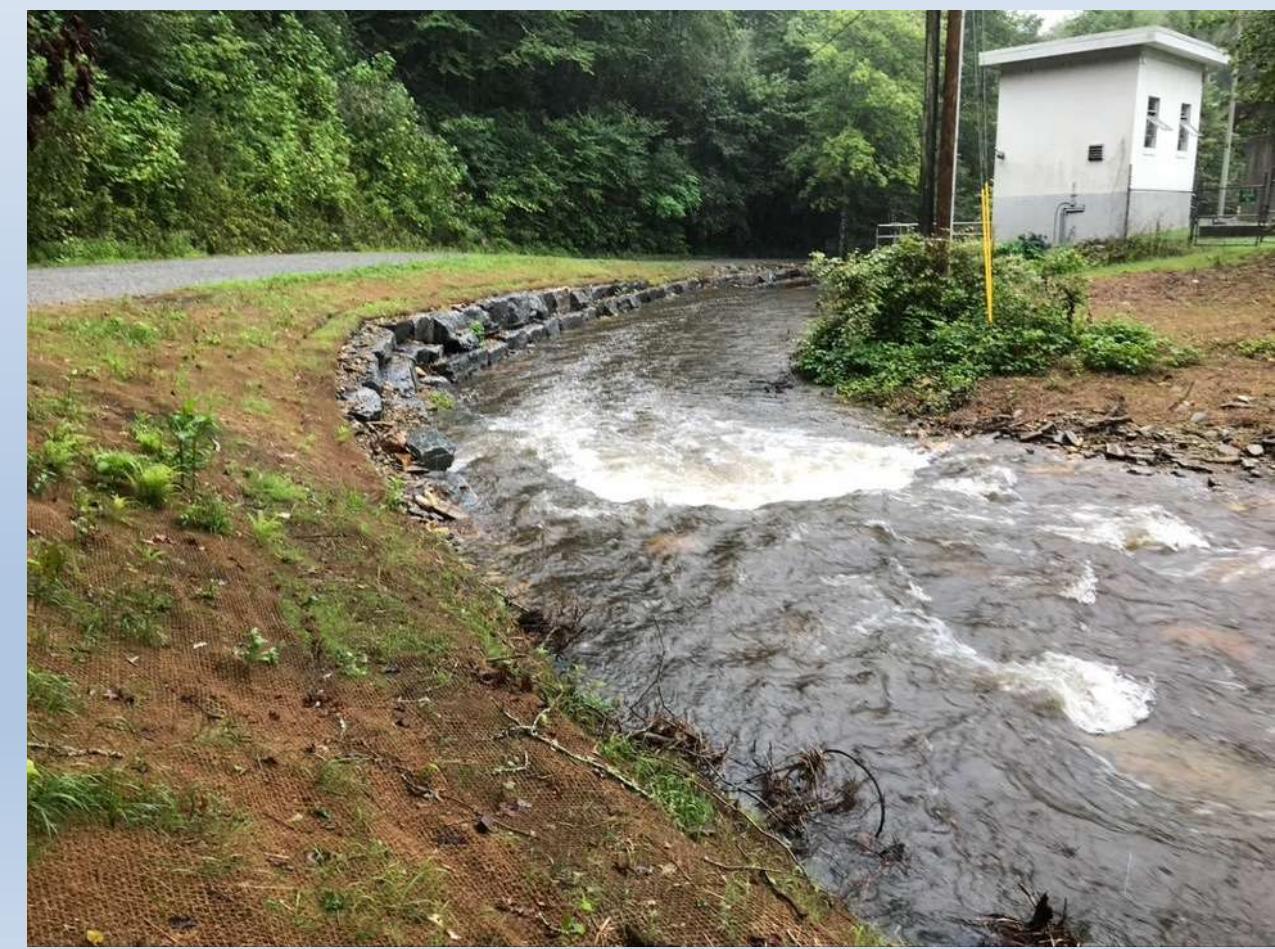
#### As-Built in October 2020

### Catheys Creek Reach 3: Water Plant and Gravel Road

- Eroding bank threatening road stability
- Floodplain Connection, Log J-Hook Vanes, Wood Toe Revetments, Riparian Vegetation
