Passive Wetland Restoration Through Stream Restoration

Prepared for: National Stream Restoration Conference, August 2023

Bacon Ridge Branch (Elks Camp Barrett) Stream Restoration

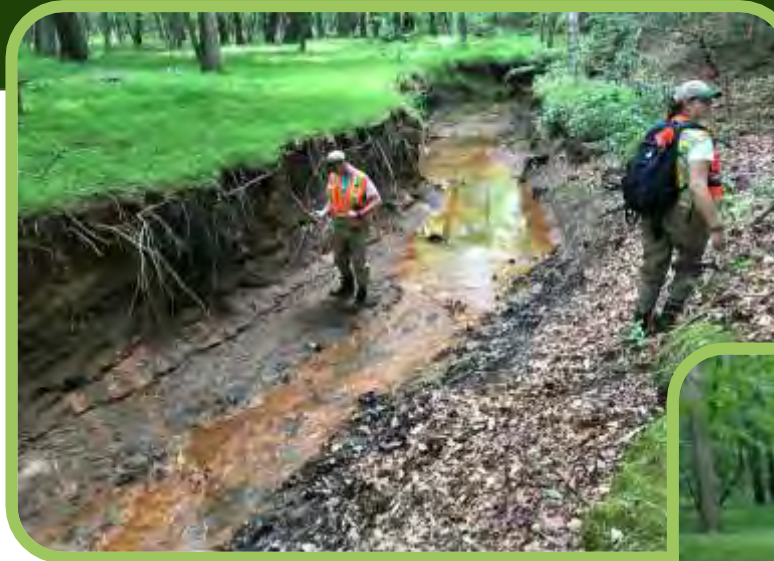
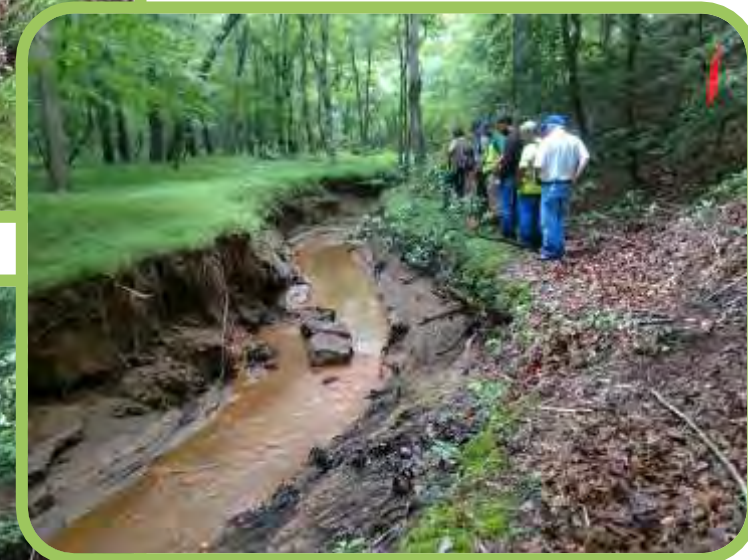
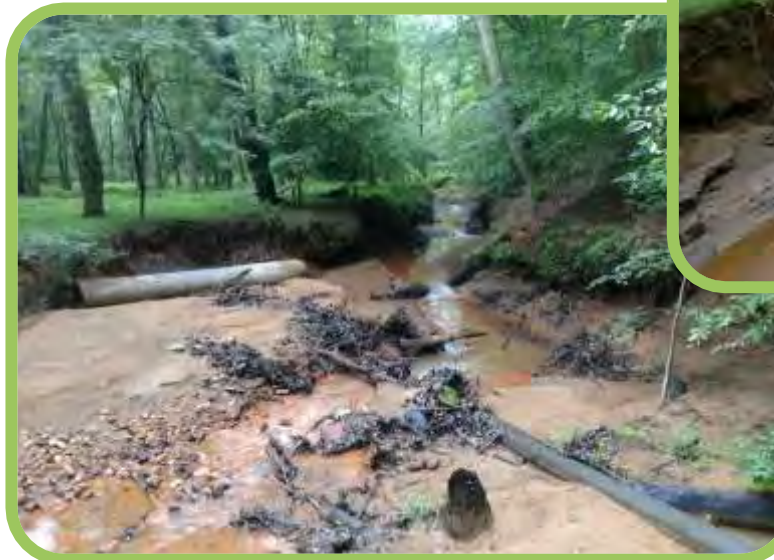
- Streams incised, 3' to 8' deep
- Typical baseflow approx. 1-3 cfs in Main Stem and Main Tributary
- Stilt grass (*Microstegium vimineum*) dominated understory lacking smaller trees and shrubs
- Groundwater depth assessment
 - Groundwater depth sampled approx. 10' and 70-100' from edge of stream at multiple locations
 - Plots closer to the stream had greater depth to free water
 - Channel incision draining groundwater

The photographs to the right show preconstruction conditions along the project's Main Tributary, including an understory dominated by stilt grass.

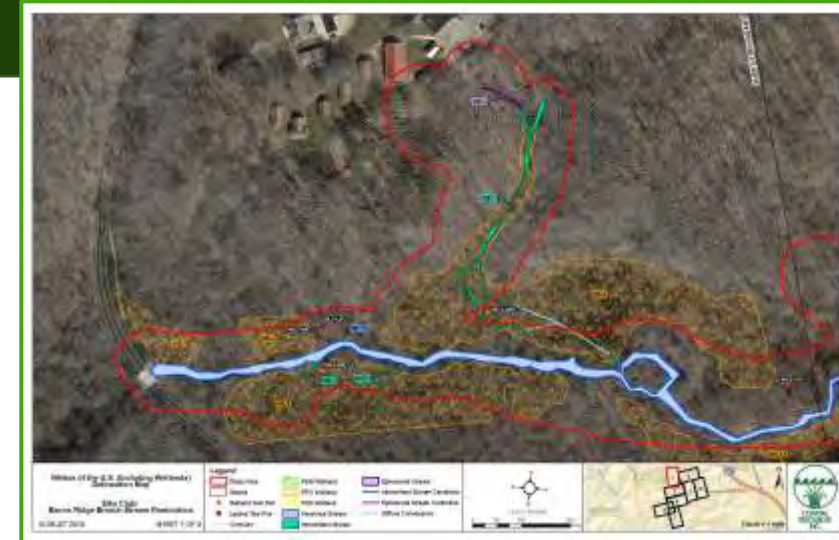
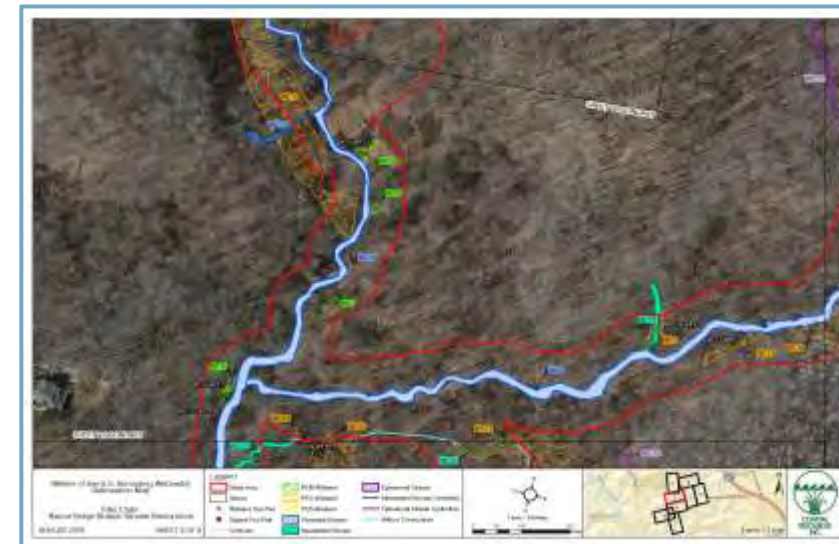
- Wetlands adjacent to streams in some areas, but not throughout floodplain
 - Patchy, not contiguous
- Some wetlands extending into headwater tributaries
- Primarily PFO wetlands, some PEM and PSS
- Regulatory tidal boundary is a few hundred feet downstream from the restoration area, but the downstream end of the restoration area is tidally influenced

The maps to the right show representative locations of delineated wetlands and a lack of wetlands in the existing/pre-construction condition.

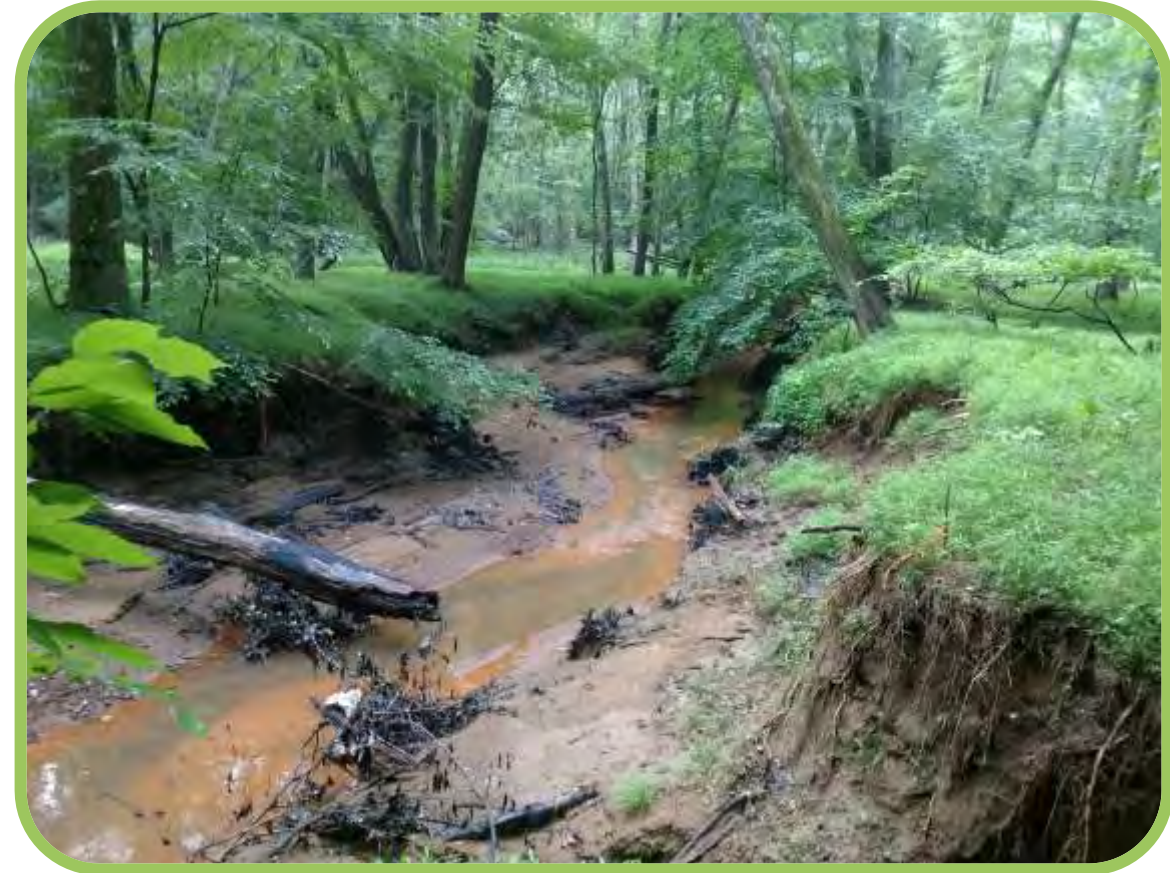
The photograph shows preconstruction conditions along the project’s Main Tributary.

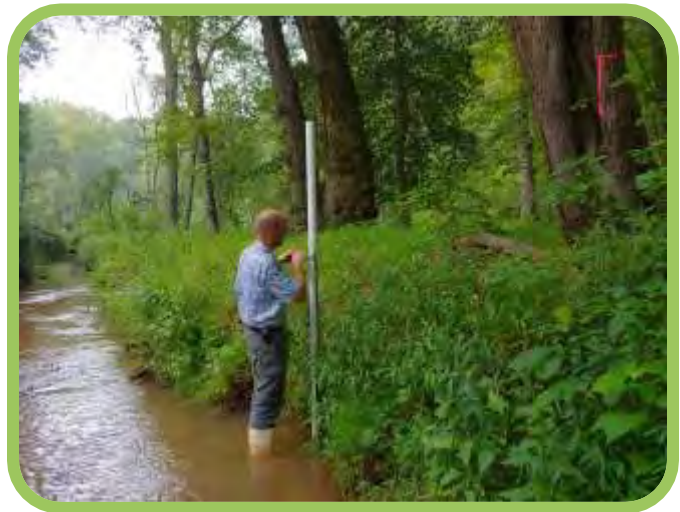
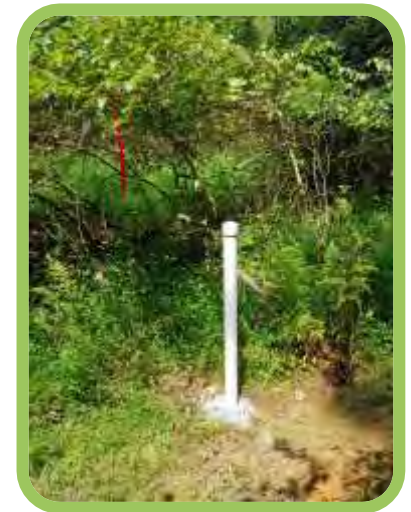
- 3 transects installed on site pre-construction
 - 2 on Main Stem, 1 on Main Tributary
- Each has 3-4 groundwater loggers and an in-stream logger
 - 11 groundwater wells and 3 in-stream loggers total
- Wells installed 50' to 300' from top of bank
- Wetland delineation data sheet completed at each well upon install

Right: Map showing the locations of in-stream loggers and groundwater wells.
Above: An in-stream logger (left) and groundwater well (right).

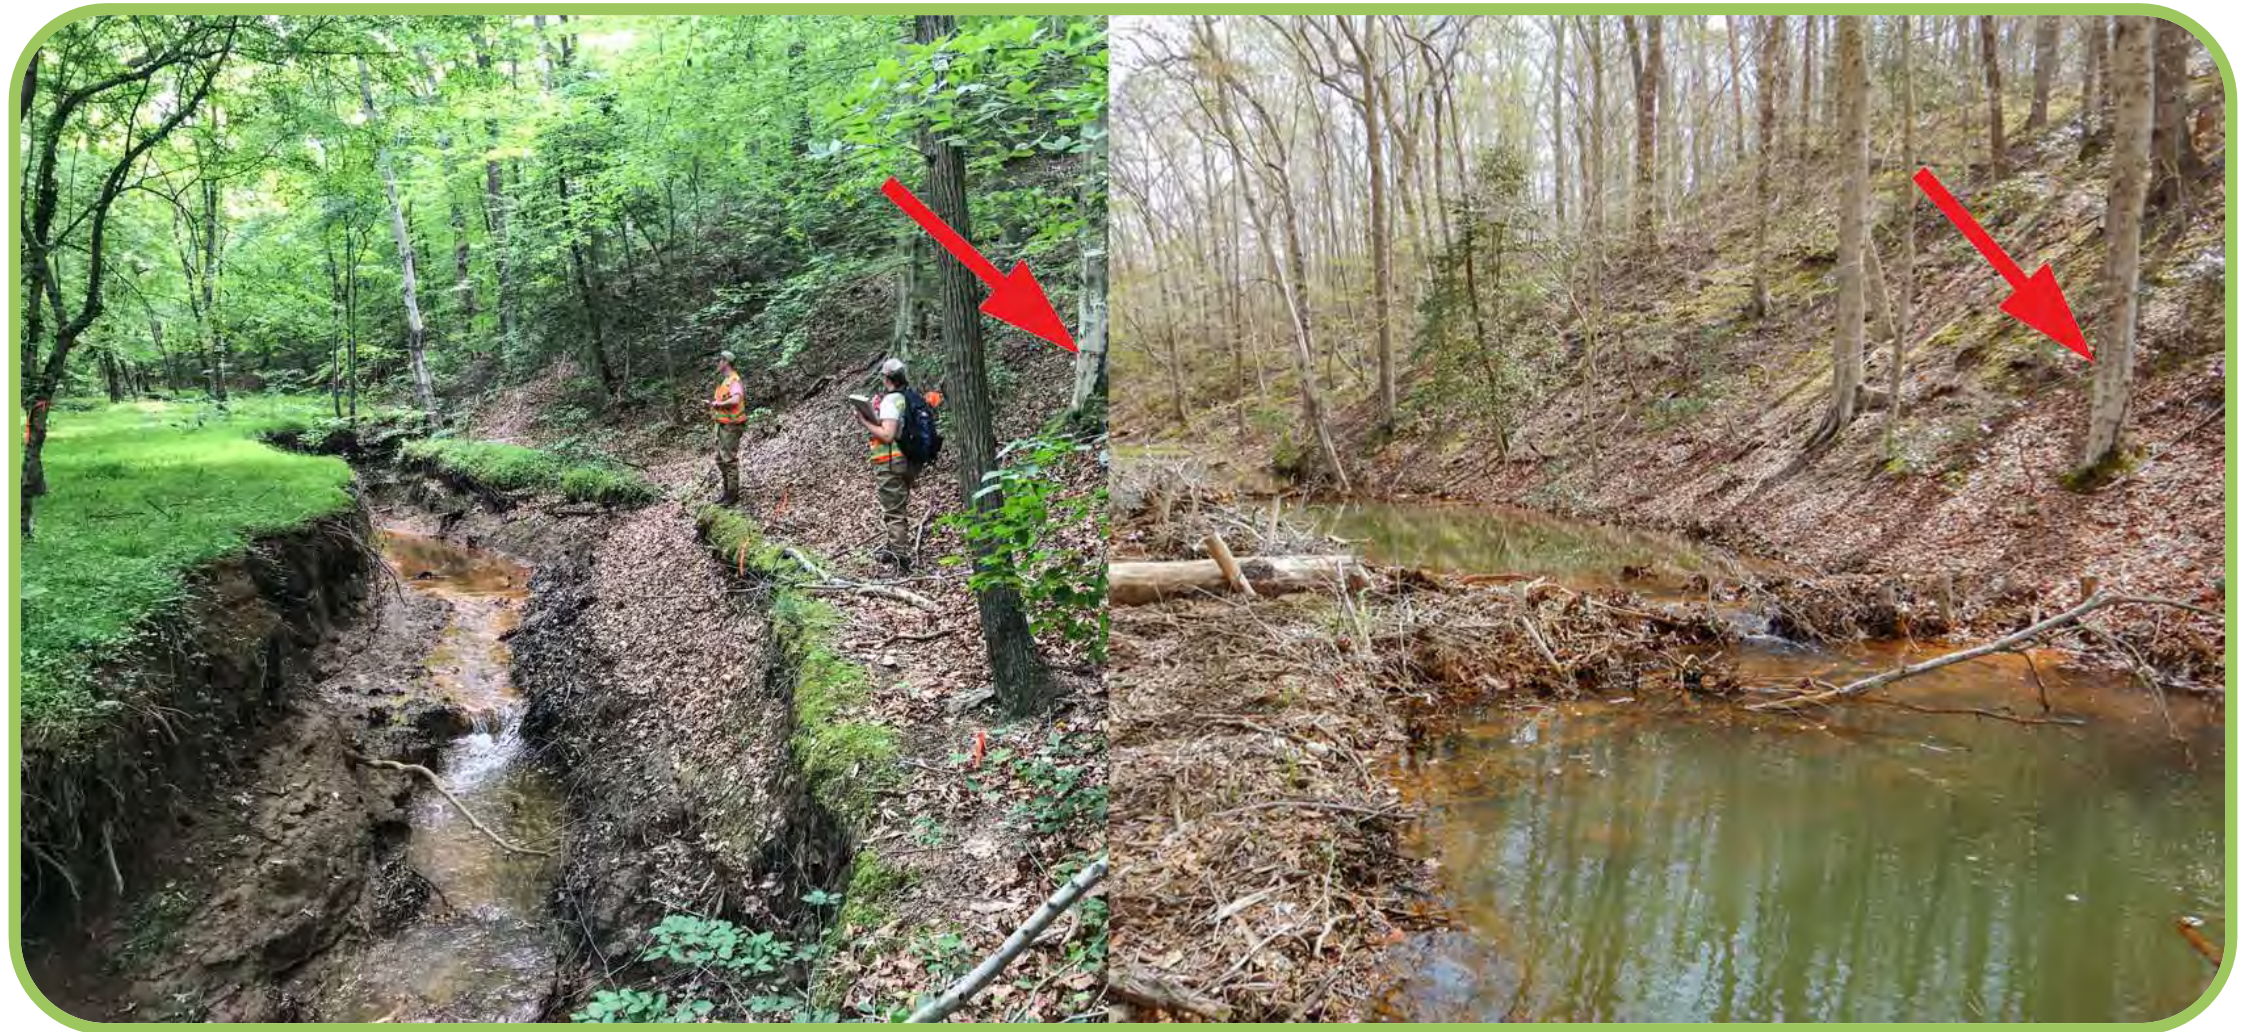
These photos show the increase in stream water surface elevation at the location of a constructed log jam pre- and post-construction.

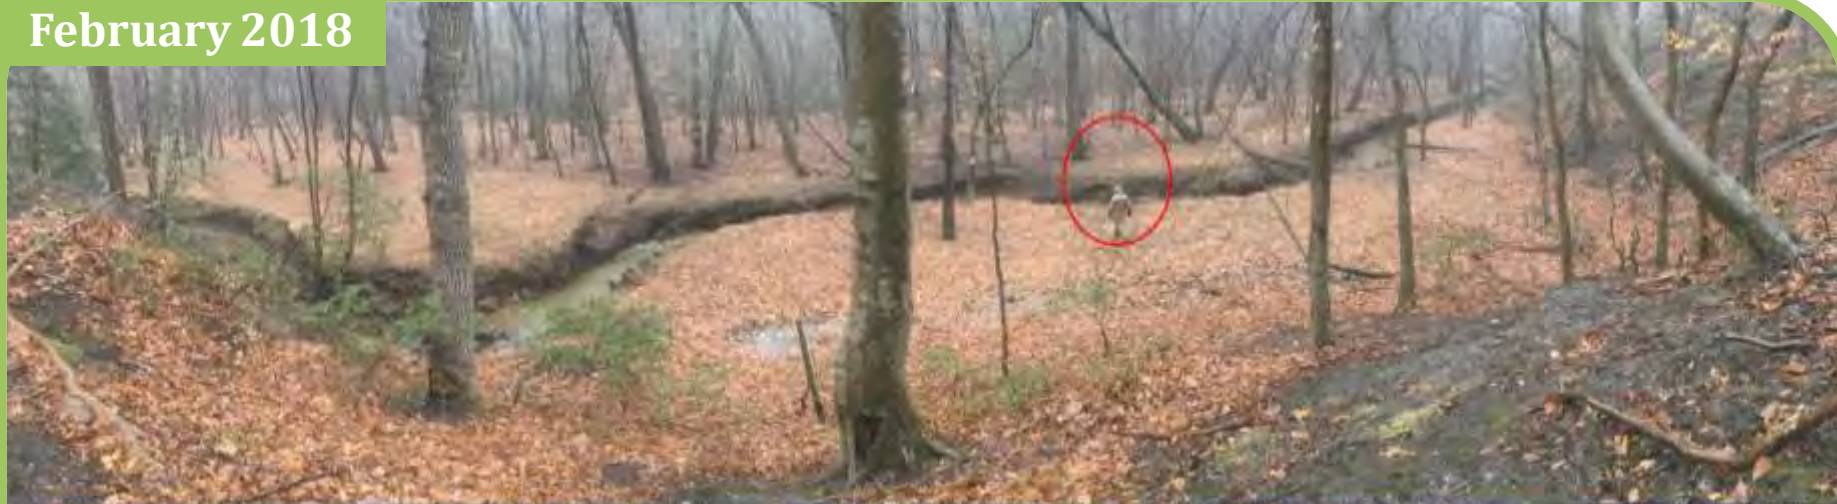
February 2018

These photographs, taken by Biohabitats, show the increase in stream water surface elevation pre- and post-construction.

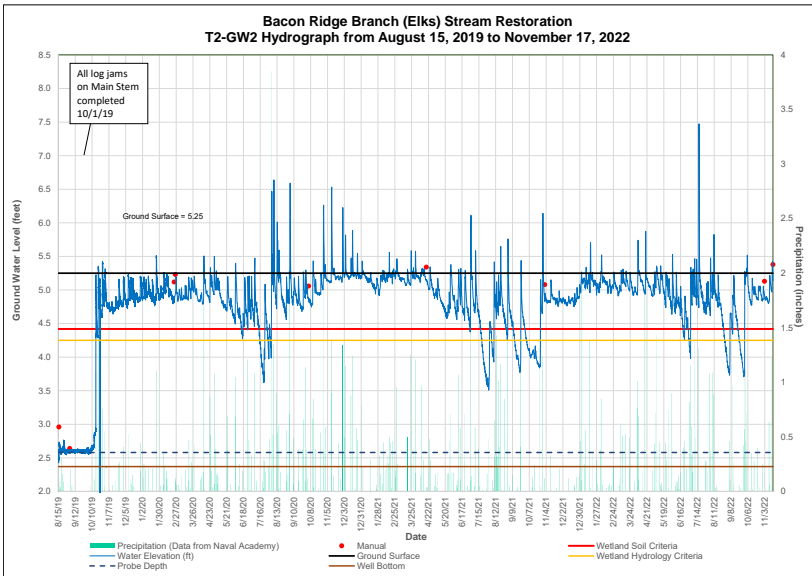
Transect T2 on the Main Tributary

Logger ID	Approx. Distance from Stream (ft)
T2-S1	In-Stream
T2-GW1	50 feet
T2-GW2	100 feet
T2-GW3	200 feet
T2-GW4	270 feet

- Groundwater elevation increased immediately $\geq 2'$ at the majority of wells right after construction
- T3-GW3 only increased approx. 1', but it's 200' from the stream channel
- The groundwater increase necessary to re-create hydric soil conditions has been sustained

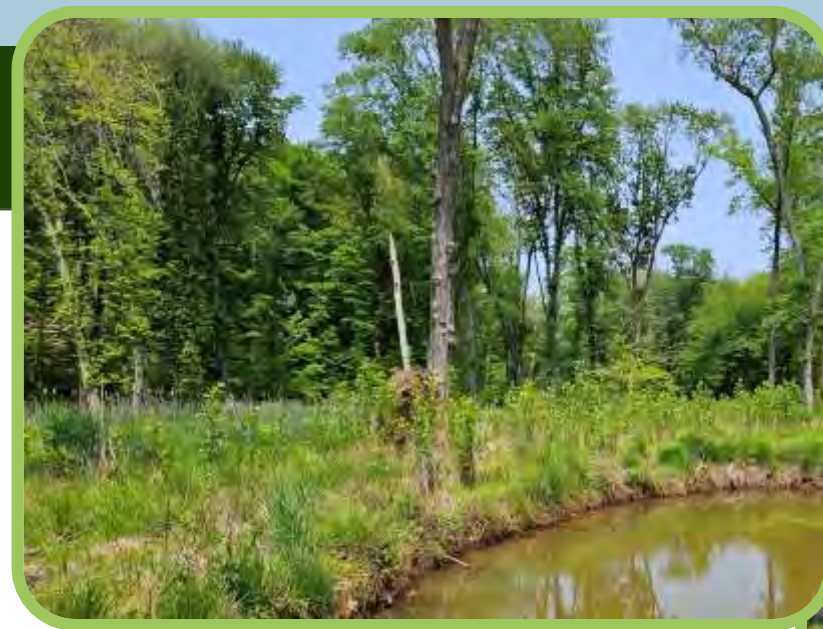
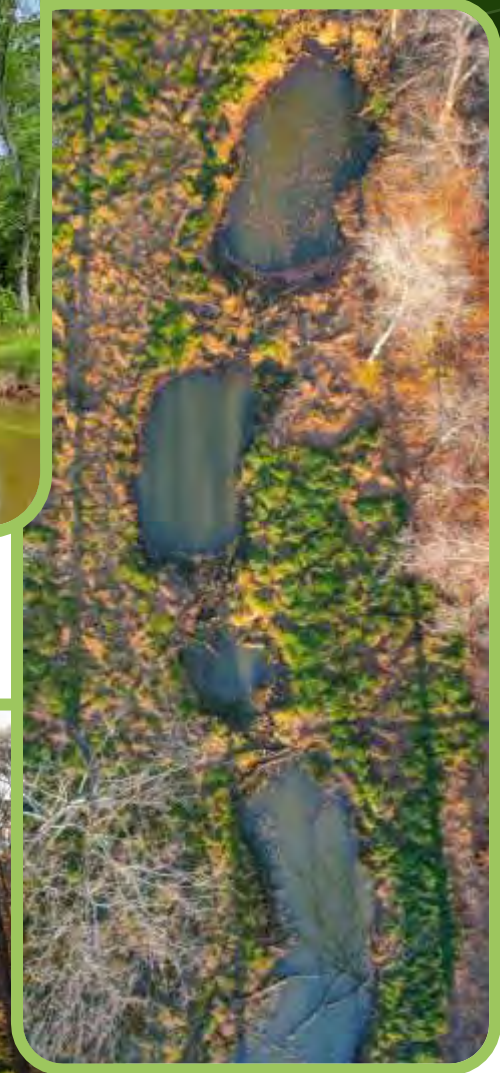
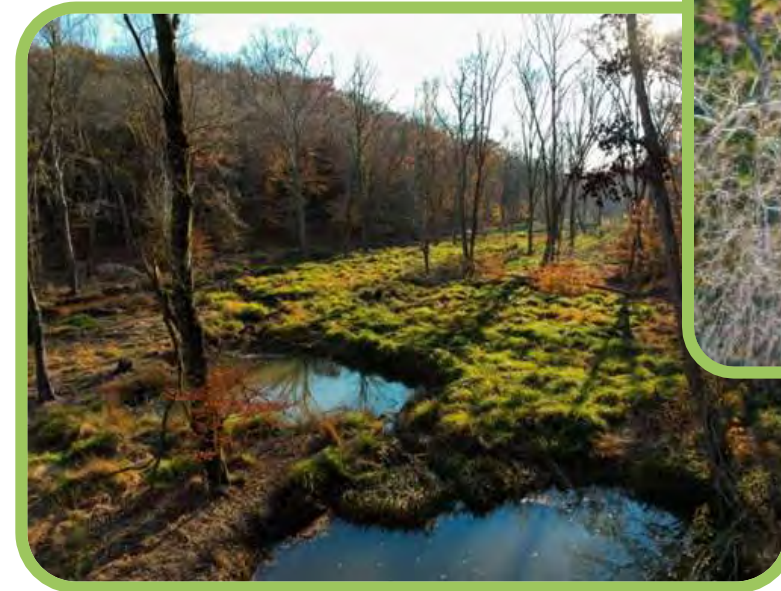
Above and Below: Vegetation along the Main Tributary.
Right: Aerial view of log jams and pools on the Main Tributary.

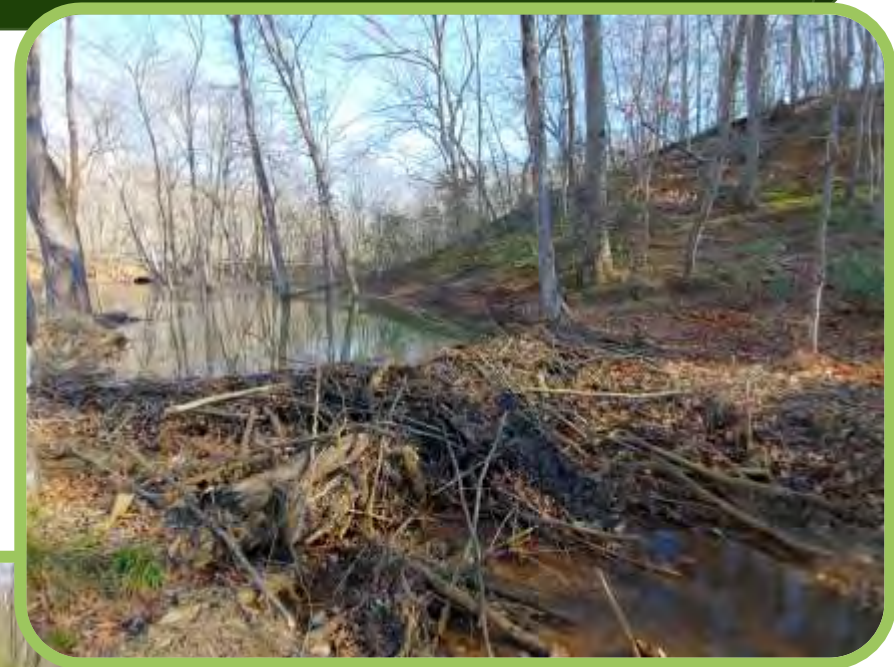
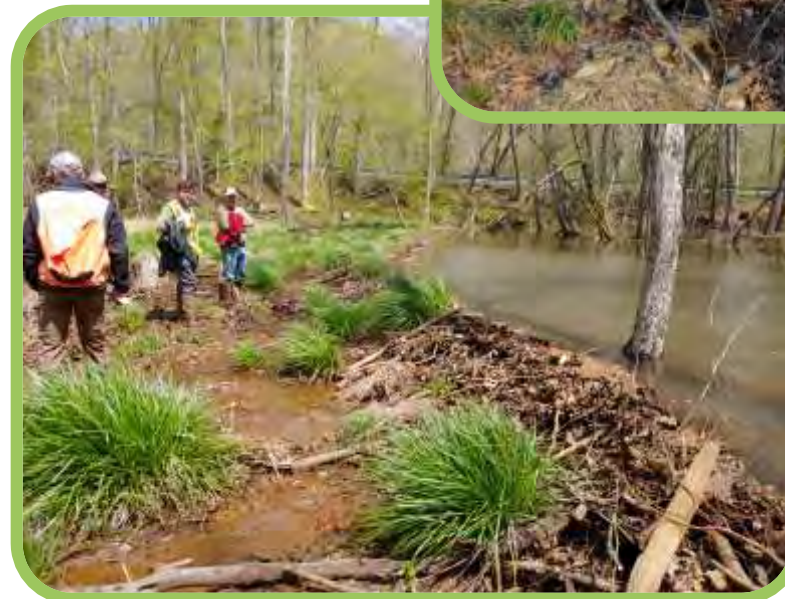
A large beaver dam on the upstream end of the Main Tributary – facing upstream to the dam in December 2021 (above) and the adjacent right floodplain in April 2022 (left).

- Beaver
 - Eating some woody vegetation
 - Large (3' high) dam on first Main Tributary log jam retaining organic matter → less entering system
 - Adaptive Management: Managing beaver impacts if needed, not beaver presence
- Woody vegetation survival lower than anticipated
 - Deer, increased hydrology, beaver
 - Adaptive Management: Supplemental plantings
- Highly erodible soils coupled with hydrology contribute to more flow around and through log jams than anticipated
 - Adaptive Management: Filling voids in log jams where possible with a variety of material

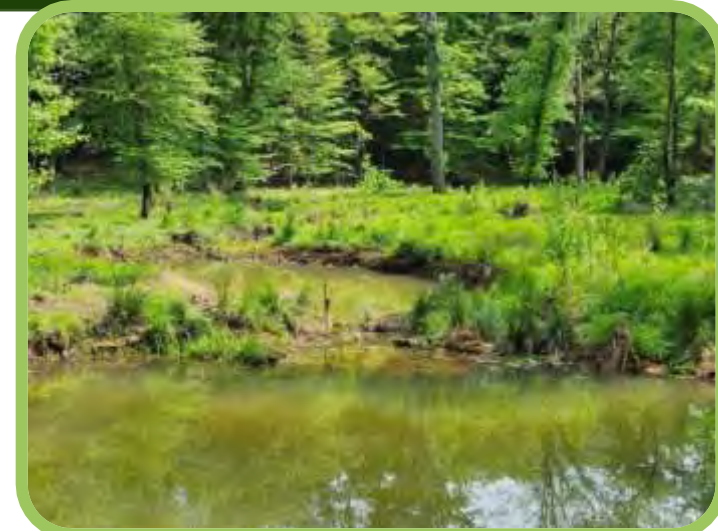
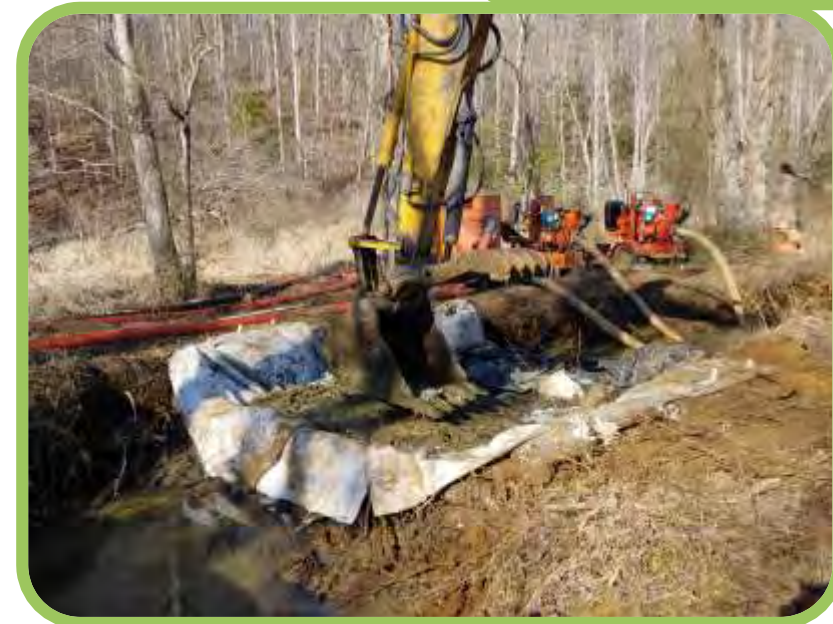
Above: A log jam that received adaptive management to encourage flows over the structure.
Left: A new log jam under construction at the downstream end of the project. The white material in the photo is bentonite fabric.

- Decreased water surface elevations in some locations, particularly the Main Tributary
 - Potentially due to increased porosity, piping flows, precipitation
 - Some sediment in structures has likely washed away
 - Adaptive management: Filling voids in log jams where possible with a variety of material, supplemental planting including sod mats
- Log jam at downstream tie-in to unrestored, tidal channel was not holding upstream water surface elevation
 - Adaptive Management: Re-constructed 3 log jams and built 3 new log jams at the tidal interface to slowly decrease invert elevations and build a stronger tie-in
 - Tie-in now includes imported rock, and all new and re-constructed log jams include bentonite fabric
